LTB00891NAS3

# TECHNICAL BULLETIN

501-08

Roof Opening Panel Rear Glass Seal Loose

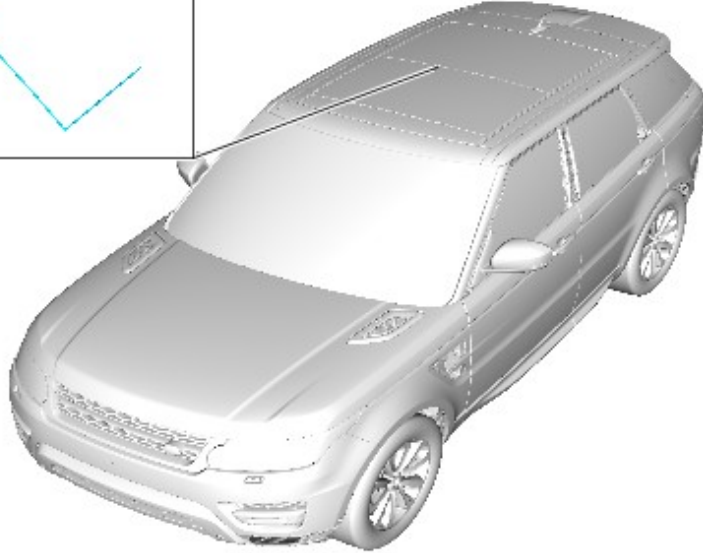
E186000

**Component location.**

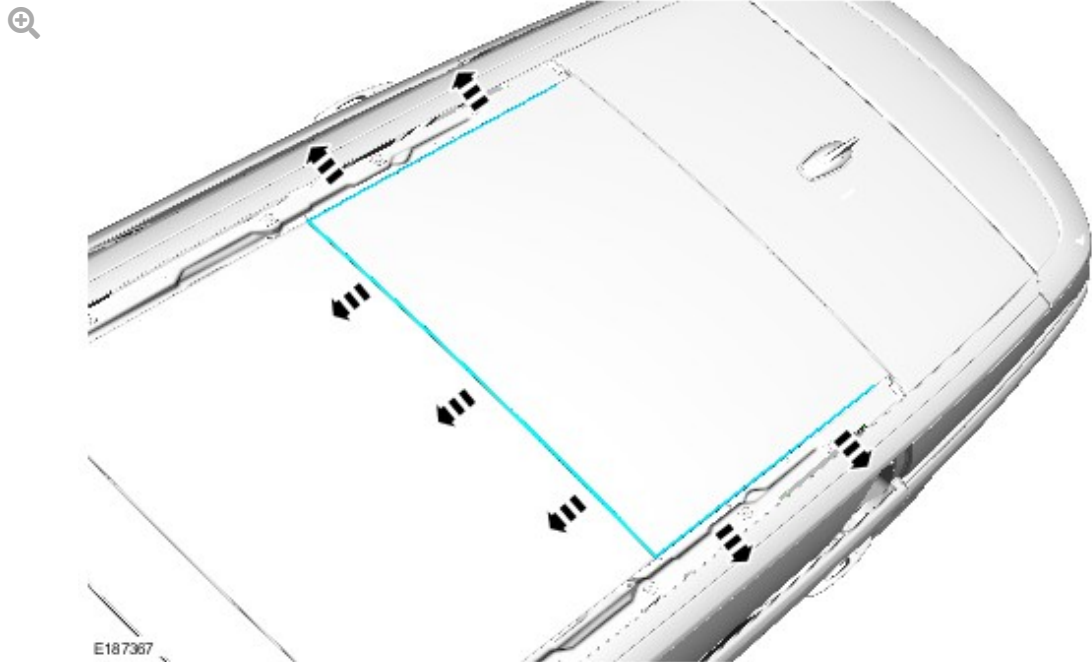
Note the orientation of the rear glass roof panel seal when removing from the vehicle.

Remove the roof opening panel rear glass seal.

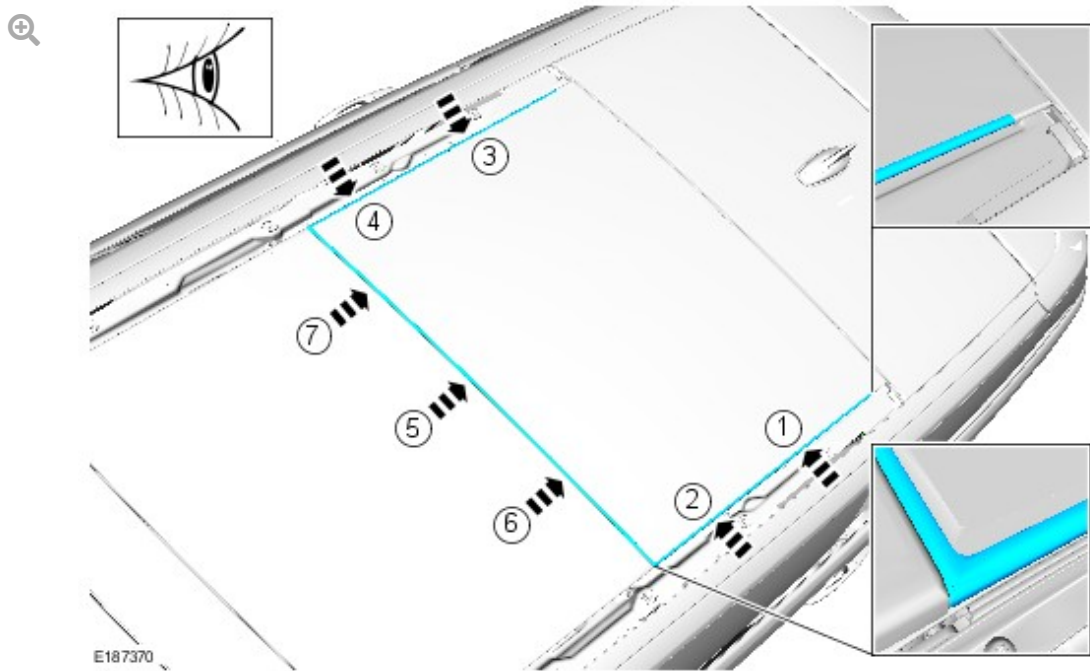
Make sure the roof opening panel rear glass seal is correctly installed and fully located.

Make sure the seal is installed in the correct orientation.

Install the new roof opening panel rear glass seal.

- **1.** Make sure the end and the corners of the roof opening panel rear glass seal are installed first.
- **2.** Install the roof opening panel rear glass seal in the order shown.
