LTB00923NAS2

# TECHNICAL BULLETIN

501-10

Second Row Seat Rail Edge Exposed

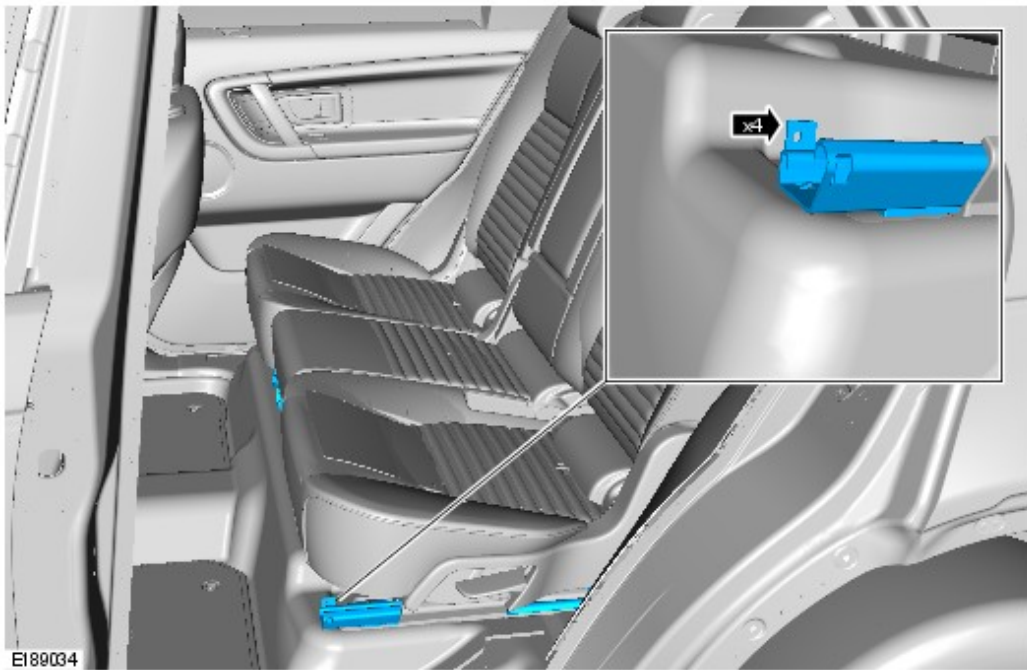
3.

The leading edge of the second row seat rail may cause discomfort to passengers if contacted with force while the seat is in its rearmost setting.

This may be caused by seat rail edge being exposed while the seat is in its rearmost setting.

Identify the area of the four second row seat rails to be modified.

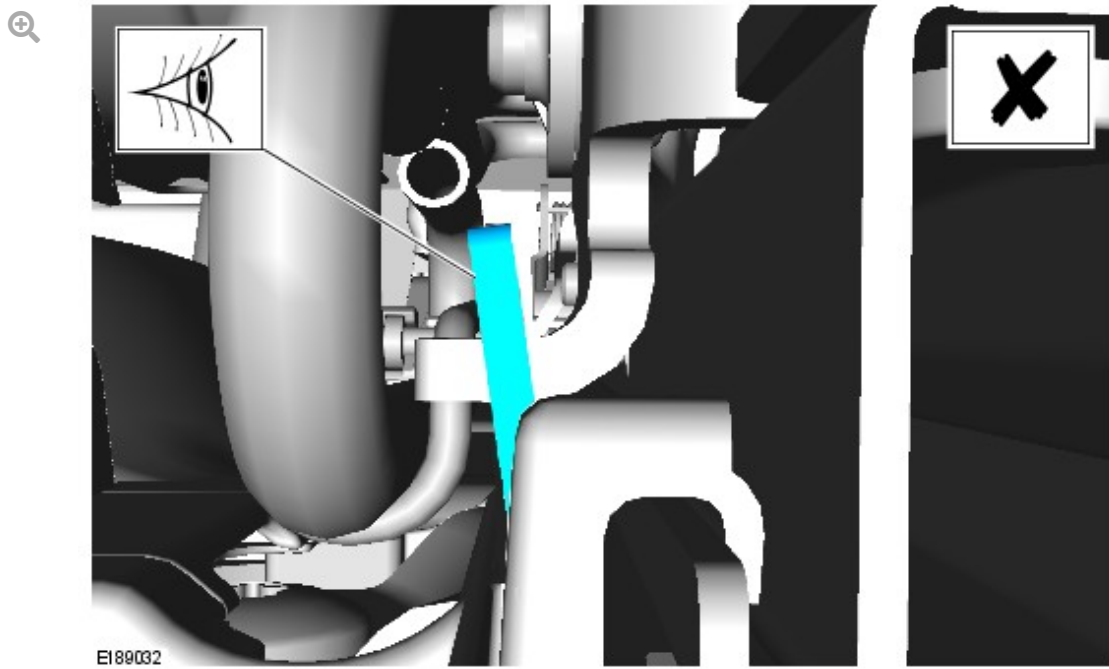
4.

Check the alignment of the seat rail tang.
