LTB00960NAS2

TECHNICAL BULLETIN

Loadspace Cover Support Peg(s) Broken

MODEL:	MODEL YEAR:	VIN:	ASSEMBLY PLANT:
Range Rover (LG)	2013-2016	001204-290763	Solihull

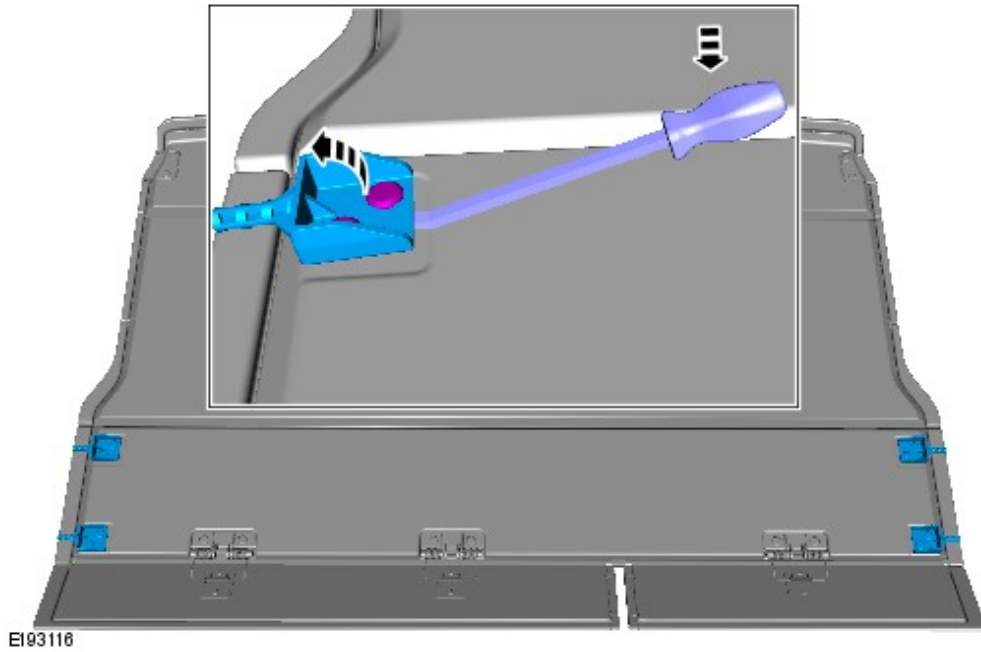
3.

One or more of the loadspace cover support pegs may be broken, snapped, or loose.

This may be caused by general wear and tear on the loadspace cover support peg.

Using a suitable tool, lever off the affected loadspace cover support peg.
