LTB01211NAS3

TECHNICAL BULLETIN

05 OCT 2020

Carbon Fiber Hood Delamination

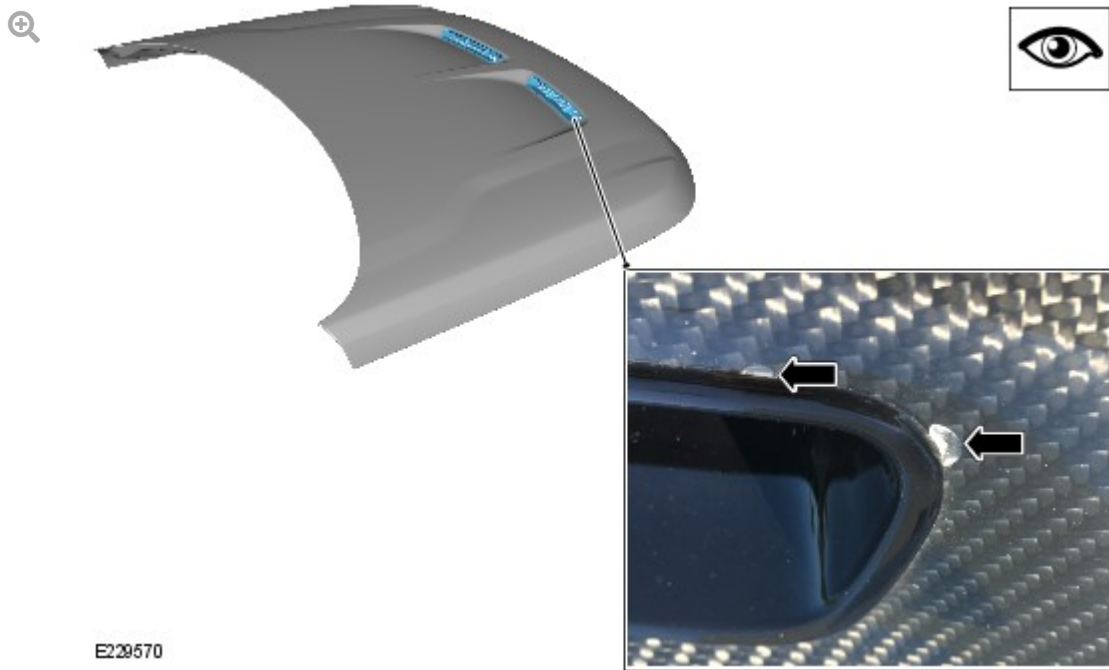
On vehicles with a carbon fiber hood, the area surrounding the hood vents on the carbon fiber hood may be delaminating.

This may be caused during hood vent installation where the hood vents lift the laminate away from the hood.

Inspect the hood for delamination in the area surrounding the hood vents.

- ■ If similar delamination on the hood in the area surrounding the hood vents is not evident, go to the Workshop Procedure below and perform **Steps 1 and 14 only**.
- ■ If similar delamination on the hood in the area surrounding the hood vents is evident, go to the Workshop Procedure below.
