N400NAS4

TECHNICAL BULLETIN

Service Action: Startup Battery Ground Stud - Insufficient Ground Contact

| MODEL: | MODEL YEAR: | VIN: |
|---|---|---|
| Discovery (LR) | 2019-2020 | 400099-418197 |

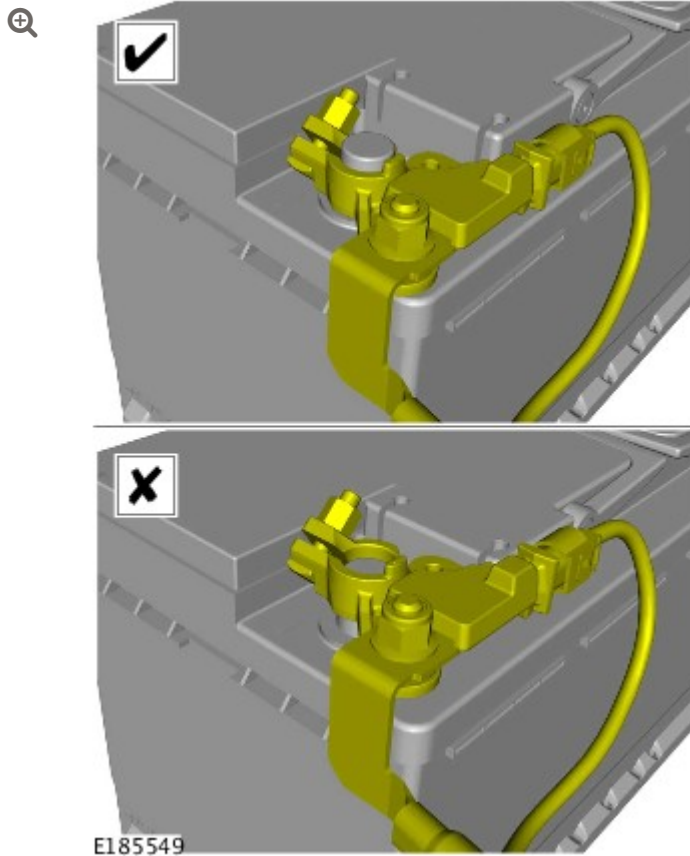
7.

Make sure the battery terminal is in the correct position.

Connect the startup battery ground cable (see TOPIx Workshop Manual section 414-00: Battery and Charging System - General Information - Specifications).
