SERVICE PROGRAM BULLETIN

APPLICABILITY: 2015-2016MY Legacy 2.5L

SUBJECT: Exhaust Pipe Front (EPF) Bellows Cracking

NUMBER: WUJ-95R **DATE:** 02/11/20

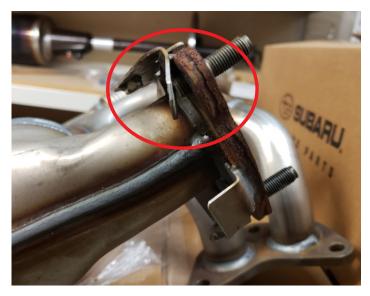
• Some reports have been received regarding the mounting bracket tabs as pictured below. Occasionally, the fastener holes in the bracket are not fully aligned with the holes in the center exhaust pipe mounting flange. The pictures show one of the center exhaust pipe mounting studs displacing the bracket tab. If this happens, it may cause the bolt hole for the converter shield to become mis-aligned (or, it may have no effect at all). This condition MAY require some <u>VERY CAREFUL</u> manipulation of the mounting bracket to re-align it with the converter shield bolt hole.

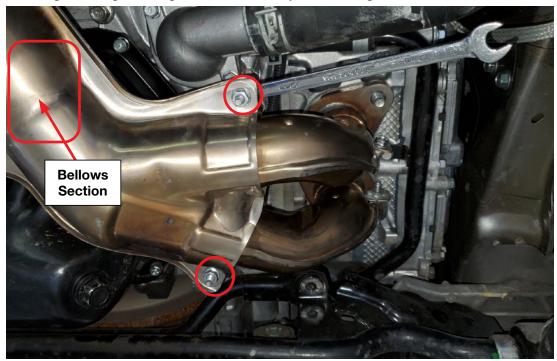
(9.6 ft. lbs.) **EXCEPT** for the two on the driver's side shield shown in the photo below. This shield covers the bellows section of the EPF and if tightened, the dimension of the bellows may be changed enough to keep the EPF assembly from fitting back onto the exhaust studs properly.

- Install the EPF assembly and torque the six cylinder head flange nuts to 30 Nm (22.1 ft. lbs.) **THEN tighten the last 2 heat shield bolts** shown above to 13 Nm (9.6 ft. lbs.).
- Re-connect the A/F sensor connectors.
- Reinstall the center exhaust pipe with the new gaskets supplied in the kit in reverse order of removal.

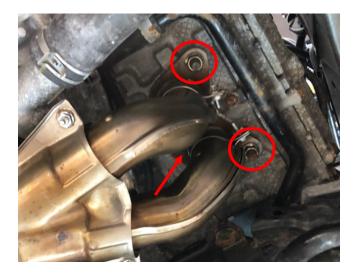
In response to reports of the cylinder head studs coming out when removing the six (6) EPF retaining nuts, the following TIPS will provide helpful solutions:

- It is STRONGLY recommended to not attempt removal of these nuts with the engine hot. Always allow the engine to adequately cool before proceeding.
- Apply a penetrant (e.g. PB Blaster or equivalent) to the nuts while the engine is cooling.

- Use a small wire brush after applying the penetrant to remove any loose rust from the studs where they extend past the top of the retaining nuts. Re-apply the penetrant as needed.

- Use **6-point sockets ONLY** (sockets with "flank-drive" are preferred) to remove the retaining nuts and prevent rounding. Applying a small amount of valve grinding compound to the flats of the retaining nuts can also help prevent rounding them and add some extra grip for the socket.

- USE HAND TOOLS ONLY to break the retaining nuts loose then add penetrant, work them back and forth, add penetrant and repeat until removed.
- As a last resort, CAREFUL use of auxiliary heat can be used. Use of inductive tools is recommended when heating is required as opposed to tools using open flame but, either method may be used successfully and safely based on the Technicians experience level.
