SERVICE PROGRAM BULLETIN

APPLICABILITY: 2020MY Outback 2.5L NA Models
SUBJECT: WRE-20 Ignition Coil Campaign

NUMBER: WRE-20
DATE: 10/27/2020

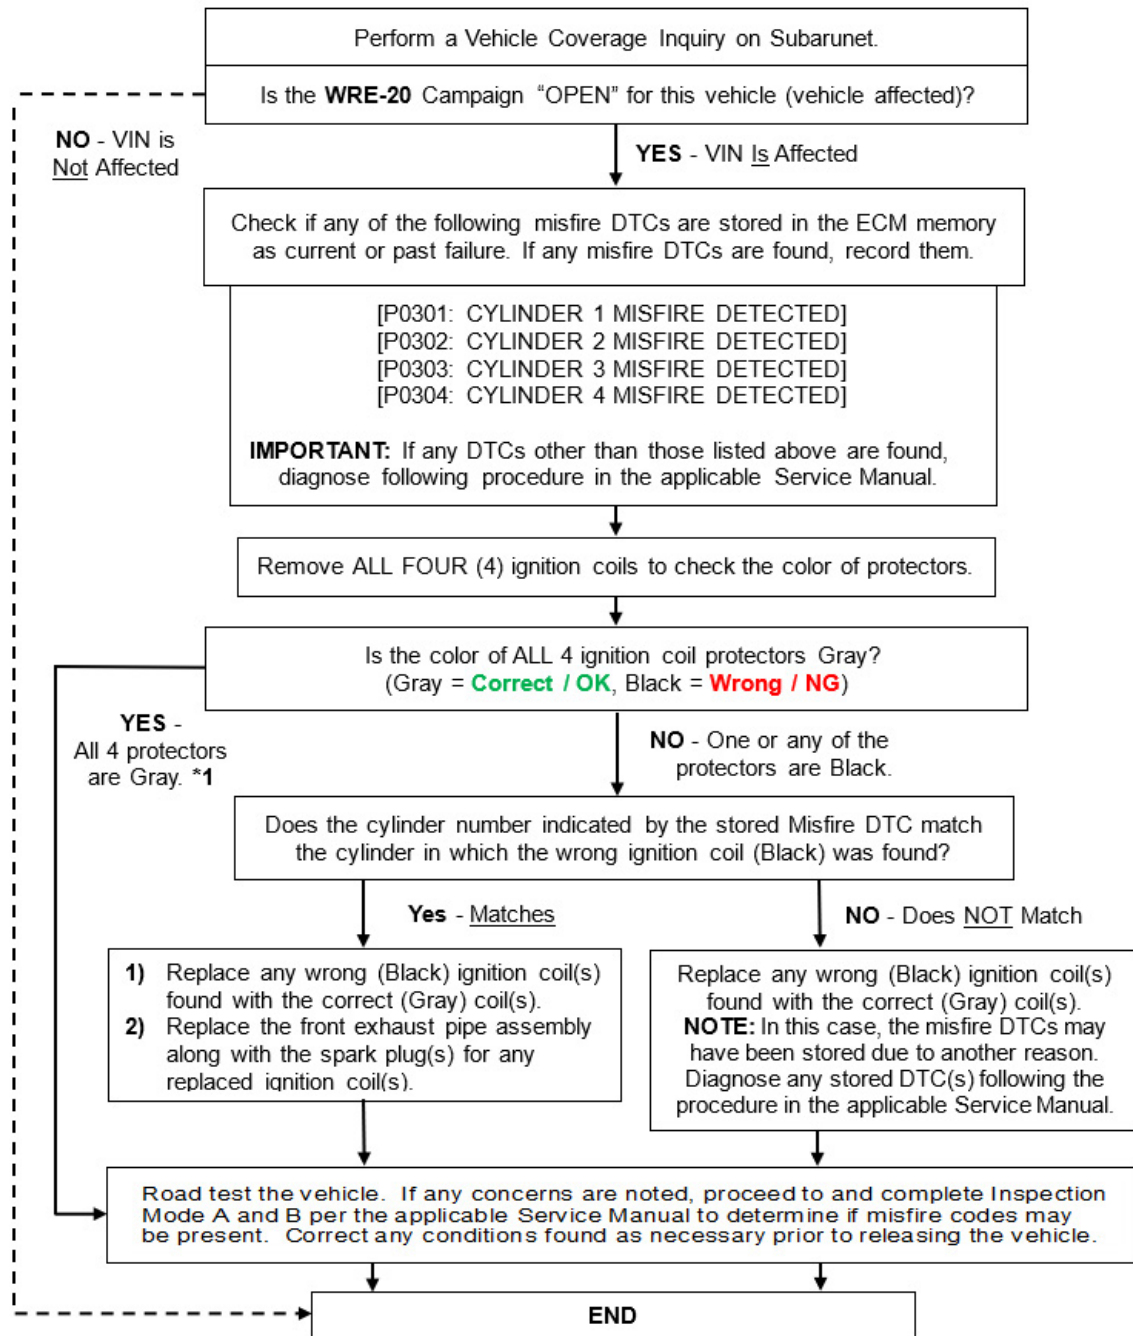
*1: **NOTE:** If any misfire DTCs are stored but the protector color is Gray, there may be a different failure. Perform diagnosis following procedure in the applicable Service Manual.

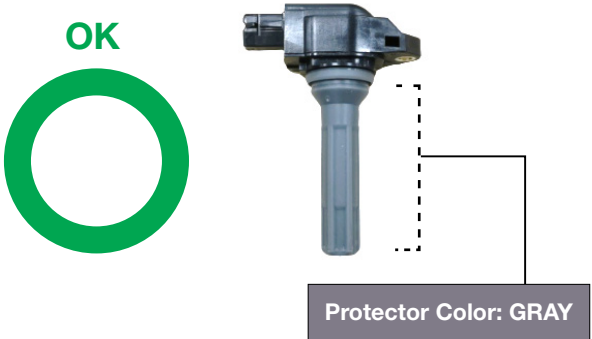
CORRECT Ignition Coil (22433AA81A for 2.5L NA Engine)	Wrong Ignition Coil (22433AA82A for 2.4L Turbo Engine)

<p>OK</p> <p>Protector Color: GRAY</p>

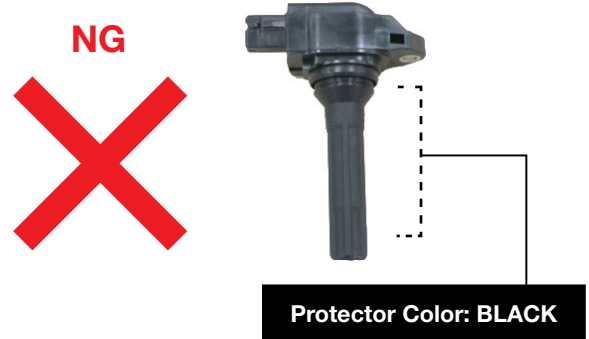
One or more incorrect ignition coils may have been installed in the affected vehicles during production. As a result, over time, a misfire might occur if the incorrect ignition coil continues being used. If a misfire occurs, the Check Engine Light may illuminate, and certain Diagnostic Trouble Codes (DTCs) may be set and stored.

<p>NG</p> <p>Protector Color: BLACK</p>

- 1) Replace any wrong (Black) ignition coil(s) found with the correct (Gray) coil(s).
- 2) Replace the front exhaust pipe assembly along with the spark plug(s) corresponding to any replaced ignition coil(s) ONLY.

Replace the wrong (Black) ignition coil(s) with correct (Gray) coil(s)*.
