SERVICE BULLETIN

APPLICABILITY: 2017-20MY Impreza
2018-21MY Crosstrek

NUMBER: 09-73-20

SUBJECT: Radiator Coolant Seepage

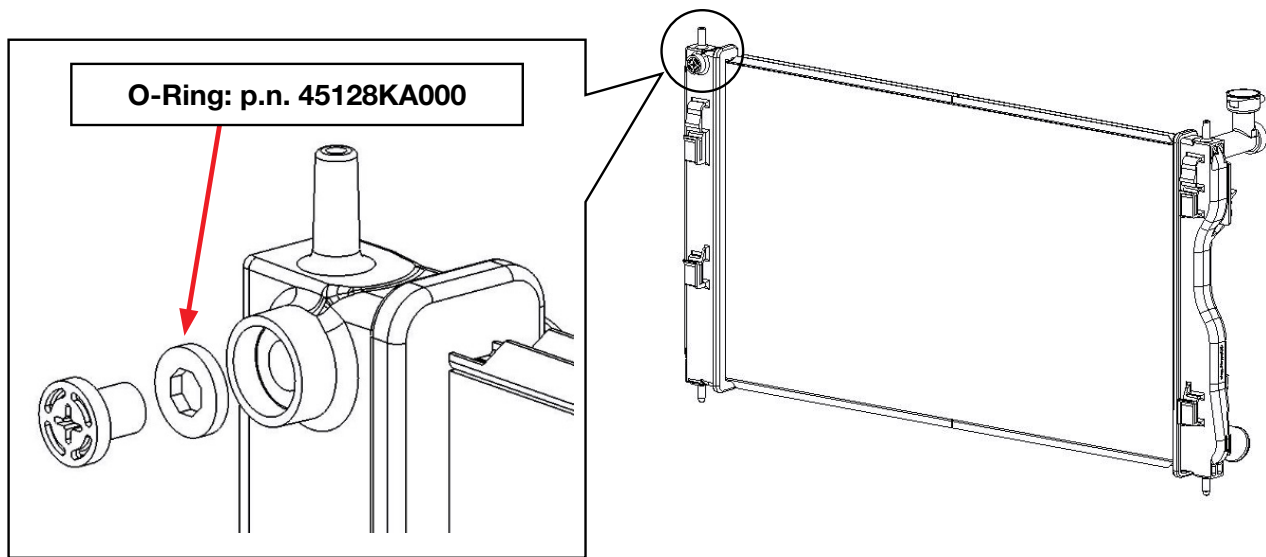
This bulletin provides a revised service procedure to follow when repairing minor coolant seepage identified to be coming from the air plug at the top of the radiator. If the air plug is not sufficiently tightened, the O-ring on the plug may not seat properly and compress, resulting in coolant seepage in cold weather. The repair involves replacing the O-ring and tightening the air plug to the new torque specification of 2 Nm (18 inch-pounds).
