Technical product information

Topic	Infotainment screen turns red sporadically
Market area	Bentley: worldwide (2WBE),Hongkong-Macau (5HK)
Brand	Bentley
Transaction No.	2055846/3
Level	EH
Status	Released for publishing
Release date	22-Oct-2020

New Continental GT and New Continental GTC

New Flying Spur

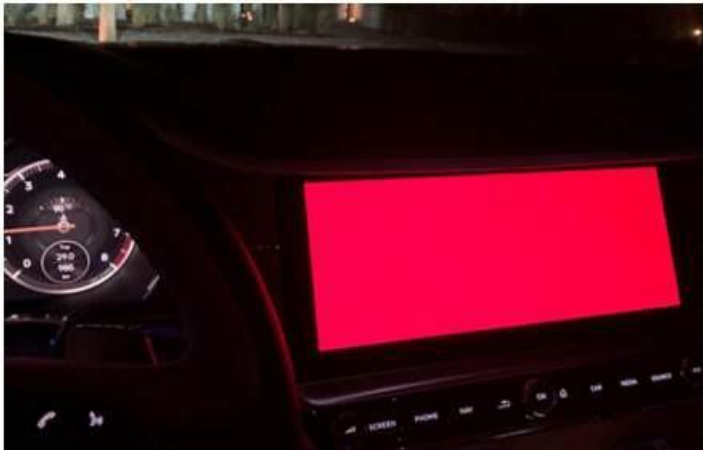
Figure 1

Infotainment screen turns red sporadically (Figure 1)

Reset the Infotainment system as follows:

- Press and hold the volume rotary switch (Figure 2) for 10 seconds
