| <b>Topic</b> | New Continental GT 48V anti-roll bar cable routing |
| <b>Brand</b> | Bentley |
| <b>Transaction No.</b> | 2051712/5 |

### New Continental GT

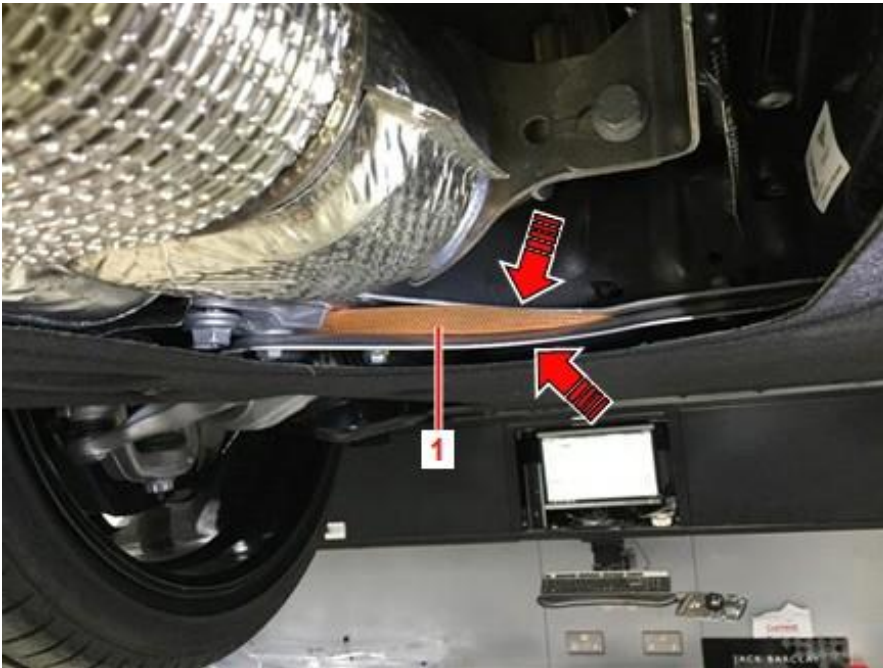
Figure 1

The 48 volt supply cable (1) to the anti-roll bar may appear to be trapped between the front subframe and the engine undersheet (arrows). See Figure 1.

This would be visible on the LH underside of the vehicle and is the normal condition for this routing of cable.

Do NOT raise a DISStechical query for this concern.
