Technical product information

Topic	New Continental GT - Ski hatch difficult to latch/unlatch
Market area	Bentley: worldwide (2WBE),Hongkong-Macau (5HK)
Brand	Bentley
Transaction No.	2052208/5
Level	EH
Status	Released for publishing
Release date	21-Oct-2020

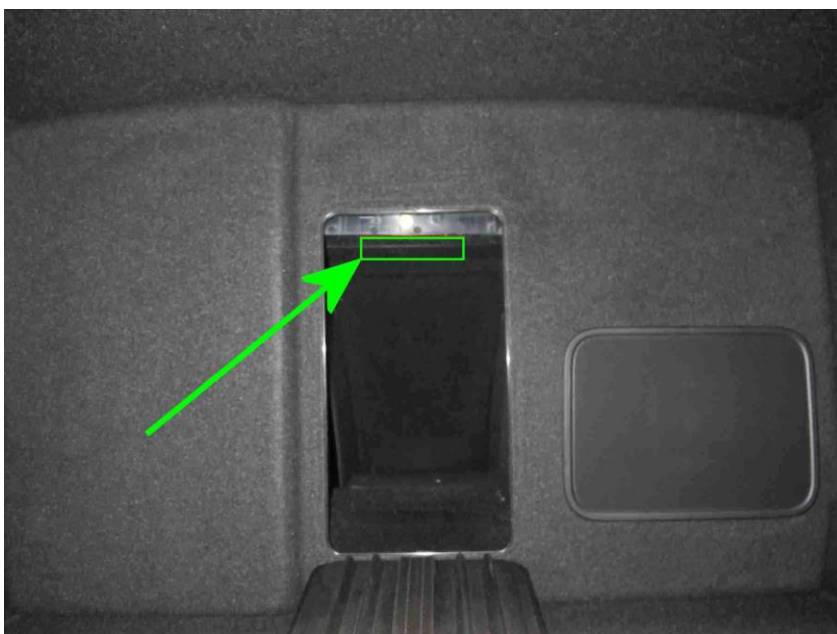
Figure 1

- Refer to Figure 1, looking into the boot locate the ski hatch lock aperture which is in the area shown

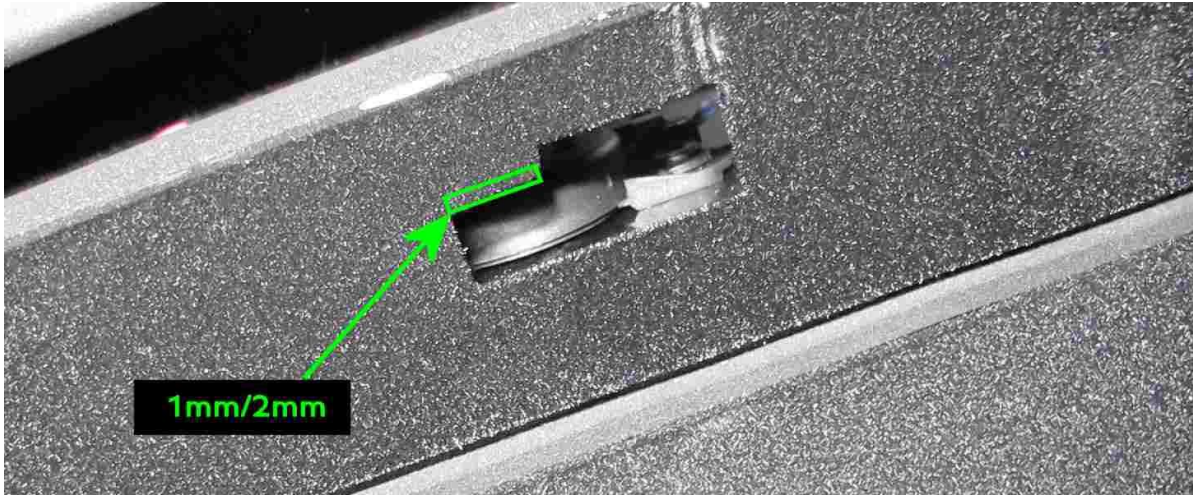
Figure 2

Due to tight tolerances the ski hatch mechanism fouls the upper ski hatch trim when closed/locked.

- Referring to Figure 2, Using a suitable tool initially remove up to 1mm from the trim and retest
- In the event the hatch does not close remove a further 1mm from the lock trim and retest
