# Technical product information

<b>Topic</b>	New Continental GT - Wind noises
<b>Market area</b>	Bentley: worldwide (2WBE),Hongkong-Macau (5HK)
<b>Brand</b>	Bentley
<b>Transaction No.</b>	2051748/8
<b>Level</b>	EH
<b>Status</b>	Released for publishing
<b>Release date</b>	21-Oct-2020

# GT Wind noise concerns – Fix documentation

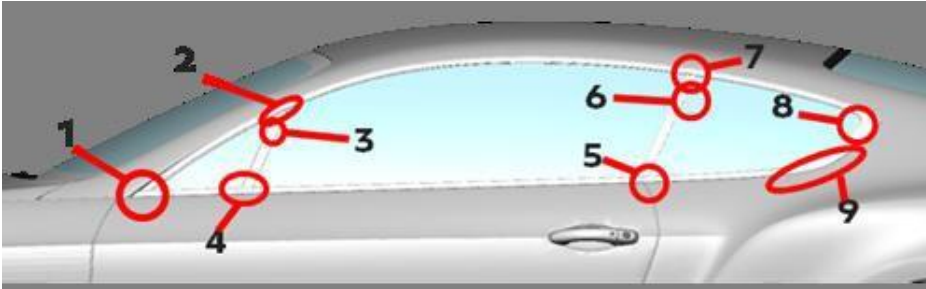
Figure 1

Possible wind noises in the following areas shown in *Figure 1*

Location	Symptom	Concern onset speed
1. Bottom of quarter glass	Openness/Leakage	120km/h
2. Front Div. Bar Upper	Leakage	120 km/h
3. Front Div. Bar Moulding	Openness/Leakage	140 km/h
4. Front Div. Bar lower	Openness	140 km/h
5. Rear Div. Bar lower	Minor leakage	140km/h
6. Rear Div. Bar Upper to Glass	Openness	140 km/h
7. Rear Div. Bar Upper interface	Leakage	120 km/h
8. C-Post corner	Minor Leakage	140 km/h
9. Rear Qtr. Waist including Brightware	Minor Openness	140 km/h

Note: Both sides of the vehicle can be affected

Identify the location of the wind noise as per *Figure 1*. Carry out visual and functional checks of the affected area then use the attached workshop instructions to help identify the possible cause/issue, applying the relevant fix where necessary

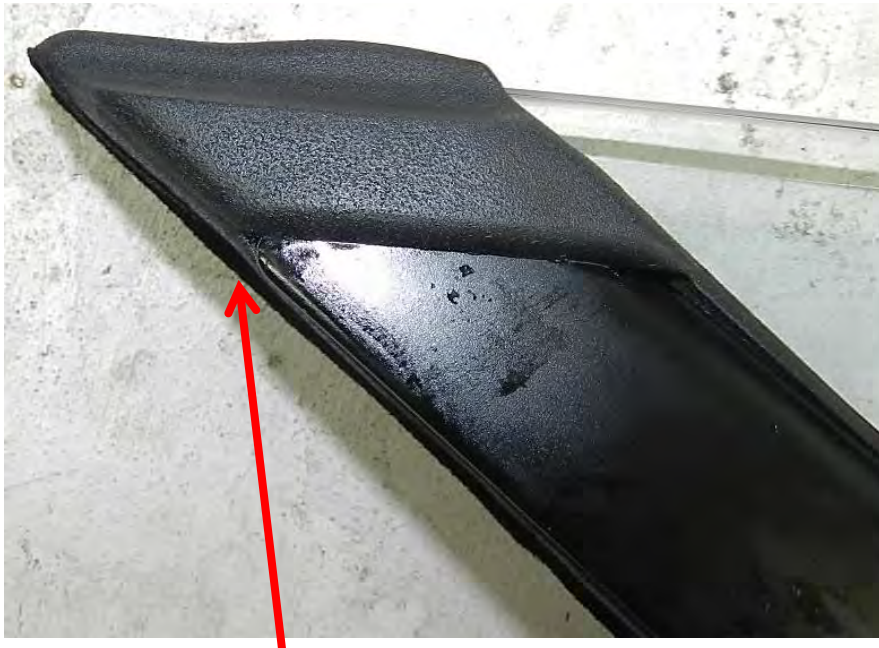
Issue - Division bar seal not fitted correctly

Poor condition – Top corner radius of division bar visible. Moulding should sit lower and cover this edge.

Fix – Strip qtr glass & re-assemble correctly

1. See aftersales documentation to remove the front quarter glass assembly.

Refer to "Front door division bar - To remove and fit".

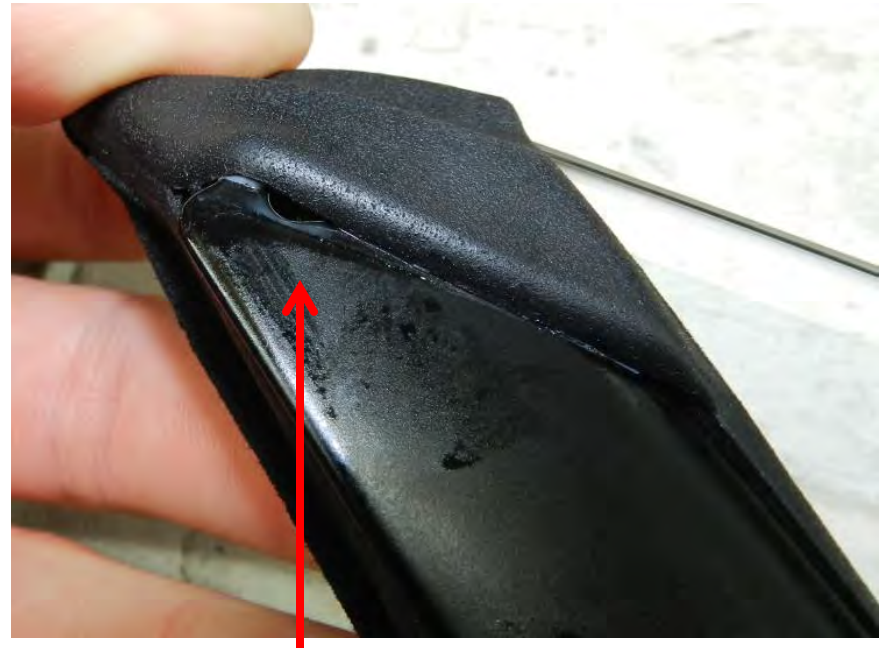
Poor condition - seal not hooked into div bar retention feature

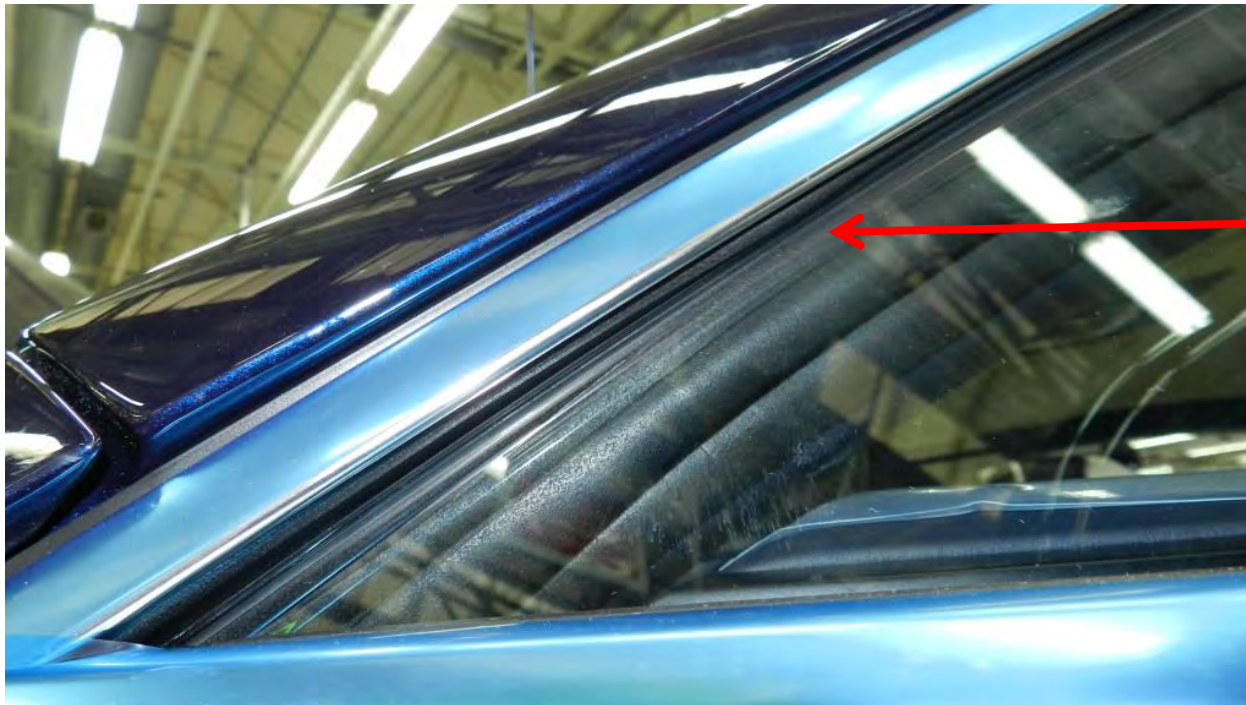
Issue – Front quarter glass not engaging seal

Poor condition - Edge of glass exposed, not in contact with seal.

Fix – Remove door pad & adjust quarter glass assembly upwards

See aftersales documentation to re-set qtr glass

Refer to “Side glass - To set”. → Rep. Gr.64

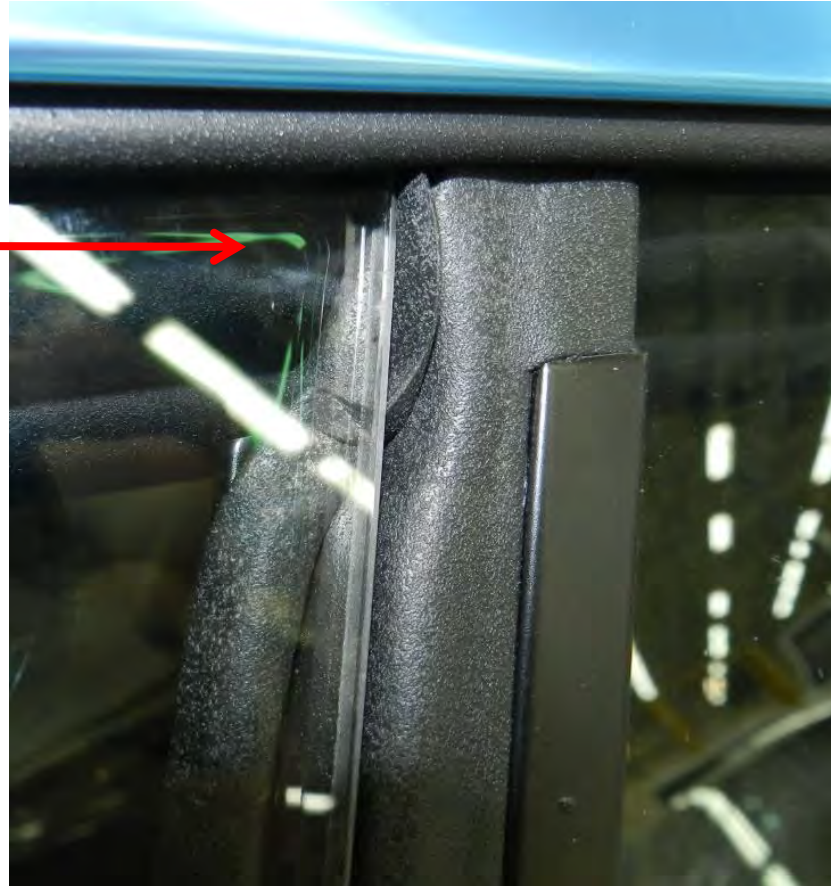
Issue – Top of seal 'folded' on itself behind door glass

Poor condition - seal folding on the edge of the door glass

## Fix – 1. Re-set seal condition

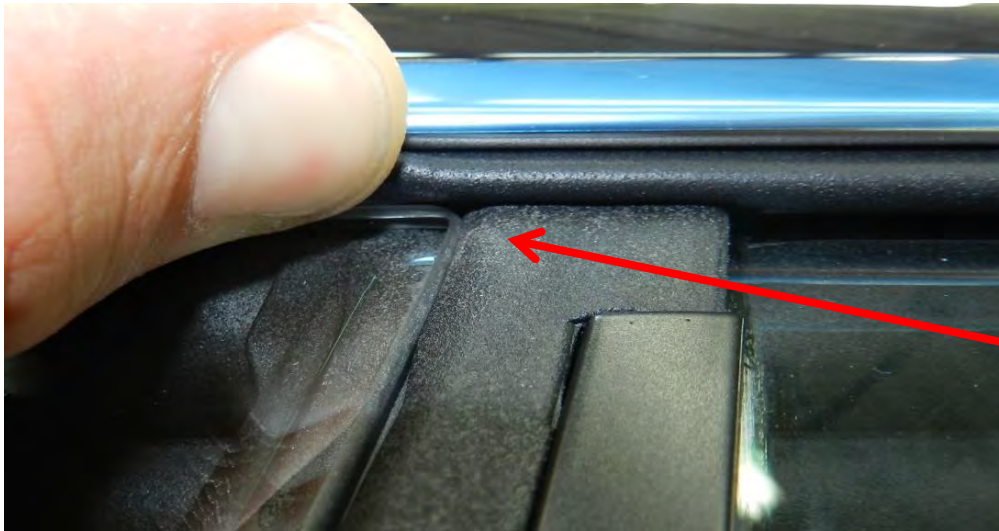
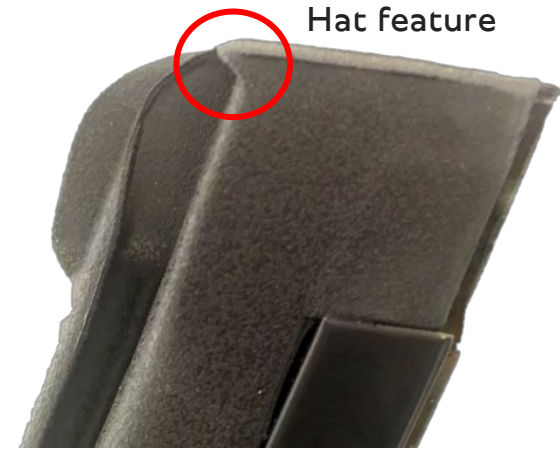
Issue – Hat feature folding

Division bar seal “hat” should not fold. ‘Hat’ will fold if rear quarter glass is set more than 1mm lower than door drop glass in Z

Fix – Set door glass level or 1mm lower than rear quarter glass

Re-set glass as per aftersales document in Z-axis.

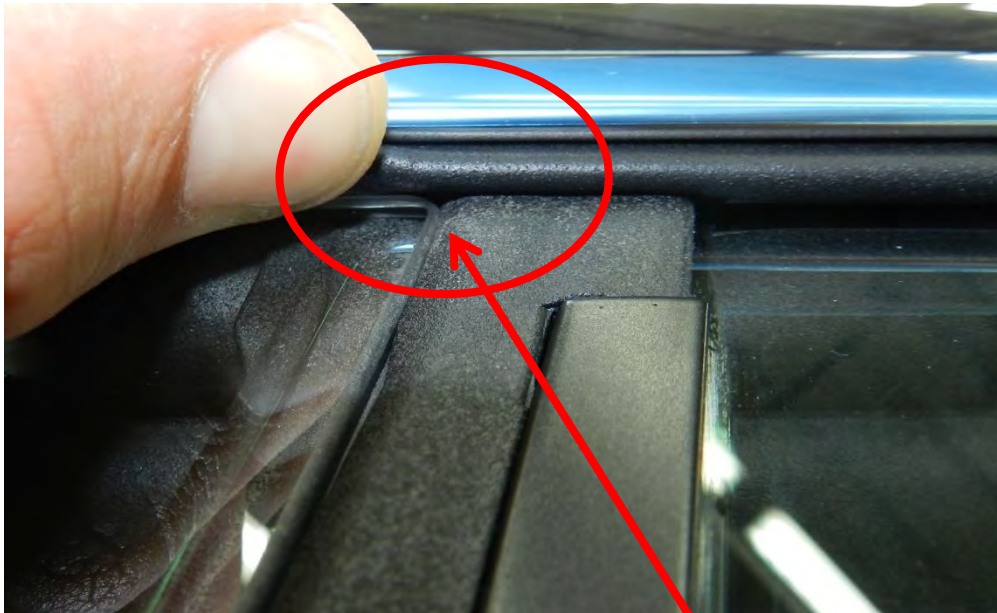
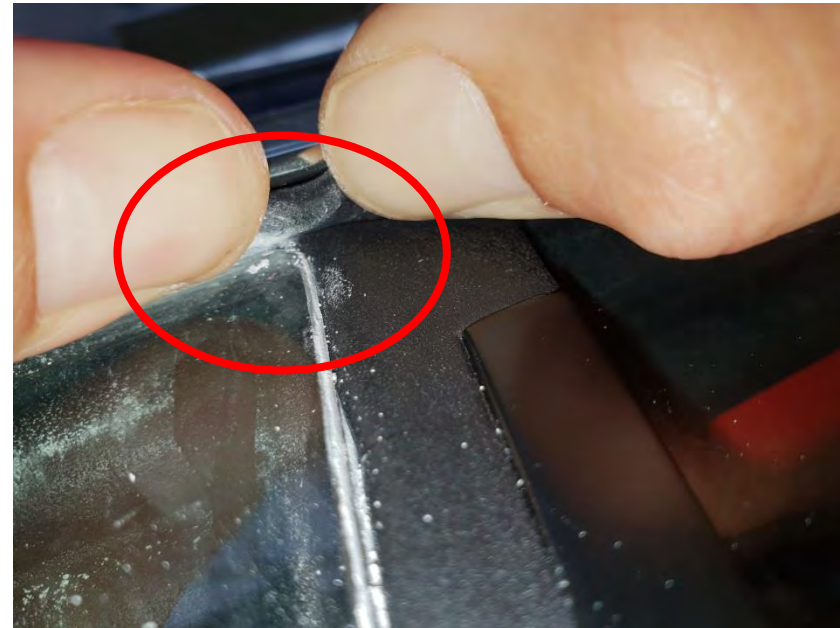
Issue – Door Glass Rear Corner & Rear Quarter Glass relationship

Div-bar seal "hat" should have a consistent touch condition with the top rear corner of the door glass and should not fold. 'Hat' will fold if rear quarter glass is set more than 1mm lower than door drop glass in Z

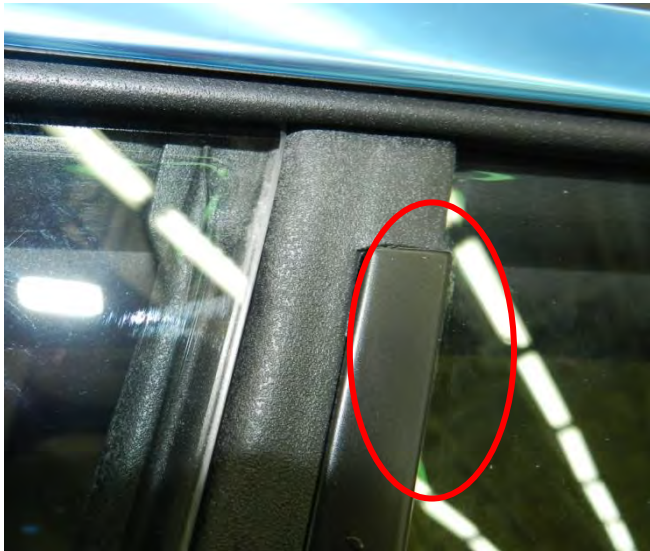
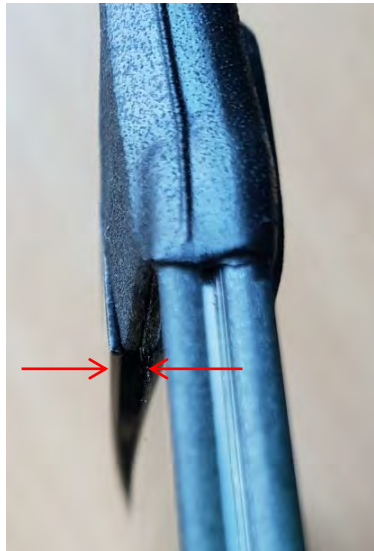
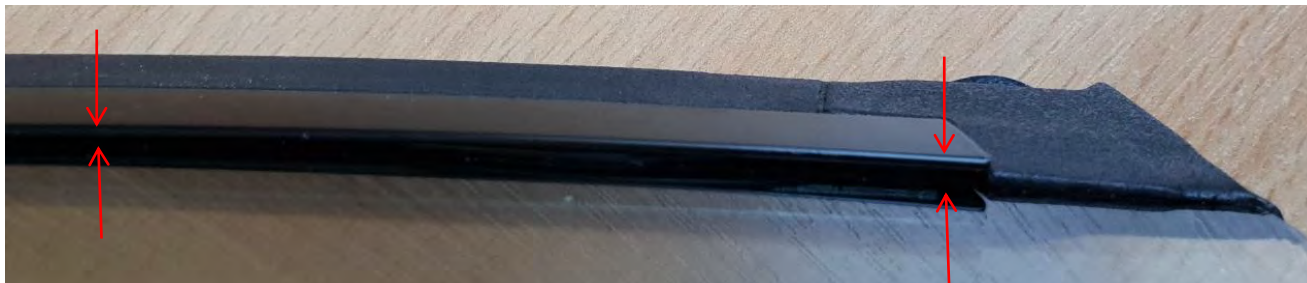
## Issue – Division bar gaps to glass

Rear division bar channel gaps to rear qtr glass

### Fix – Add sealant between division bar & glass

1. Sealant 'Betafil' to be applied down the length of the division bar with small nozzle to glass surface and cleaned with alcohol wipe / glass cleaner so that no sealant is protruding onto the glass surface
