Technical product information

Topic	Bang & Olufsen - BeoSonic sound settings reset after ignition cycle
Market area	Bentley: worldwide (2WBE),Hongkong-Macau (5HK)
Brand	Bentley
Transaction No.	2056276/2
Level	EH
Status	Released for publishing
Release date	22-Oct-2020

New Continental GTC

New Continental GT

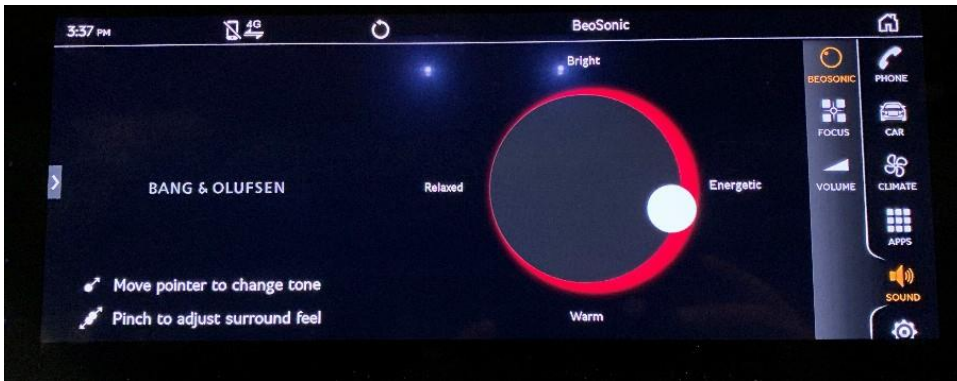
The BeoSonic sound settings are lost when the ignition is turned off.

Incorrect software in the Sound system control module.

Measure

The following must only be applied on receipt of a relevant customer complaint.
