**HYUNDAI**
Technical Service Bulletin

| GROUP BODY ELECTRICAL | NUMBER 20-BE-011H |
| DATE OCTOBER, 2020 | MODEL(S) Santa Fe (TMa) Palisade (LX2) |

SUBJECT: SURROUND VIEW CAMERA DISPLAY TROUBLESHOOTING GUIDE

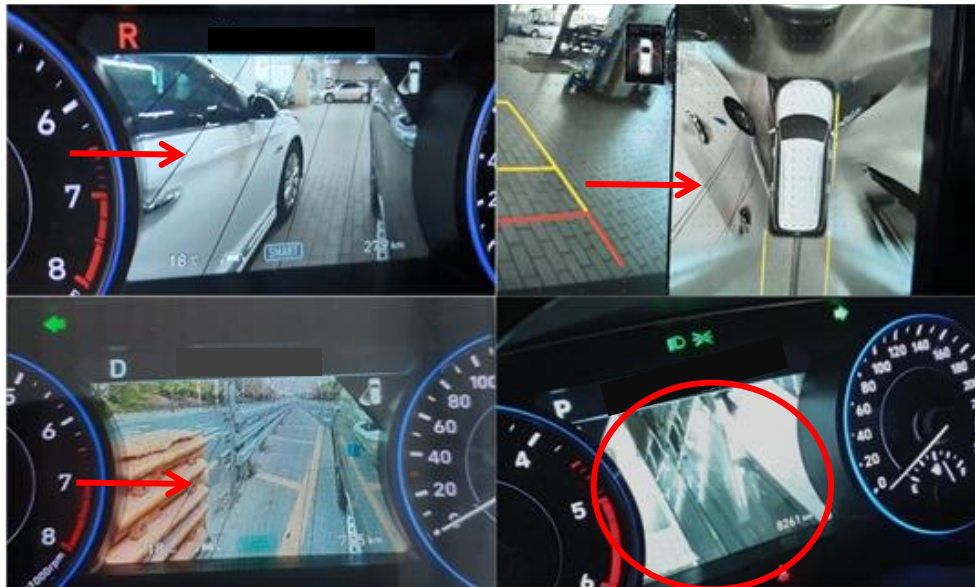
Description: Some 2020-2021 Santa Fe (TMa) and Palisade (LX2) may intermittently experience abnormal camera image display conditions on the instrument cluster when the turn signal is turned ON or the radio screen when transmission is in Reverse. The following conditions may occur; blurry image, line on the screen, fuzziness, or blue screen. This bulletin provides information to assist with troubleshooting the condition(s) above.

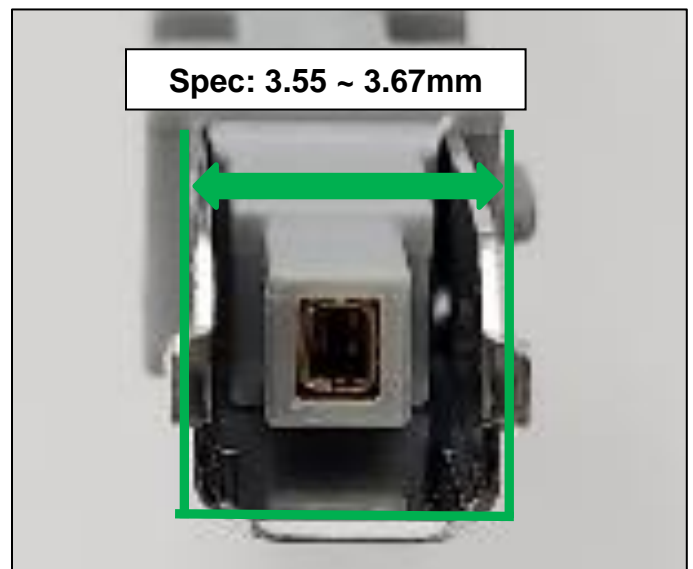
- 5a. Inspect the female pins for deformation. Measure the distance between vertical sides to ensure they are within specification.

Spec: 3.55 ~ 3.67mm

The pins are U-shaped, and should form 90 degree angles (square corners).
