Technical product information

Topic	New Continental GT and GTC - Rattle / Buzzing Noise - Head-Up display
Market area	Bentley: worldwide (2WBE),Hongkong-Macau (5HK)
Brand	Bentley
Transaction No.	2052431/4
Level	EH
Status	Released for publishing
Release date	21-Oct-2020

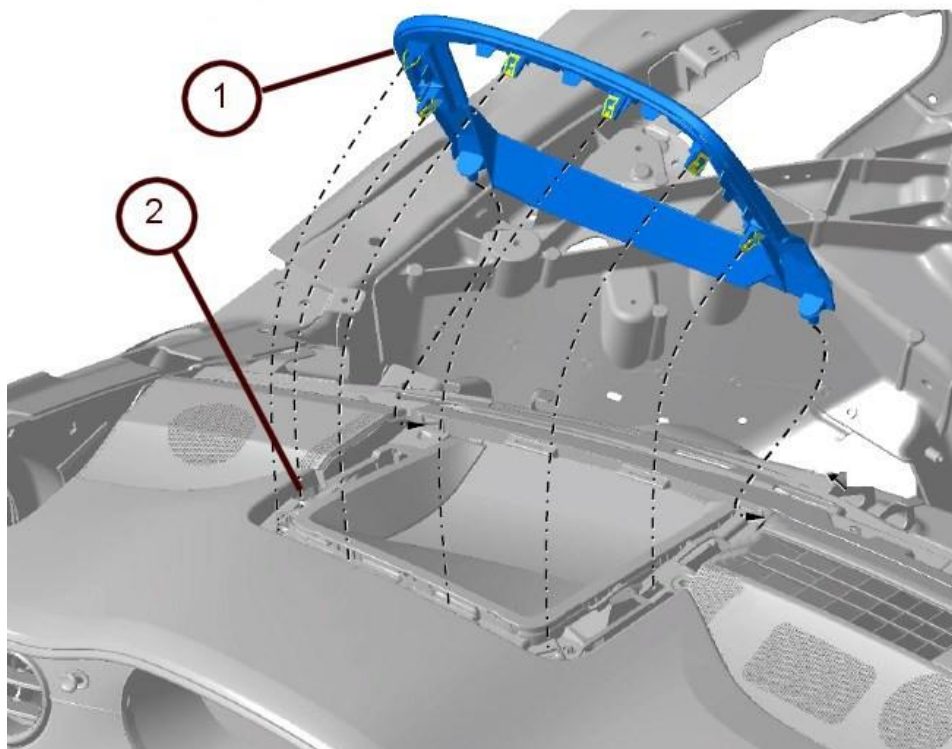
Figure 1

- Relative movement between Control Unit for Head-Up Display and associated Trim Ring – figure 1.
- Contact between the dashboard and dashboard upper trim panel.
- Head-up Display internal fault

1 – Trim Ring

2 – Control Unit for Head-Up Display

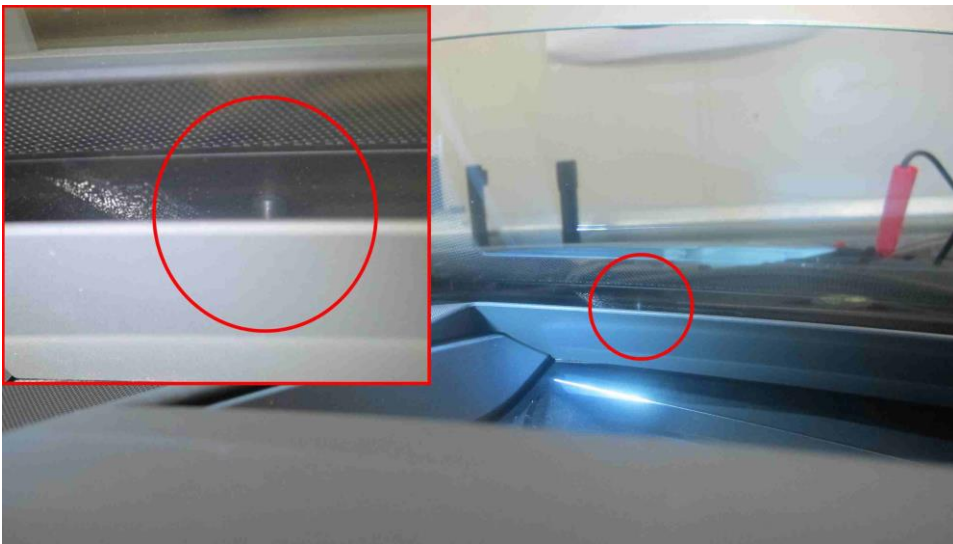
Figure 2

Bump stop introduced to the dashboard at the forward area of the HUD – figure 2.
