Technical product information

Topic	Reverse camera image - Blurred
Market area	Bentley: worldwide (2WBE),Hongkong-Macau (5HK)
Brand	Bentley
Transaction No.	2054229/4
Level	EH
Status	Released for publishing
Release date	22-Oct-2020

New Continental GT and New Continental GTC

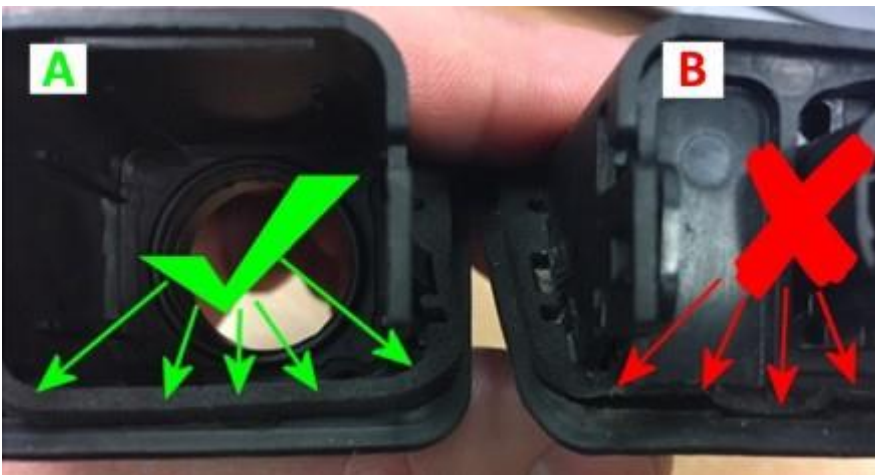
Water ingress into the holder of the reverse camera can cause temporary fogging of the camera lens which may result in a blurred reverse camera image within the Infotainment screen

The ingress is due to a displaced foam seal around the edge of the camera holder

3) Referring to Figure 1 - Carry out an inspection of the reverse camera holder foam seal

- Should the seal be as shown (Point A) this is to correct specification, should the seal be at the correct specification and the reverse camera has evidence of moisture on OR within the lens - Allow the camera to fully dry out ensuring that no moisture is evident then carry out the modification instructions as detailed in step 5 - Reverse camera holder modification instructions
- Once the modification has been completed - Refit the reverse camera holder/reverse camera ensuring the seal is fitted/located correctly - Refer to Repair manual Rep.Gr94 IMPORTANT: Ensure the instructions within the Repair manual are strictly adhered to including all camera calibration instructions

4) Should the seal be as shown in Figure 1 (Point B) this is not to correct specification, a new replacement holder should be sourced/ordered

An improved reverse camera holder is under development which will include a drain hole, until this part is available the modification detailed in step 5 must be followed on all replacement holders in which the drain hole is not evident

- Allow the camera to fully dry out ensuring that no moisture is evident
- Once the modification has been completed - Refit the reverse camera holder/reverse camera ensuring the seal is fitted/located correctly - Refer to Repair manual Rep.Gr94 IMPORTANT: Ensure the instructions within the Repair manual are strictly followed including all camera calibration instructions

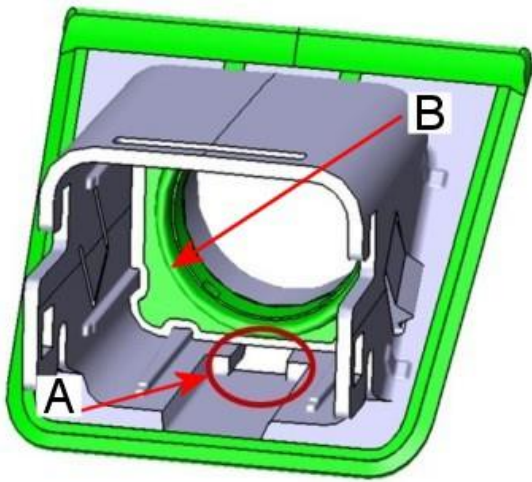
Figure 2

IMPORTANT: REFERRING TO FIGURE 2 - PRIOR TO ADDING THE HOLE (Point A) THE OPERATIVE SHOULD FAMILIARIZE THEMSELVES WITH THE LOCATION OF THE SEAL (Point B)

The seal should remain intact to ensure the seal does not split or dislodge away from the housing as the fitting position of the camera may be compromised should the seal be damaged

- Add a drain hole to the reverse camera holder as follows:
