<b>HYUNDAI</b> <b>Technical Service Bulletin</b>	GROUP <b>HVAC</b>	NUMBER <b>20-HA-003H</b>
	DATE <b>OCTOBER, 2020</b>	MODEL(S) <b>Sonata (DN8)</b>
<b>SUBJECT: A/C INOPERATIVE - ENGINE ROOM JUNCTION BOX REPAIR</b>

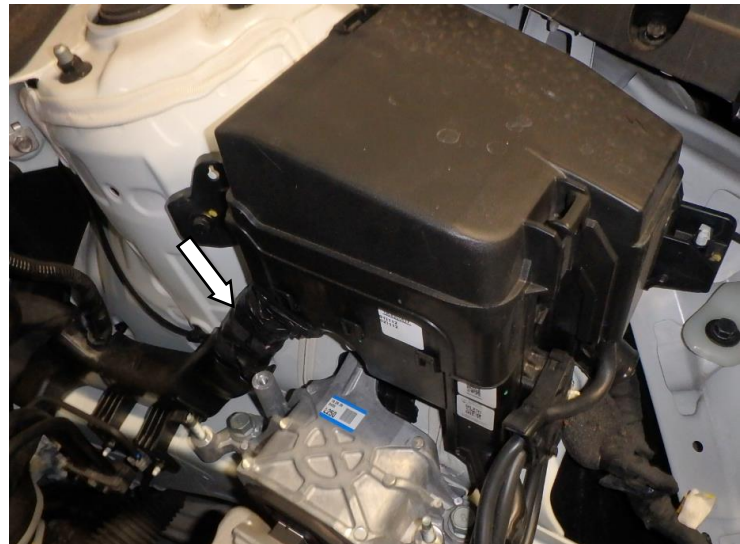
10. In order to identify which terminal has the terminal pull out (TPO) condition, remove the A/C relay and then inspect each terminal. The terminal that is not secured by the locking tab is not fully inserted.

As an example, (O) in the picture shows the unseated terminal.

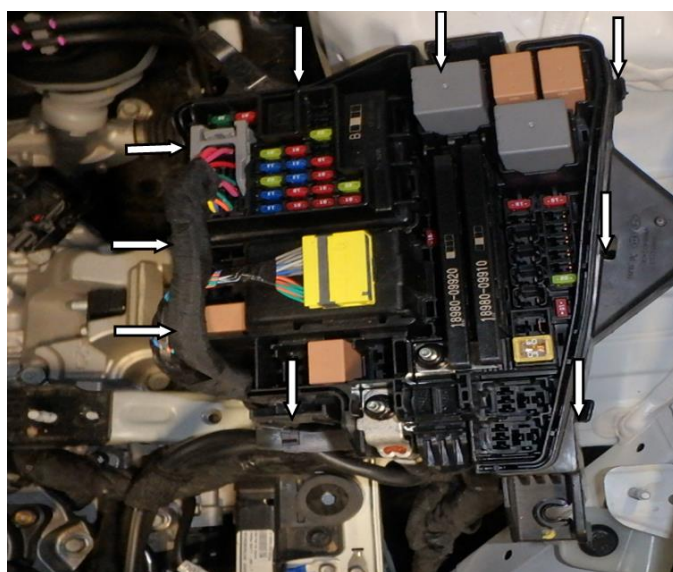
**Vehicles from the affected production range will not have a secondary lock on the wiring.**

12. Re-insert the unsecured terminal (P) and ensure it is fully secured in the cavity inside the junction box.
