HYUNDAI Technical Service Bulletin	GROUP CAMPAIGN	NUMBER 20-01-041H
	DATE OCTOBER, 2020	MODEL(S) IONIQ PLUG-IN (AE PHEV) IONIQ HYBRID (AE HEV) SONATA HYBRID (DN8 HEV)
SUBJECT: NAVIGATION SOFTWARE UPDATE (SERVICE CAMPAIGN T5J)

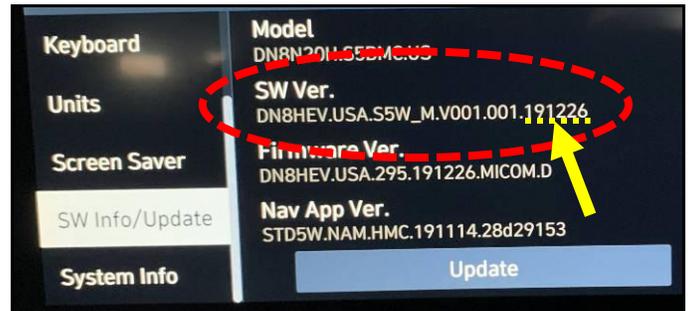
In the example to the right from a SONATA HYBRID (DN8 HEV), the last six digits are 191226 which is lower than 200702. This vehicle qualifies for the software update.
