# Technical product information

<b>Topic</b>	Buzzing/vibration from the left and/or right headlamp and/or DTC's C119C01-C119D01 stored - Matrix beam headlamp only
<b>Market area</b>	Bentley: worldwide (2WBE)
<b>Brand</b>	Bentley
<b>Transaction No.</b>	2059246/2
<b>Level</b>	EH
<b>Status</b>	Released for publishing
<b>Release date</b>	26-Oct-2020

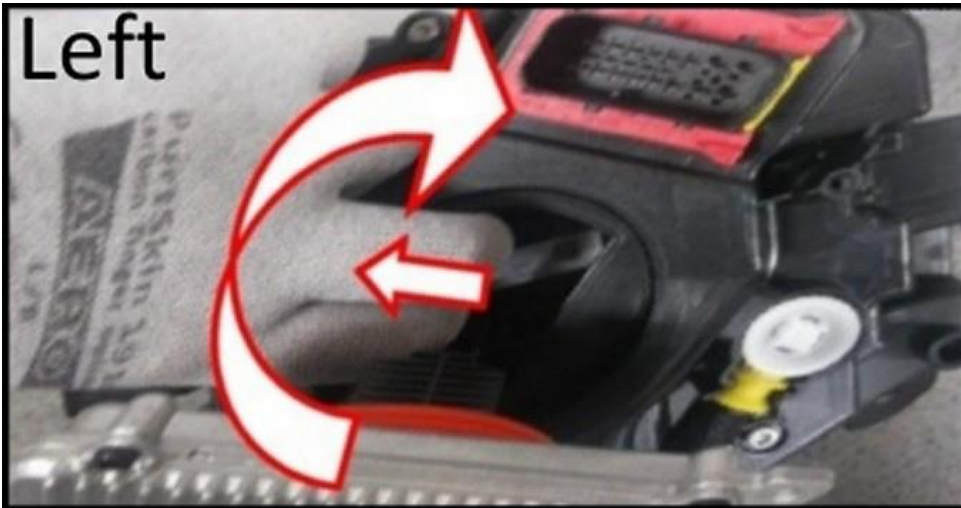
Wiring harness routed incorrectly within the headlamp module at the rear of the headlamp, the noise and DTC's are evident due to the harness contacting the headlamp cooling fan

5) Referring to Figure 5 (left hand module) – Gently push the harness to the desired position away from the cooling fan and pushing the harness up to create a loop between the main connector and the unit
