#### Knocking Noise From Front Suspension Lower Control Arms

20MY RR Evoque & Discovery Sport

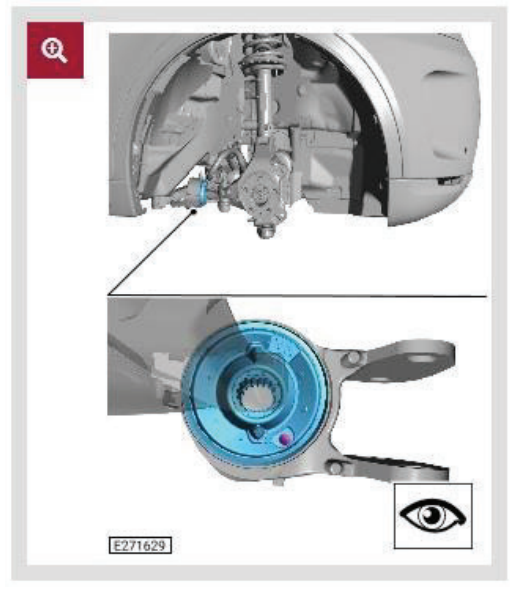
- The fluid in the lower control arm hydrabush is moving around within the bushing creating a fluid knock noise.

- TSB LTB01294NAS3 was published to address this concern, but the supplier production could not meet the demand of parts, this TSB has now been removed.
- A revised repair procedure has been developed by engineering that eliminates the need to replace parts for this concern.
- TSB JLRTB02060 has just been published to provide a process to drain the hydrabushes currently on the vehicle.
