# Technical product information

<b>Topic</b>	Emergency Assistance (SOS) - System Unavailable
<b>Market area</b>	China 796 VW Import Comp. Ltd (Vico), Beijing (6796),United States E05 Bentley USA and rest America (6E05)
<b>Brand</b>	Bentley
<b>Transaction No.</b>	2060444/3
<b>Level</b>	EH
<b>Status</b>	Approval
<b>Release date</b>

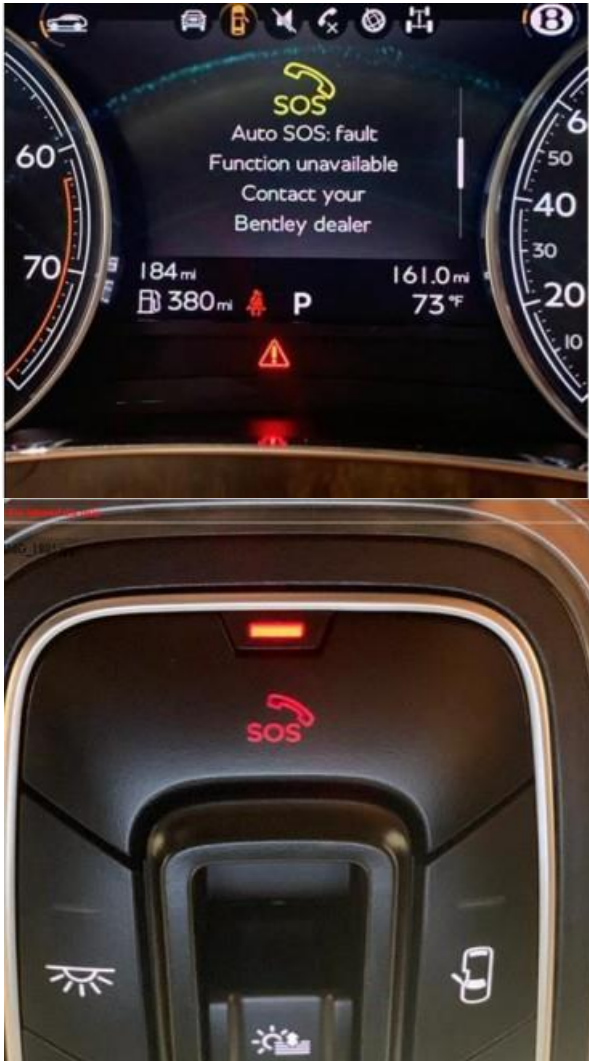
Warning on Driver Instrument Panel (DIP): *Auto SOS: fault. Function unavailable. Contact your Bentley dealer* in conjunction with the Emergency Assistance (SOS) switch in the roof console illuminating Red. The warning message on the DIP remains when the Emergency Assistance (SOS) switch has returned to Green.

Diagnostic Trouble Code (DTC) *U153E00 - Emergency call module and communication unit. Recognition in mobile communications network not possible*, stored in Address 75 – Telematics Communication Unit (TCU).

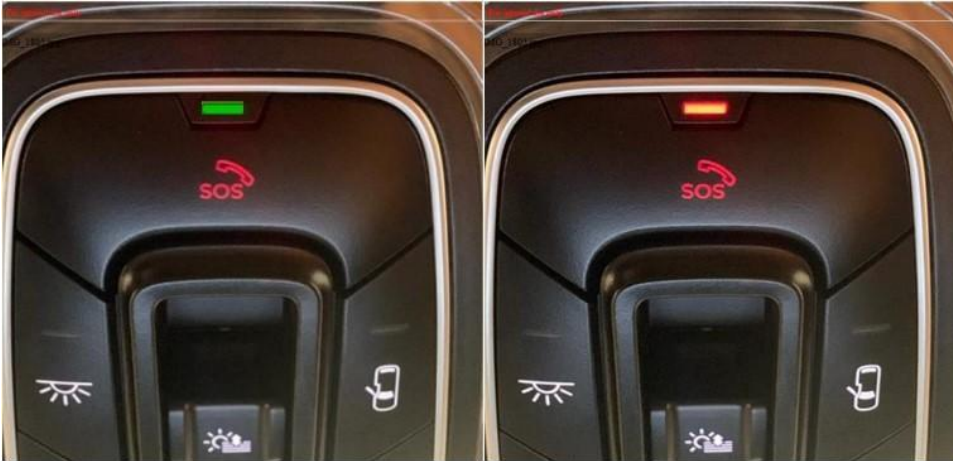
- Confirm “Auto SOS: fault. Function unavailable. Contact your Bentley dealer” warning is currently, or was previously displayed on the DIP, in addition note the colour of the Emergency Assistance (SOS) switch in the roof console (Red or Green).

- If the DIP warning is present and the Emergency Assistance (SOS) switch is illuminated Green, the system is active and a connection is being made to the Emergency Assistance system.

- Carry out an ignition cycle (off/on), the DIP warning will then clear. If required, clear the stored DTC (U153E00) using ODIS.
- If the DIP warning is present and the SOS switch is illuminated Red, check and record the following *Measured Values - Address 75 – Telematics Communication Unit (TCU)*.

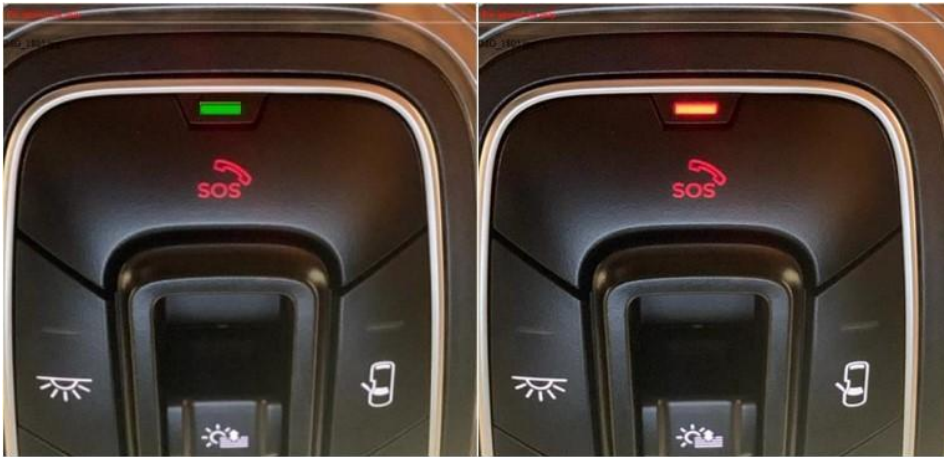
Inform the Customer that the colour of the Emergency Assistance (SOS) switch in the roof console confirms the connection status of the system. If the switch is illuminated Green, the system is active. If the switch is illuminated Red, the system is not active due to the vehicle being in an area with poor network signal strength. When the network signal strength improves, the switch will automatically display Green and Emergency Assistance will be available.
