Technical product information

Topic	Secondary air injection - Missing ODIS data
Market area	Russische Föderation (5RU),Australia E04 Bentley rest Asia and Australia (6E04),China 796 VW Import Comp. Ltd (Vico), Beijing (6796),Germany E02 Bentley rest Europe (6E02),Japan E03 Bentley Japan (6E03),Korea, (South) E08 Bentley South Korea (6E08),United Arab Emirates E06 Bentley Middle East and Africa (6E06),United Kingdom E01 Bentley UK (6E01),United States E05 Bentley USA and rest America (6E05)
Brand	Bentley
Transaction No.	2061064/1
Level	EH
Status	Approval
Release date

New Continental GT - GTC and New Flying Spur

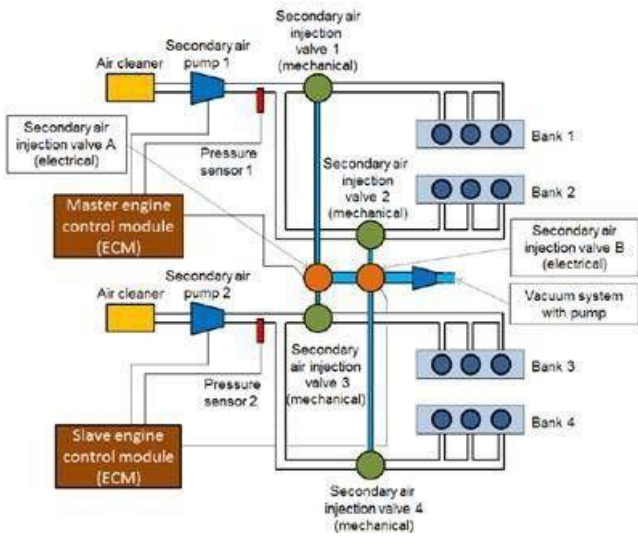
- Figure 3 shows the layout of the secondary air injection system
