Title: Baseline 1030 Update**Applicability:** MY20 Revero GT**Market Region:** All**PRIORITY:** Vehicles on list (page 2)**PURPOSE:**

In order to bring the Revero GT into the best performance Karma Automotive has released a Baseline update for the MY2020 Revero GT, BL1030.

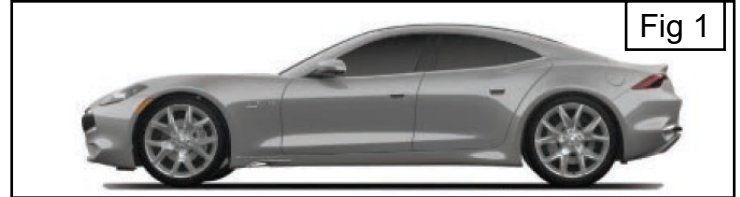
Keep the hood closed when doing a Baseline update for all Revero GT (Fig 1).

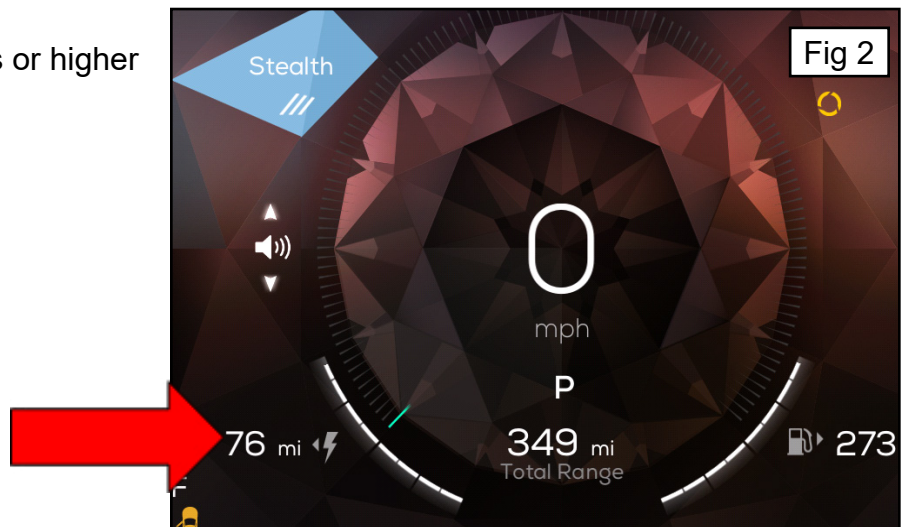
Ensure the electric range is at 25 miles or higher in the displayed range gauge (Fig 2).

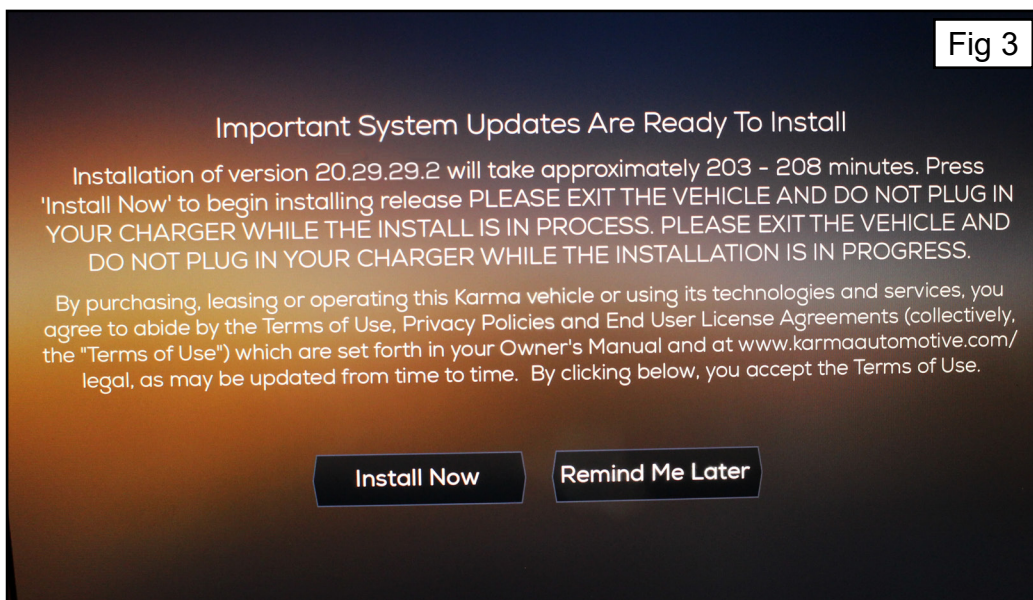
Fig 3

Accept the prompt to perform the OTA, install, do not allow the vehicle to “sleep”. Leave a door open, this is a easy way to prevent this (Fig. 3).

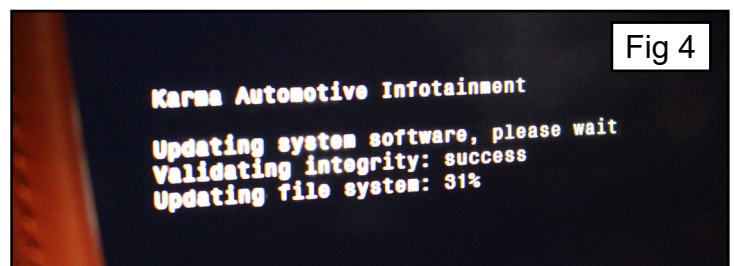
Fig 4

The Touch Panel screen will display the step it is involved in from downloading to install. the vehicle will reboot when complete (Fig 4).

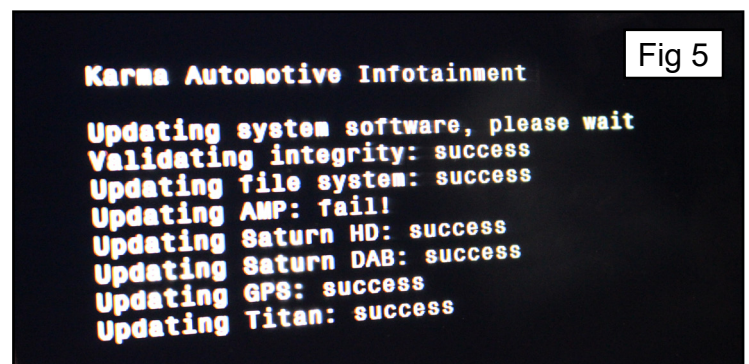
Fig 5

The amp will not be updated, observing a “fail” remark is normal (Fig 5).

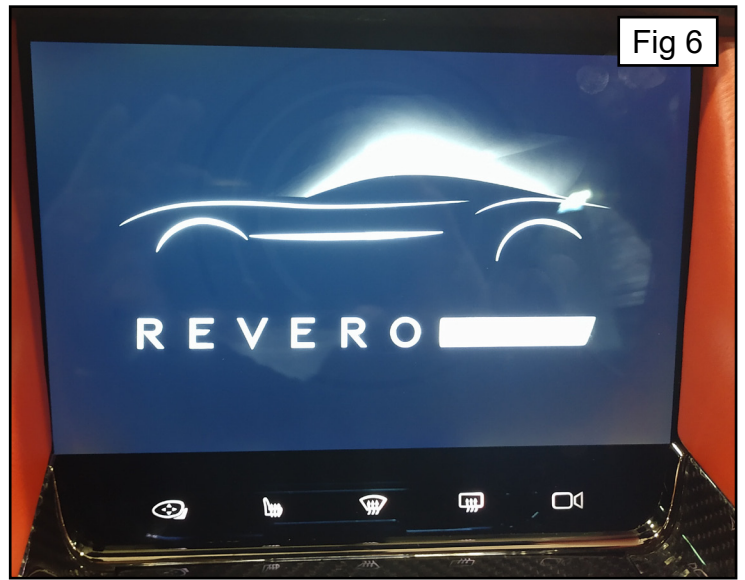
Fig 6

The TPI and Vehicle will reboot when complete, you should see the welcome screen (Fig 6).

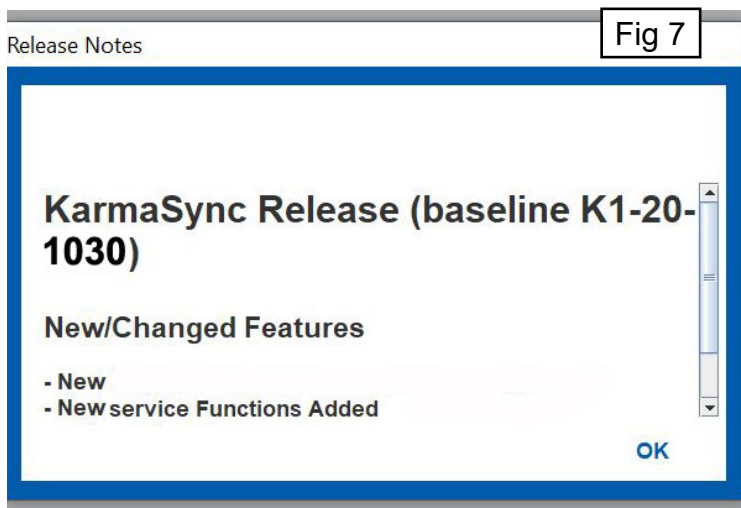
Fig 7

The Karma Sync should be updated to the latest deliverable, this message will be displayed when the initial session is launched (Fig 7), no action on Karma Sync is required other than clearing any Trouble codes present if necessary.
