# Technical product information

| <b>Topic</b> | New Continental GT / GTC and New Flying Spur - Exhaust Flap - Diagnostic Trouble Code |
| <b>Brand</b> | Bentley |
| <b>Transaction No.</b> | 2060432/2 |

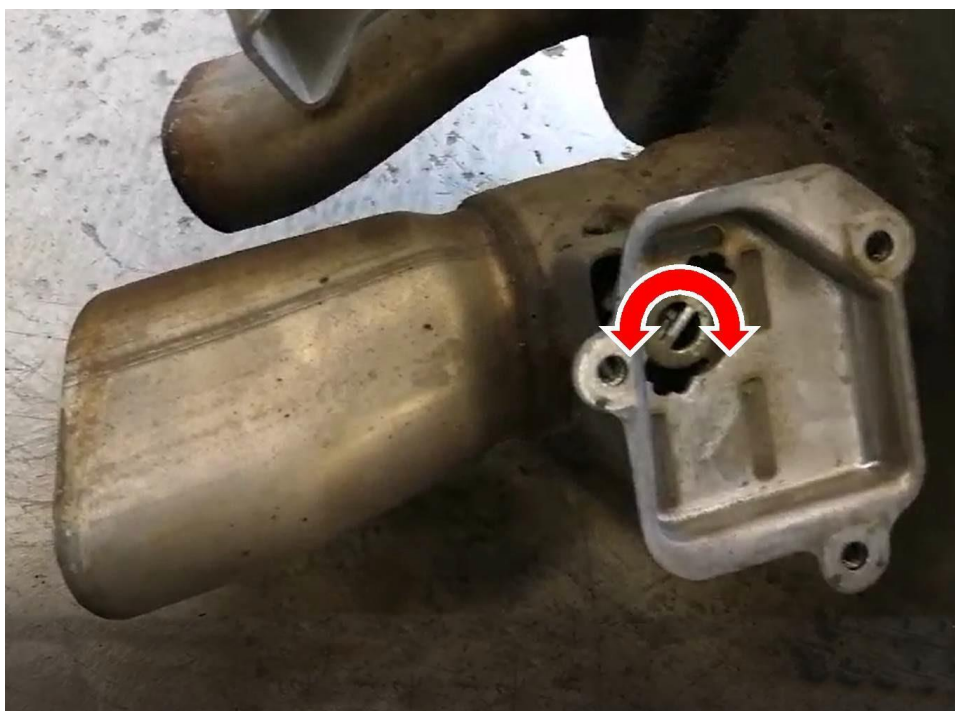
Check and confirm the Exhaust Flap spindle is free to open and close by hand - Figure 2.

If no issue is evident and the Exhaust Flap oscillates freely by hand - replace the defective Exhaust Flap Control Unit, refer to *Repair Group. 26 Exhaust system – Exhaust flap control units (J883, 945) – To remove and fit.*
