This bulletin supersedes TSB JLRTB02040NAS1/2020 dated 26 MAY 2020, which should either be destroyed or clearly marked to show it is no longer valid (e.g. with a line across the page). Only refer to the electronic version of this Technical Bulletin in TOPIx.

418-00

Heated Tailgate Window Inoperative

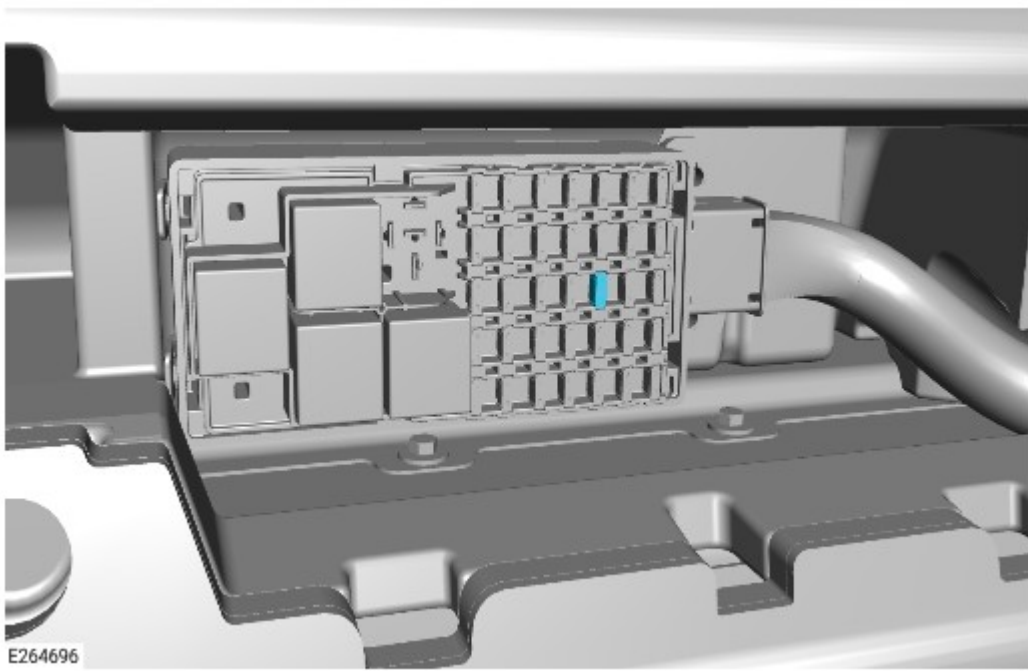
4.

The heated tailgate window is inoperative when the switch is in the ON position. Further investigation has found that fuse F17 in the Passenger Junction Box (PJB) has blown.

Operating current higher than expected.

Remove and discard fuse F17 from the PJB.

- Install the new 30A mini fuse in F17 of the PJB.
