Technical Service Bulletin

50 Water ingress into the longitudinal member and footwell

50 20 02 2060335/2 November 10, 2020. Supersedes Technical Service Bulletin Group 50 number 20-00 dated August 4, 2020 for reasons listed below.

Model(s)	Year	VIN Range	Vehicle-Specific Equipment
A6, A6 Avant, A6 allroad, and A7	2019 - 2021	All	Not Applicable

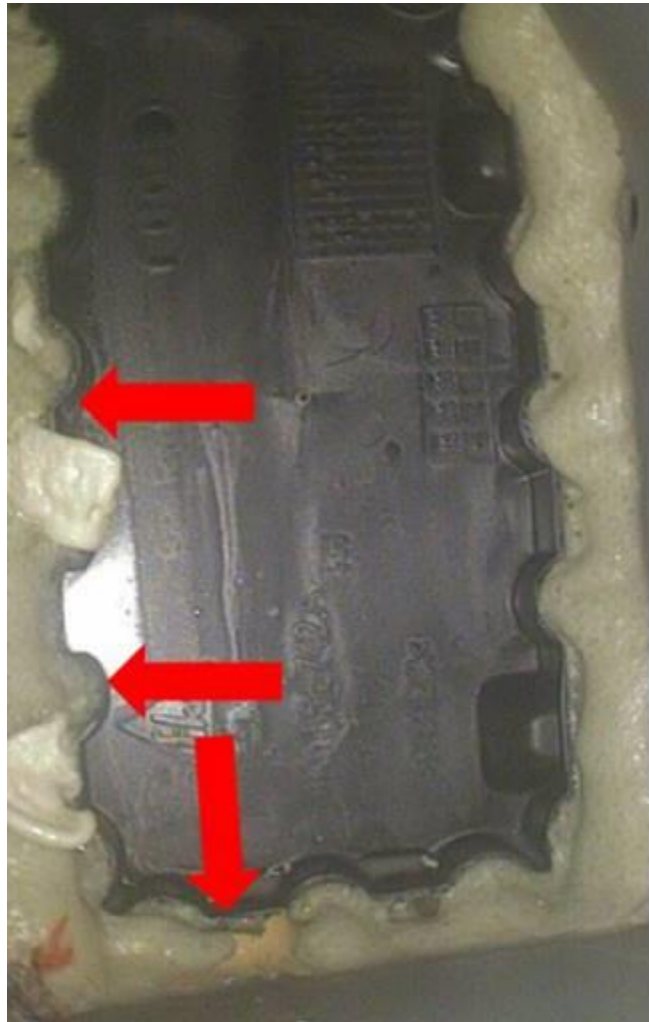
1. The cause for the water ingress is due to incorrect bonding of the sound absorber inside of the longitudinal member (Figure 1).

Figure 1. The exact location of the water intrusion.

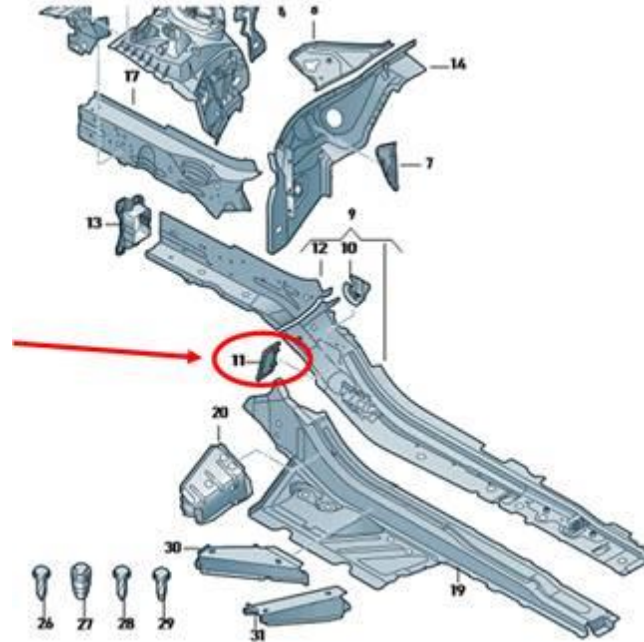
- ETKA drawing (803-000) shows the location of the sound absorber inside the longitudinal member (Figure 2).

Figure 2. ETKA drawing (803-000) showing the location of the sound absorber.

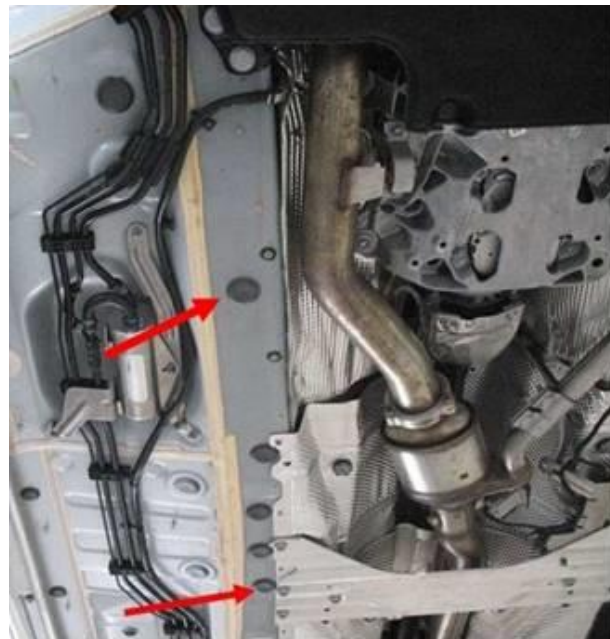
- Remove any necessary underbody covers to gain access to the longitudinal member plugs (Figure 3).

To check the water ingress in the footwell, remove plug 1 and 5 on the longitudinal member's lower right and left.

Figure 3. Plugs in the longitudinal member.

If there is a water leak from the lower longitudinal member after removing the plugs, this sealing measure is to be performed on the affected side. Check this on both sides. Repair both sides if necessary.

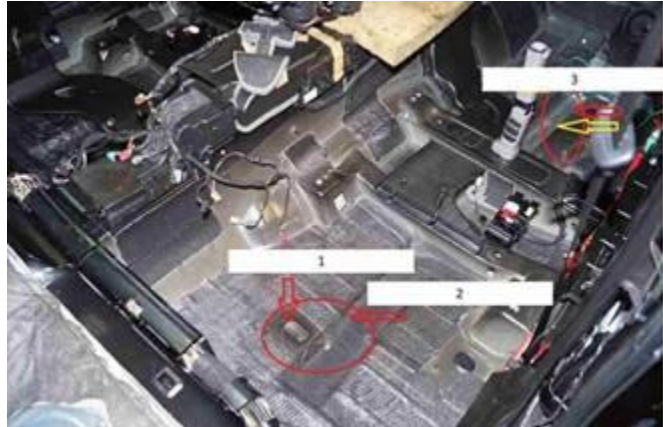
4. Figure 4 shows the areas on the inside of the cabin floor where water intrusion is likely. See arrows 1, 2, and 3.

Figure 4. Areas where water enters the cabin.

Check the electrical connectors under the floor covering for corrosion. If corrosion is found these are to be repaired according to the Elsa repair manual.

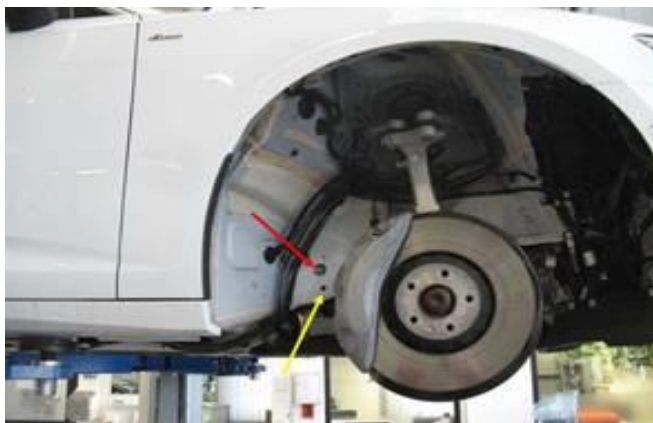
Figure 5. Point of entry for the borescope.

1. Remove front wheel housing liner from the affected side of the vehicle. Remove the plug indicated by the red arrow. This is the opening where the sealer will be applied. The opening indicated by the yellow arrow is the opening that will be used to inspect the area with a borescope (Figure 5).

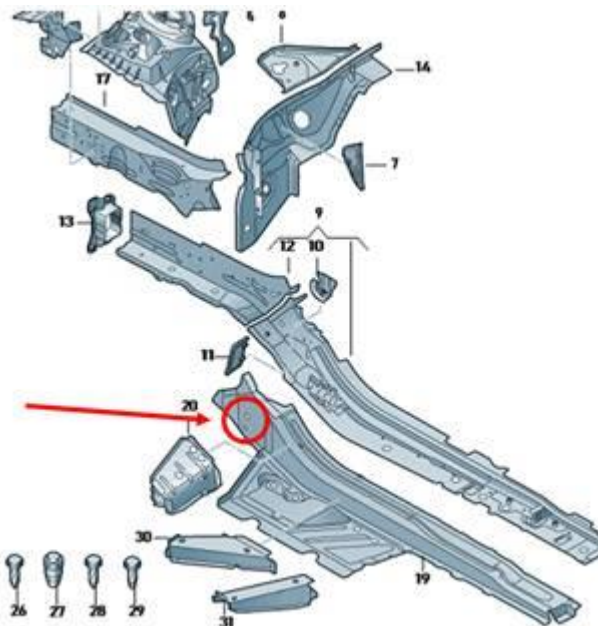
Figure 6. ETKA drawing (803-000) showing the location of the openings in the wheelhouse.

2. ETKA drawing (803-000) shows the location of the openings in the wheelhouse where the borescope is to be inserted and where the repair is performed (Figure 6).

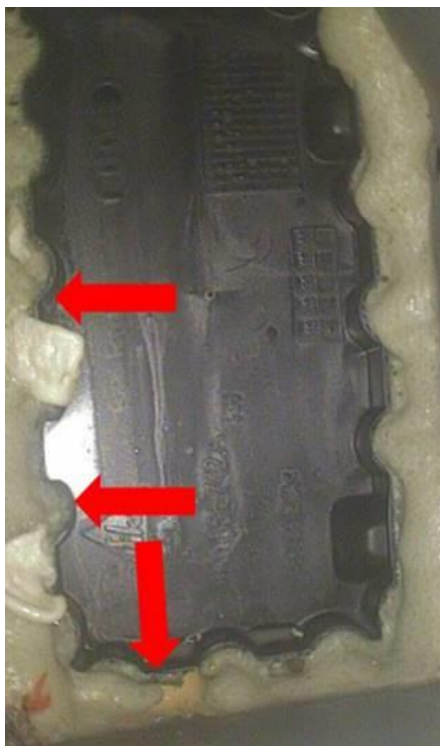
Figure 7. Sound absorber to be completely sealed off.

3. The sound absorber is to be completely sealed in the longitudinal member with 1k adhesive sealant D 511 500 A2 (or alternatively Loctite 5510) (Figure 7).

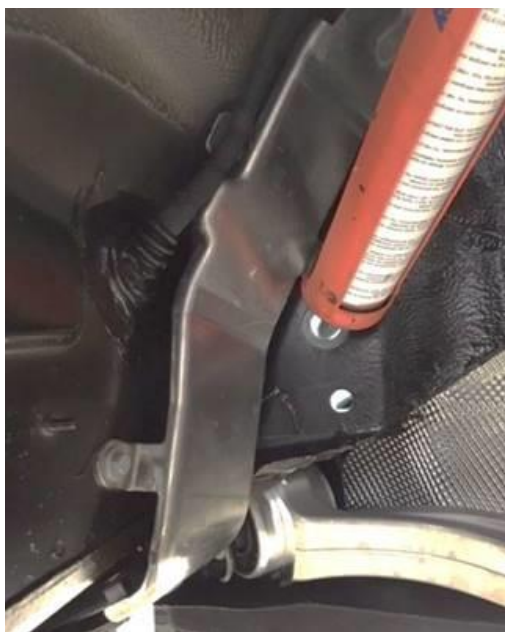
Figure 8. Sealant application.

4. Inject 1k adhesive sealant D 511 500 A2 (or alternatively Loctite 5510) using the VAG1628 (or equivalent) through the opening shown in Figure 6 onto the sound absorber (Figure 8).

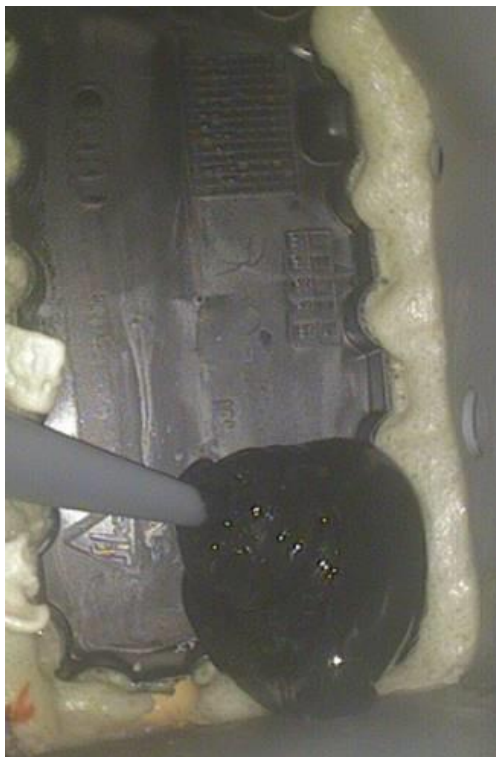
Figure 9. Applying sealer.

5. Apply an amount of sealer sufficient to cover the surface and perimeter of the sound absorber (Figure 9).

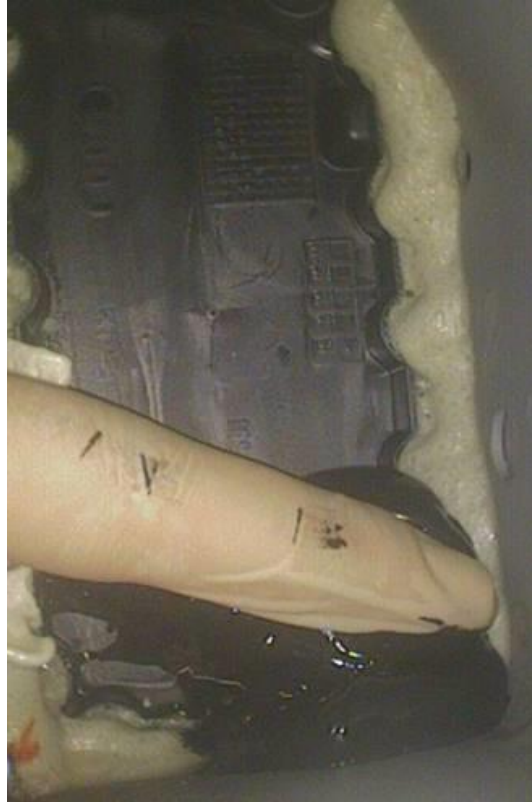
Figure 10. Distributing sealer over the web plate.

6. Spread the sealer using your gloved finger (Figure 10).

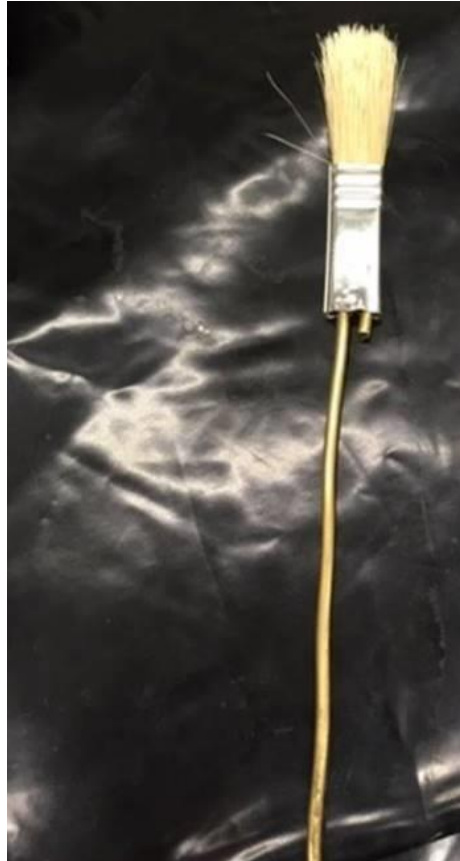
Figure 11. Modified brush.

7. Alternatively, a brush can be fashioned to distribute the sealer as shown in Figure 11. If this is the method chosen, ensure that no brush fragments are left inside the longitudinal member.

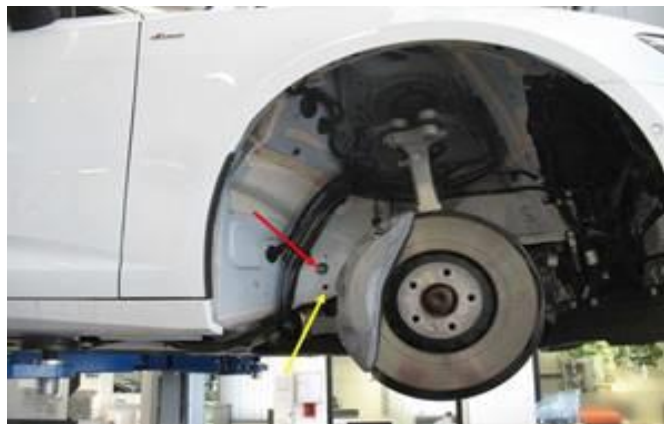
Figure 12. The yellow arrow indicates the opening where the borescope will be inserted to inspect the completeness of the sealant application.

8. Insert a borescope to confirm visually complete sealer coverage. The borescope can be inserted in the hole indicated with a yellow arrow (Figure 12).

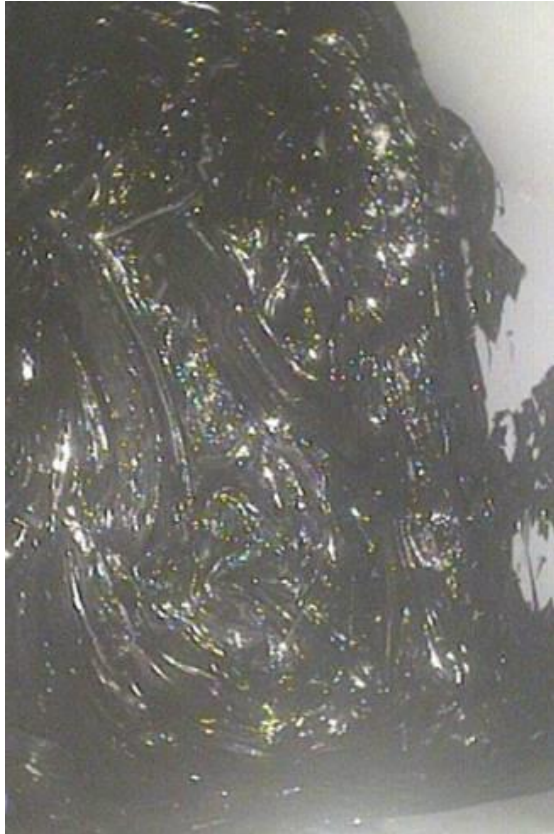
9. Figure 13 illustrates a completed seal over the sound absorber as viewed with the borescope.

Figure 13. *Sealer is completely applied and distributed.*

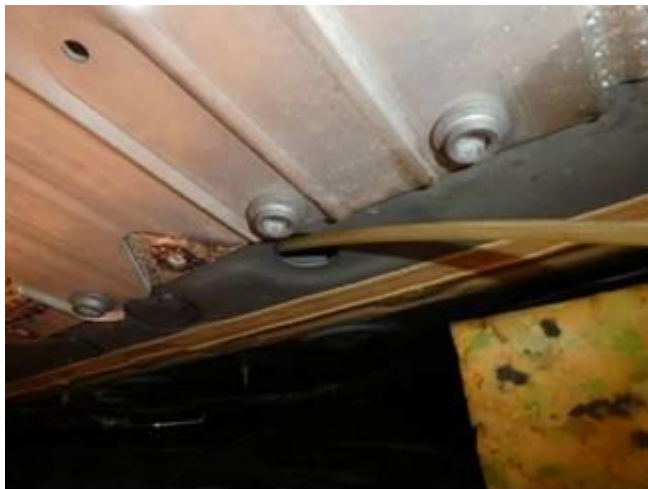
Figure 14. *Conservation wax application.*

10. After the sealing procedure is completed and the sealer has fully cured, coat the inside of the longitudinal member with cavity preservative D 330 KD2 A1 through the opening shown (Figure 14).

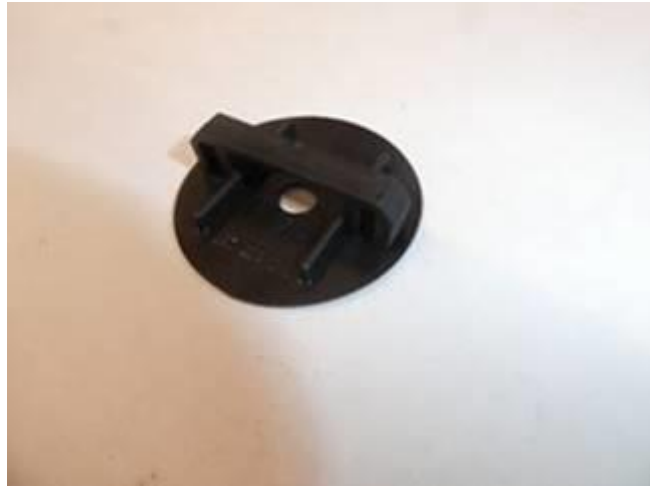
Figure 15. New longitudinal member plugs with integrated drain.

11. After cavity conservation is carried out, the removed plugs 1 and 5 on right and left are to be replaced with plugs 8K0 805 267 with an integrated drain (Figure 15).
