Technical Service Bulletin

91 Rear parking aid or hands-free tailgate release inop, DTC U115200 or others stored in various control modules

91 20 28 2057357/3 November 6, 2020. Supersedes Technical Service Bulletin Group 91 number 20-52 dated March 20, 2020 for reasons listed below.

Model(s)	Year	VIN Range	Vehicle-Specific Equipment
A6, A7, S6, and S7	2019	All	Not Applicable

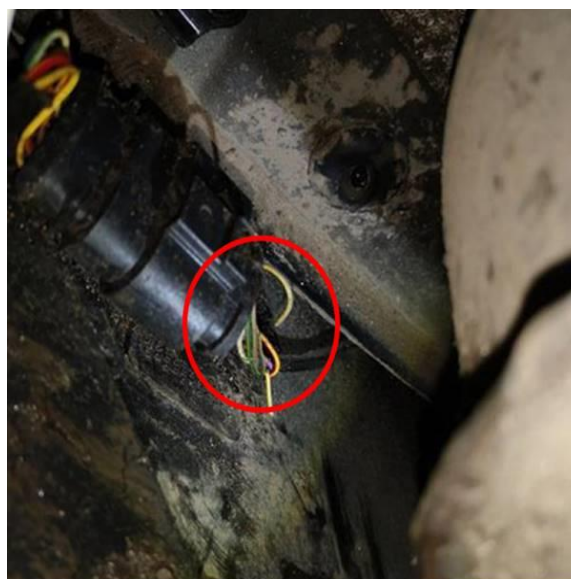
The connector housing or wires leading to connector T14m may become damaged due to road debris.

Figure 1. Location to inspect T14m for damage.

2. If there is damage found, repair the affected wires and/or connector housing using VAS1978B.
3. Slide the new grommet, part number 6X0 971 921 B onto the harness and then reassemble the connector. Ensure the grommet is fully seated on the connector before refitting the bumper.
4. Once the repair is complete, clear out all DTC's and check the system for functionality.

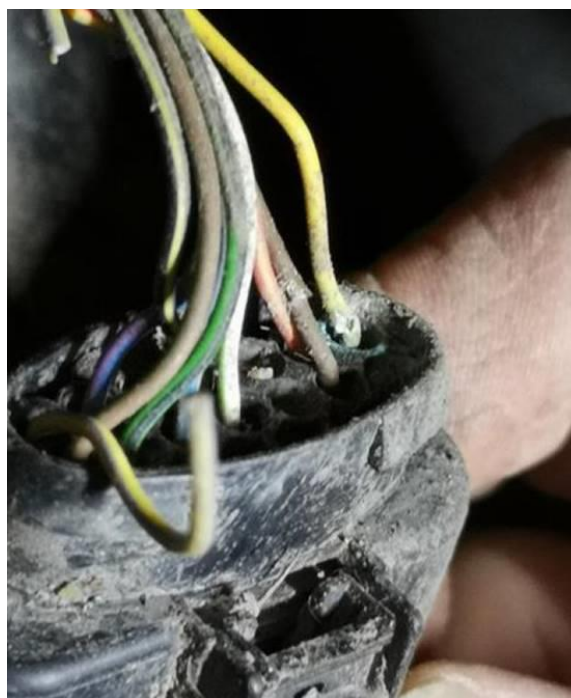
Figure 2. Close up of T14m connector showing harness damage.
