Technical Service Bulletin

91 MIB2 High: Top view camera setting changes to graphic view intermittently after startup

91 20 31 2053028/4 November 10, 2020. Supersedes Technical Service Bulletin Group 91 number 19-89 dated September 13, 2019 for reasons listed below.

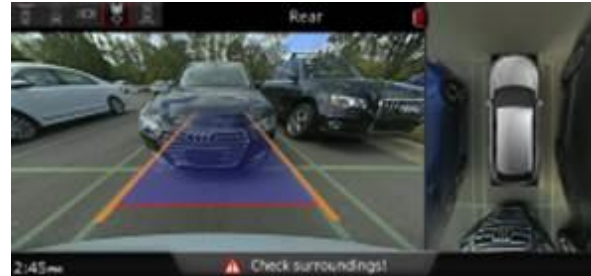
Figure 1. Correct camera view.

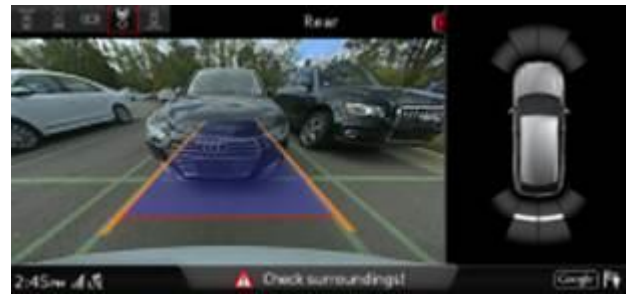
- When the reversing camera is active showing the Top view camera to the right, the display changes intermittently at startup from camera view to graphics view. Compare the images to the right (Figures 1 and 2).

Figure 2. Incorrect graphics view.

The software needs to be updated. The optimized software will correct the view switch.

- Update the MIB2 High infotainment system using either Method 1 or Method 2 according to TSB 2047576: *91 MIB2 High Software Update Instructions (PR Code 7UG)* and use SVM code MHI2QUS5087.
