Technical Journal

Blown fuse, compressor - air suspension

REF NO: TJ 31423.18.0	ISSUING DEPARTMENT: Technical Service	CAR MARKET: United States and Canada	
PARTNER: 3 US 7510 Volvo Car USA		ISSUE DATE: 2020-10-16	STATUS DATE: 2020-10-22
FUNC GROUP: 7641	FUNC DESC: Level control, complete	Page 1 of 15

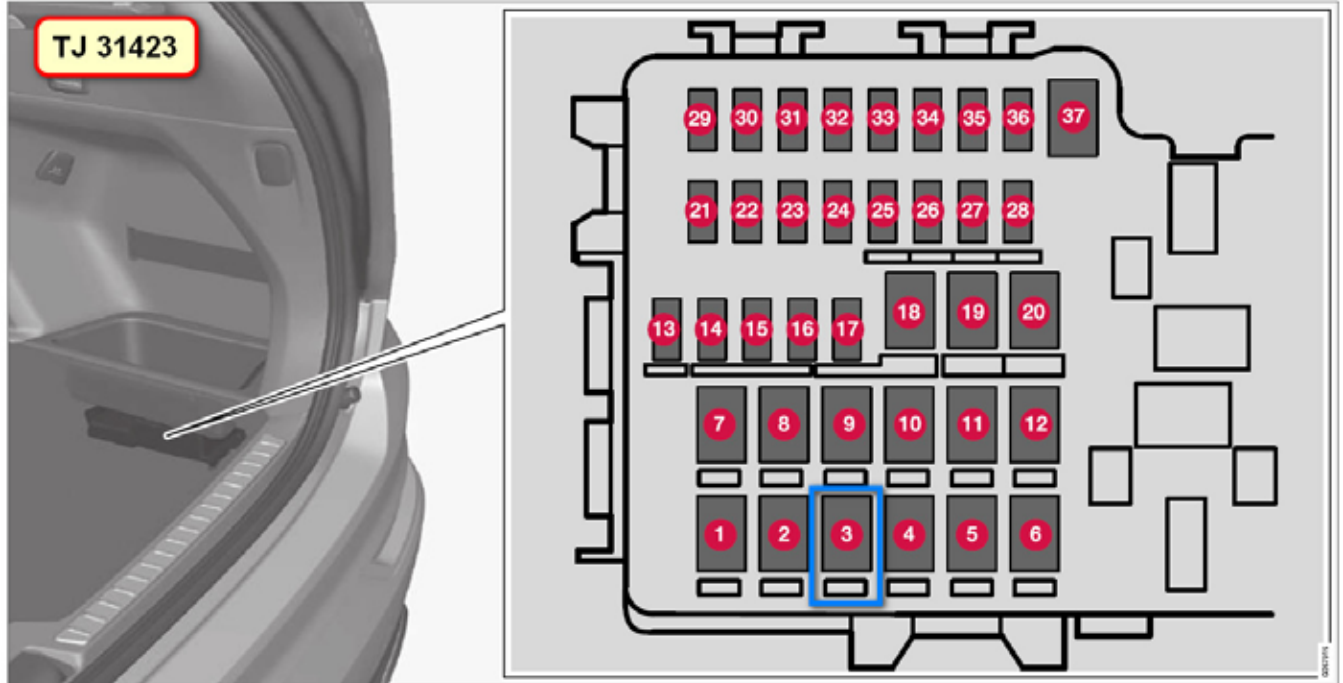
Note: The concerned fuse is located in the cargo area right side under the storage compartment, fuse number 3, refer to picture [TJ 31423 - 2.jpg](#).

Perform a fault tracing according to VIDA, secure that the fuse and relay are OK. Replace those if needed.

- Replace the compressor fuse 40A, PN 31346535
- Replace the compressor relay, PN 30765045
