TITLE: Loose trim moulding rear door

REF NO:	ISSUING DEPARTMENT:	CAR MARKET:		
TJ 35197.1.2	Technical Service	United States and Canada		
	PARTNER:	ISSUE DATE:	STATUS DATE:	
3 US 7	510 Volvo Car USA	2020-10-19	2020-10-22	
FUNC GROUP:	FUNC DESC:			
8414	Trim moulding at window	Page 1 of 6

Volvo	Car Customer Service	TJ Instruction VCC-405787-2		
Title	Weatherstrip, door window, rear	Page	1 (4)	
Action	Product fix	Operation number:	99922-2	
L		· · · · · · · · · · · · · · · · · · ·

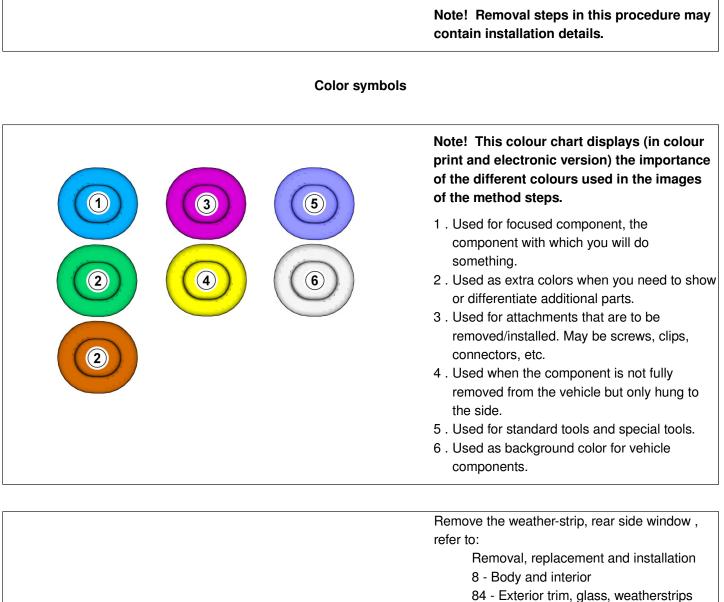
Removal

If vehicle shows symptom for loose trim moulding on rear door window, follow advice under service.

Perform the repair according to attached method.

Use WURTH tape PN 894910 (Canada) Use WURTH tape PN 189412 (US)
