Technical Journal

Panoramic sunroof, roller shade/blind hanging loose

REF NO: TJ 35583.1.1	ISSUING DEPARTMENT: Technical Service	CAR MARKET: United States and Canada	
PARTNER: 3 US 7510 Volvo Car USA		ISSUE DATE: 2020-10-21	STATUS DATE: 2020-10-26
FUNC GROUP: 8369	FUNC DESC: Miscellaneous	Page 1 of 4

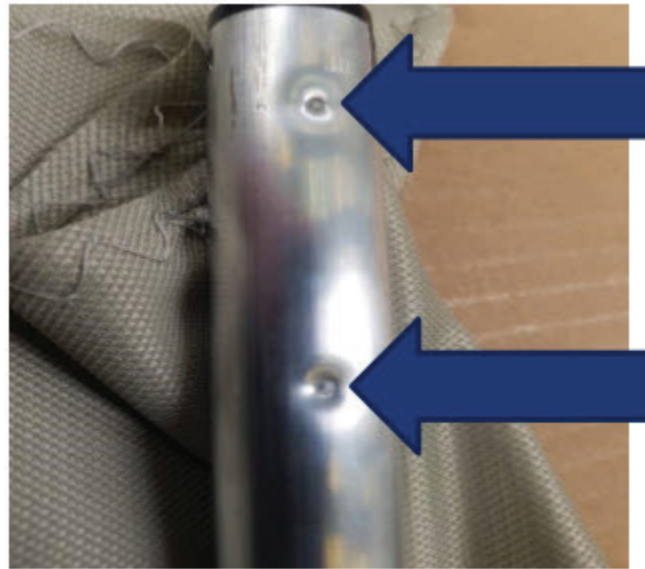
- A. Rollo tube pinching. There should be 6 separated pinchings in the tube, check each pinch that the depth is good. If possible, measure the depth using a caliper.
- B. Socket for rollo fixator. Check if any cracks or imperfections in the plastic.
- C. Roller blind fixator. Check the wings to see if there are any cracks or imperfections in the plastic.

If any problems are found, please replace the roller blind according to VIDA method (search for VCC ID: VCC-371003-6) and send a Vehicle Report with the findings including some photos.

If no abnormalities / damages could be found, repair the car by rolling back the roller blind to the correct position.
