**57-18-01 - Front Door(s) May Be Difficult to Close at Temperatures Below Freezing**

Release date: 11/4/2020

Front door lock will not unlock or lock, or the door is difficult to close during low ambient temperatures (freezing conditions, usually below 32°F / 0°C).

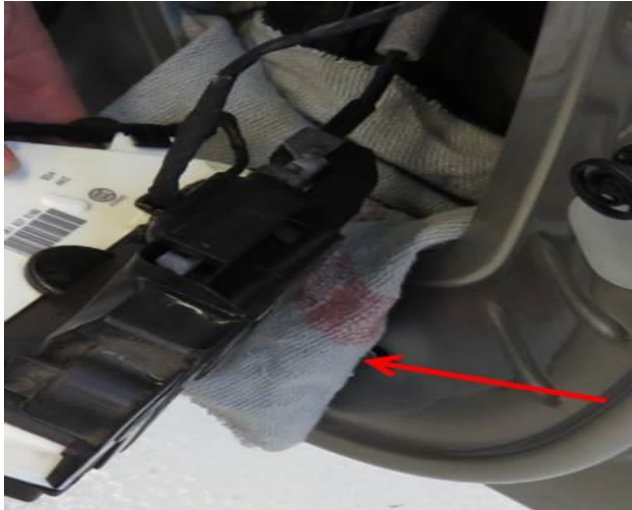
Figure 2: Example of protected lower door area.

- Using shop rags or suitable material, protect the lower section of the door against damage as shown in Figure 2.

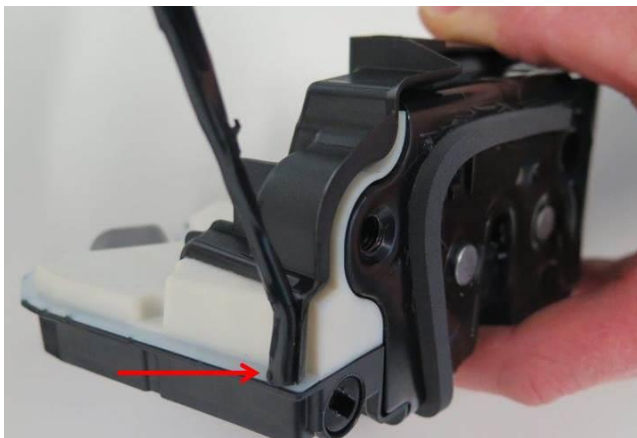
Figure 3: Starting position for routing Butyl sealing cord.

- Cut off a piece of Butyl sealing cord (part number AKL-450-005-05) to a length of about 160 mm (6 inches).
- Carefully route the butyl sealing cord, starting from position 1 (Figure 3, red arrow), along the cap (Figure 4, position 1 to 5) and press it down firmly.

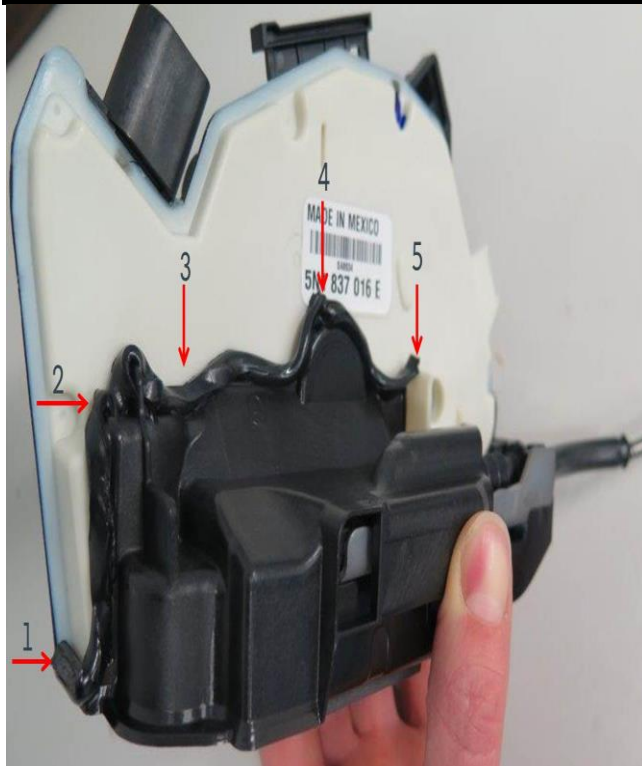
Figure 4: Area where Butyl sealing cord has to be routed.

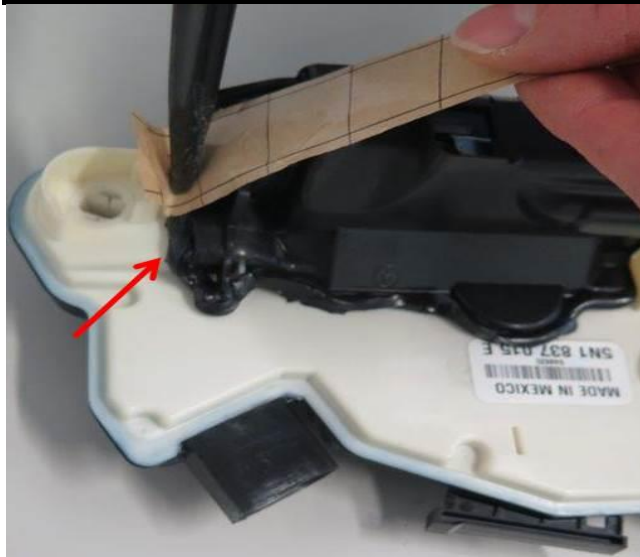
Figure 5: pressing down Butyl sealing cord with suitable tool.

On the driver door lock the Butyl sealing cord must be pressed down in the area of the follower with a suitable tool, for example a wedge (Figure 5, red arrow).

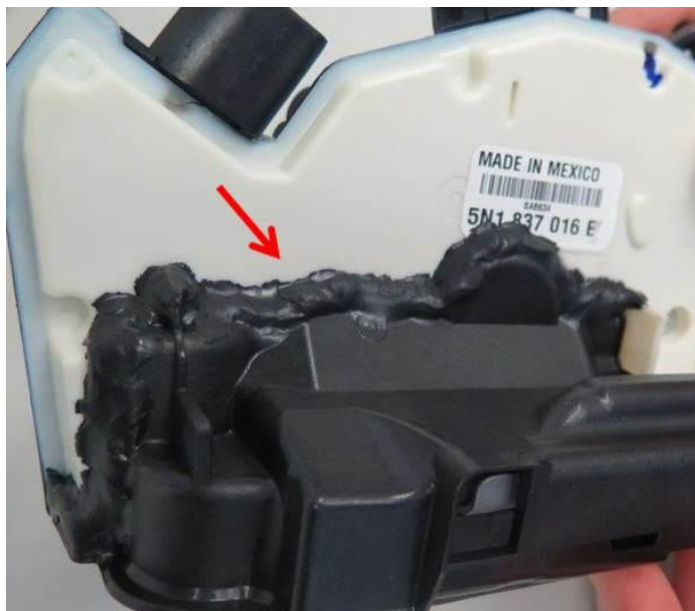
Figure 6: (Example: butyl sealing cord pressed down/spread out by hand).

- Press down again on the Butyl sealing cord (spread the Butyl) to ensure proper sealing between the cap and the door lock (Figure 6).
