Technical Service Bulletin

91 MIB2 High: rearview camera/overhead view camera does not turn on

91 20 35 2055026/5 November 10, 2020. Supersedes Technical Service Bulletin Group 91 number 19-80 dated August 26, 2019 for reasons listed below.

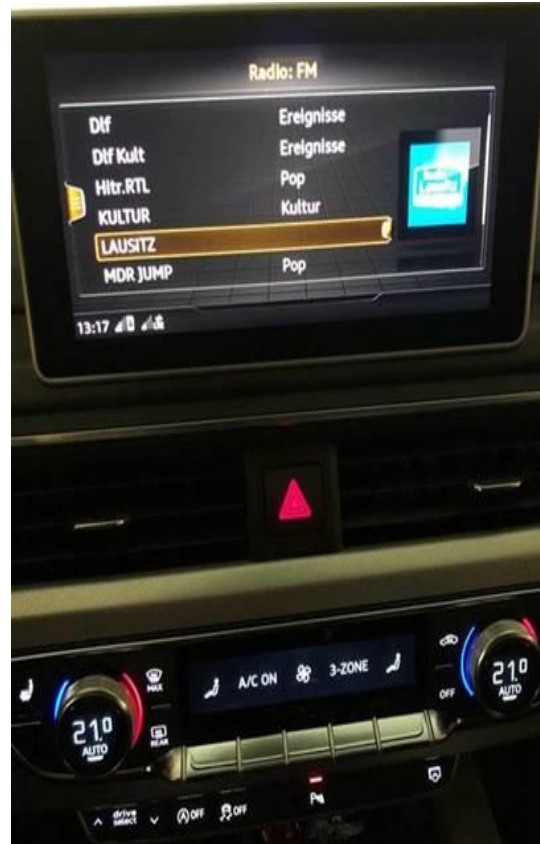
For vehicles with < 0318 camera software (address word 006C):

- The rearview/overhead view camera and the optical parking aid are sporadically not switched on when moving into reverse. The previously adjusted menu (radio, navigation, etc.) stays the same (Figure 1).
- The parking aid button in the center console lights up and an acoustic obstacle warning is given.

Figure 1. Previously adjusted menu stays the same (vehicles with camera software < 0318).

The MIB2 High software needs to be updated.

Update the MIB2 High infotainment system using either Method 1 or Method 2 according to TSB 2047576: *91 MIB2 High Software Update Instructions (PR Code 7UG)* and use SVM code indicated below:

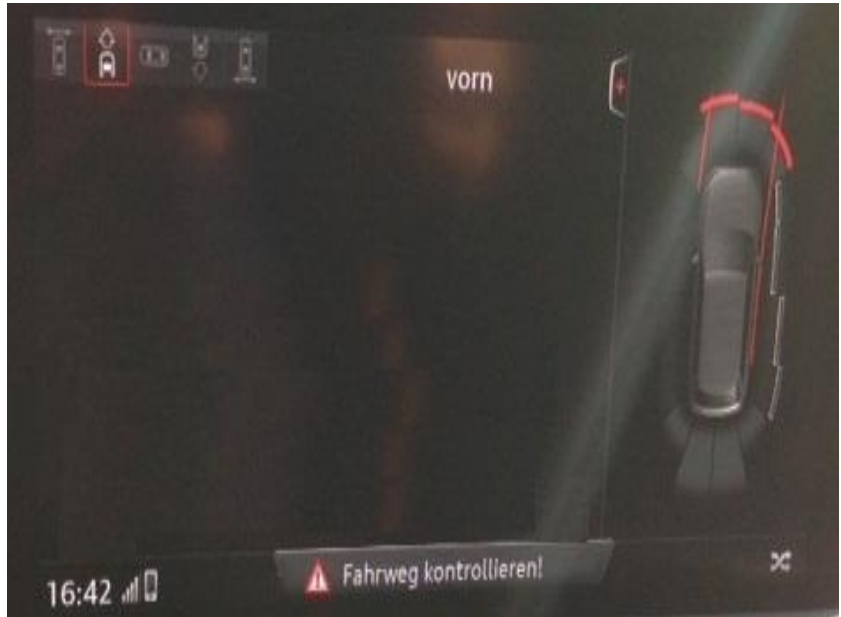
For vehicles with camera software >= 0318 (address word 006C):

- The picture of the top view camera is black and no guide lines are shown (Figure 2).

Figure 2. Camera picture without guidelines (vehicles with camera software 0318).
