Service Action

Code: 66M2

Subject	Trailer Hitch Cross Member Bolts																													
Release Date	November 04, 2020																													
Affected Vehicles

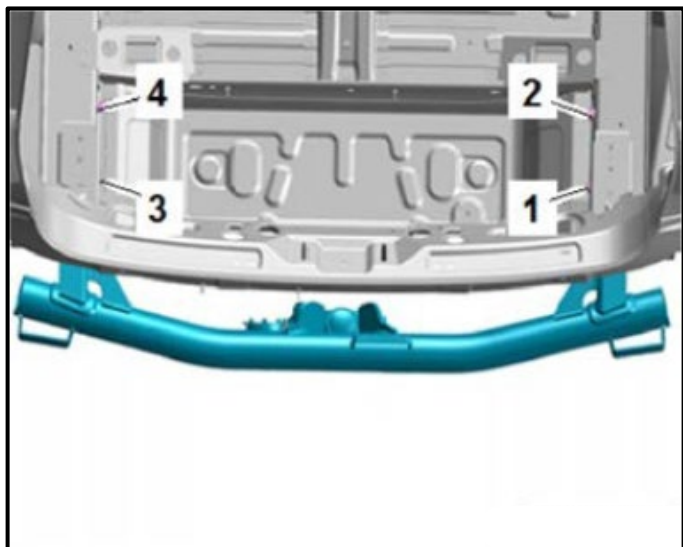
Repair Overview

What is the issue? Over time, an unexpected noise might be heard originating from the area around the trailer hitch.

- Replace bolts for trailer hitch cross member.
