Preliminary Information

PIP5681A Exhaust leak, Lean Codes, Rattle Noise, or Catalytic Converter Failures.

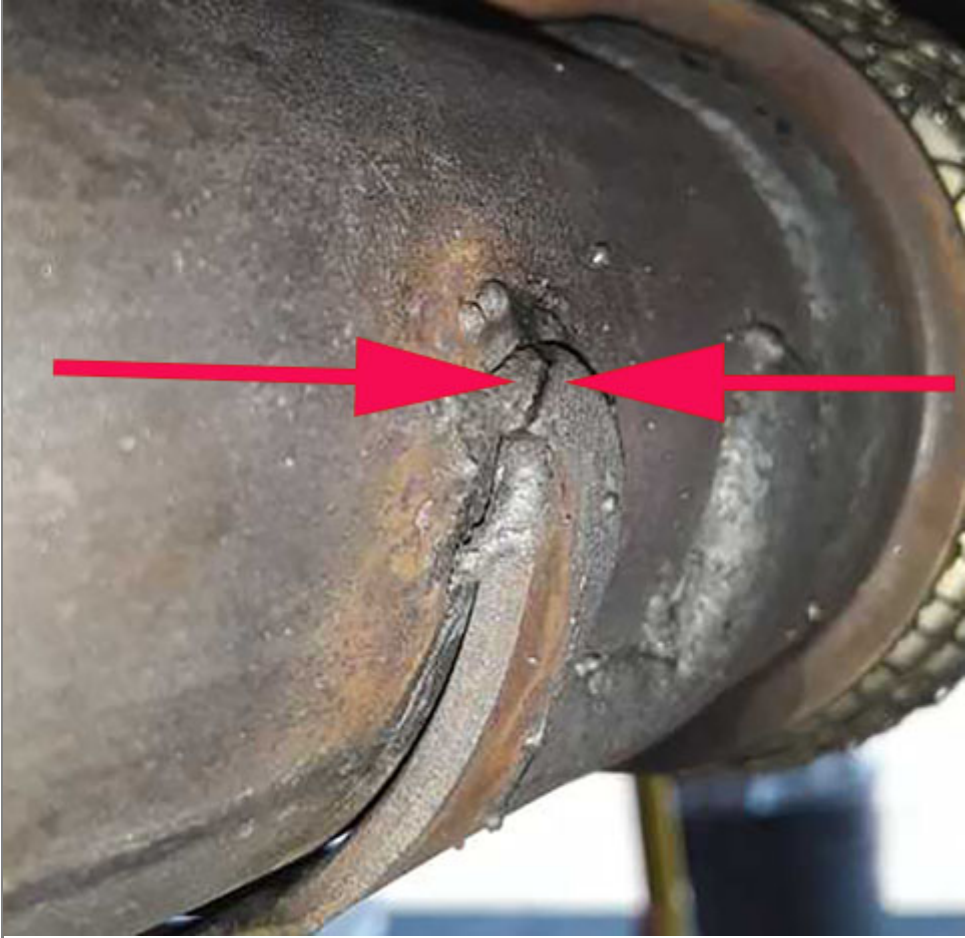
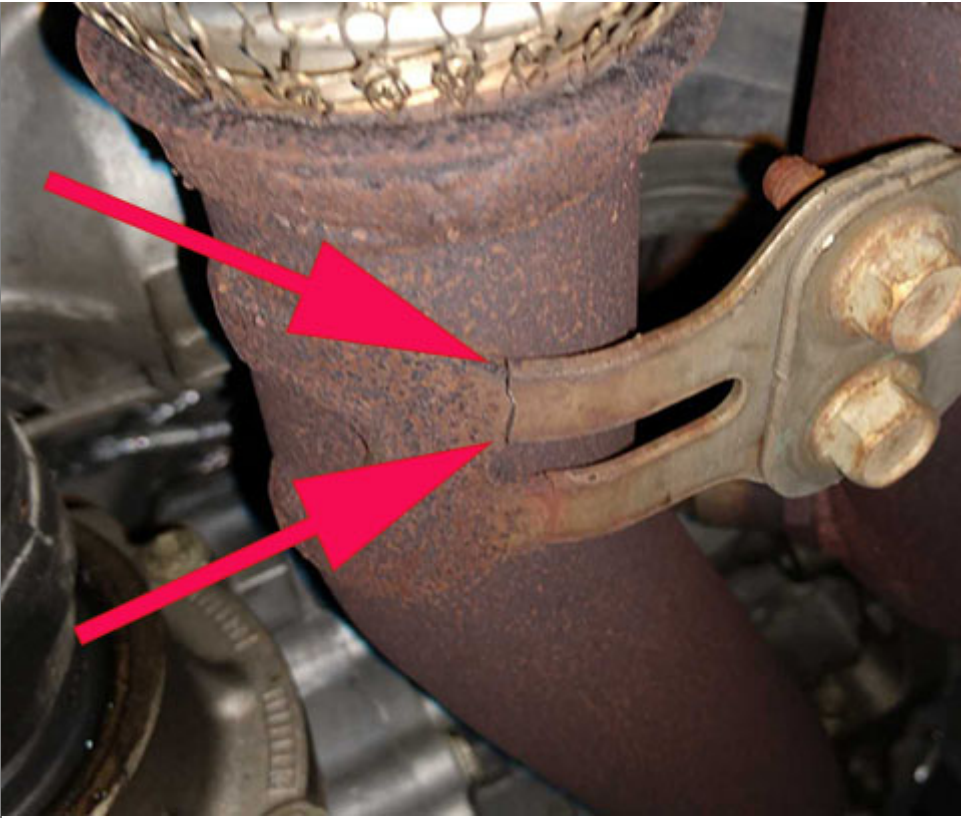
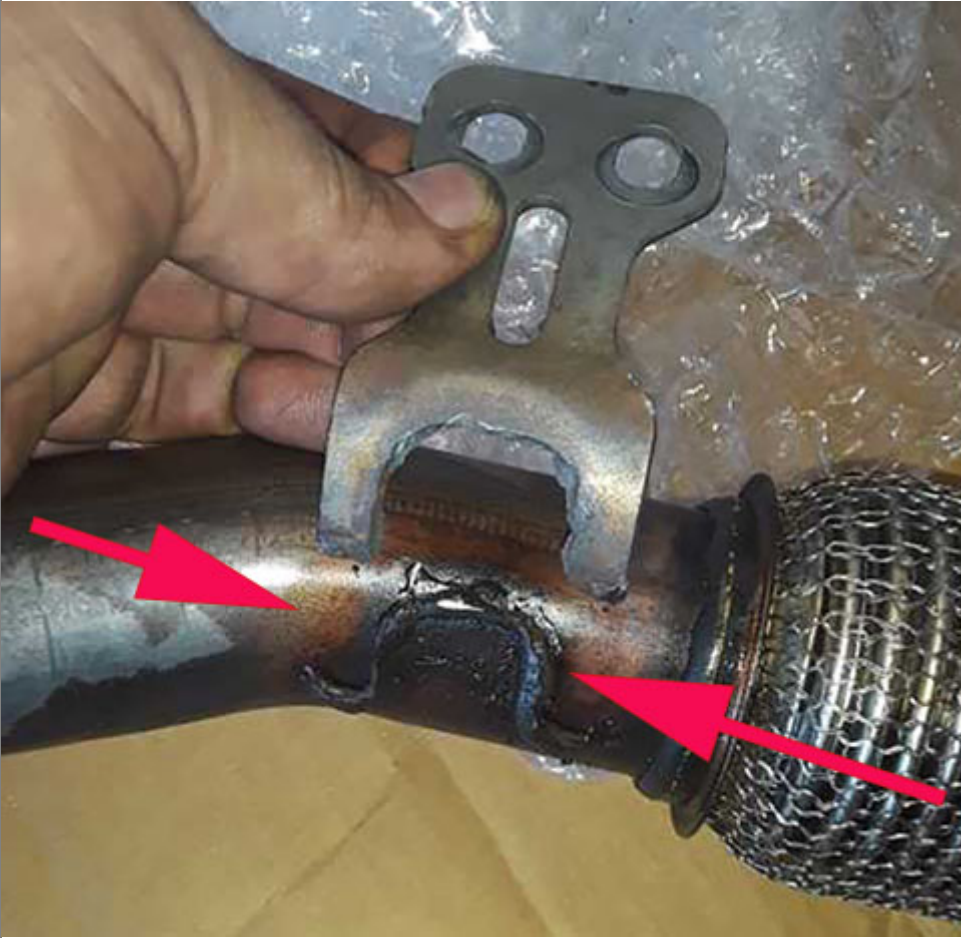
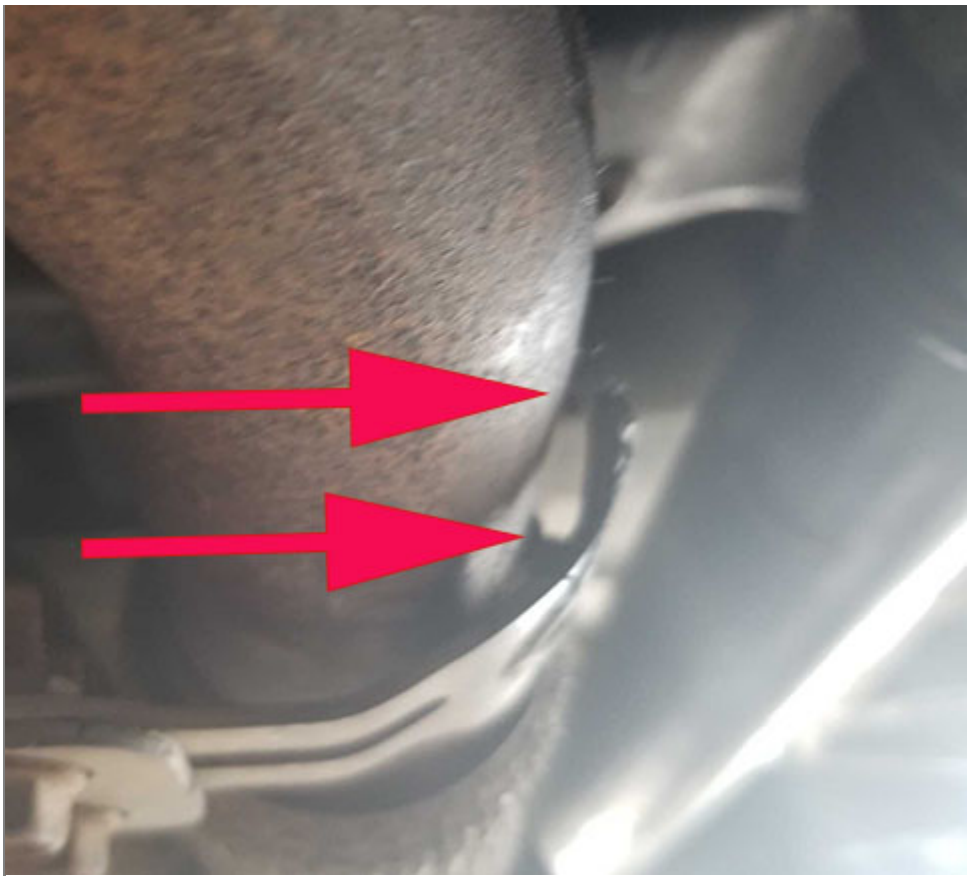
Involved Region or Country	North America
Condition	Some customers may complain of a rattle or exhaust noise, a CEL/MIL on, or repeat concerns of lean codes or converter failures. You may find a cracked pipe on Bank 2, a cracked catalytic converter on Bank 1, or any of these DTC's - P0171, P0174, P0420, P0430, P2096, P2097, P2098, or P2099.
Cause	The cause for these concerns could be a broken or poor weld with lack of penetration on the Bank 2 exhaust flex pipe bracket as shown below.

The correction for this concern is to replace the pipe from the Bank 2 converter to the mid exhaust assembly. Also inspect for damage to the right catalytic converter and pipes caused by the Bank 2 pipe being broken. Clear any codes that have set and retest the vehicle till the codes have run and ensure they pass.
