Preliminary Information

PIT5734A Poor Heater Performance - Diagnostic Tip

Brand:	Model:	Model Years:	VIN:		Engine:	Transmissions:
			from	to		
Chevrolet	Silverado 1500	2020 - 2021	All	All	3.0L LM2	All
GMC	Sierra 1500	2020 - 2021	All	All	3.0L LM2	All

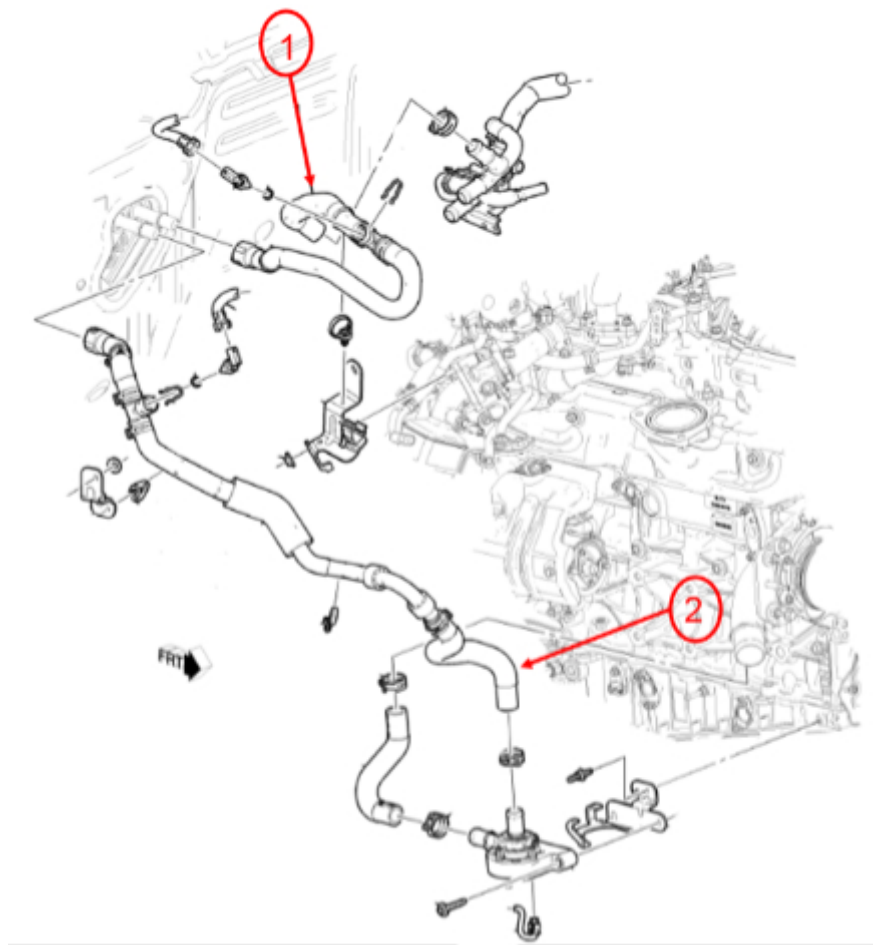
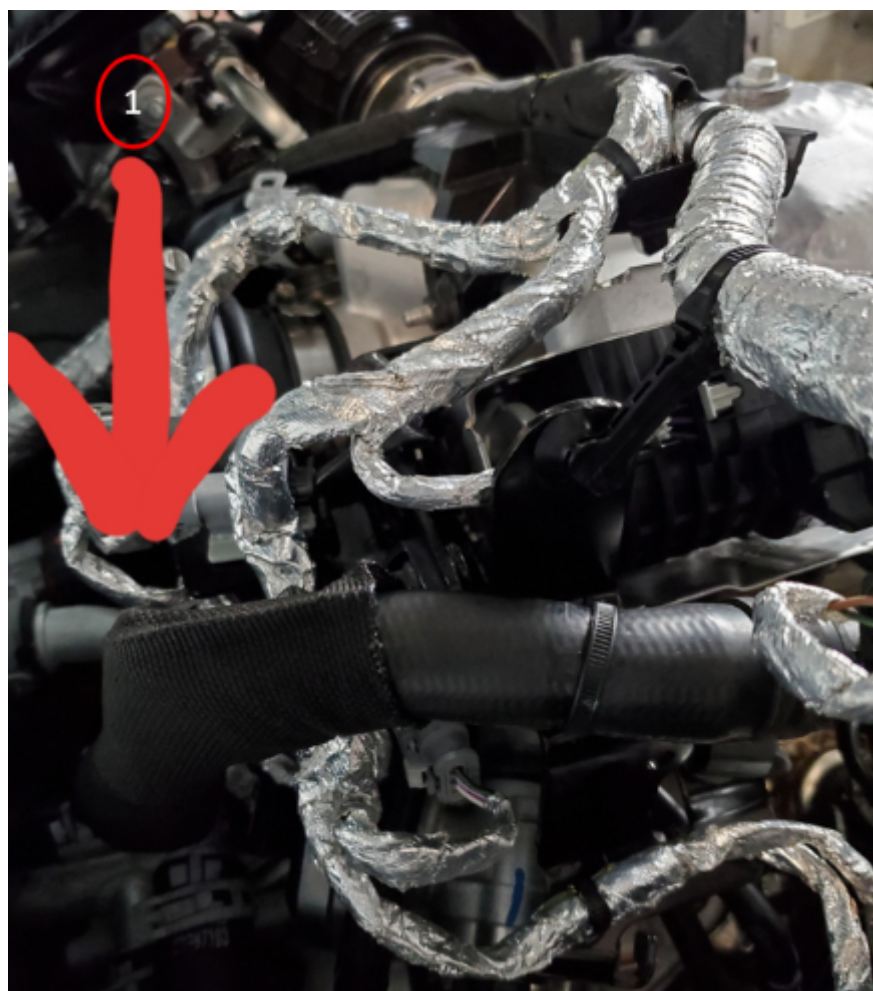
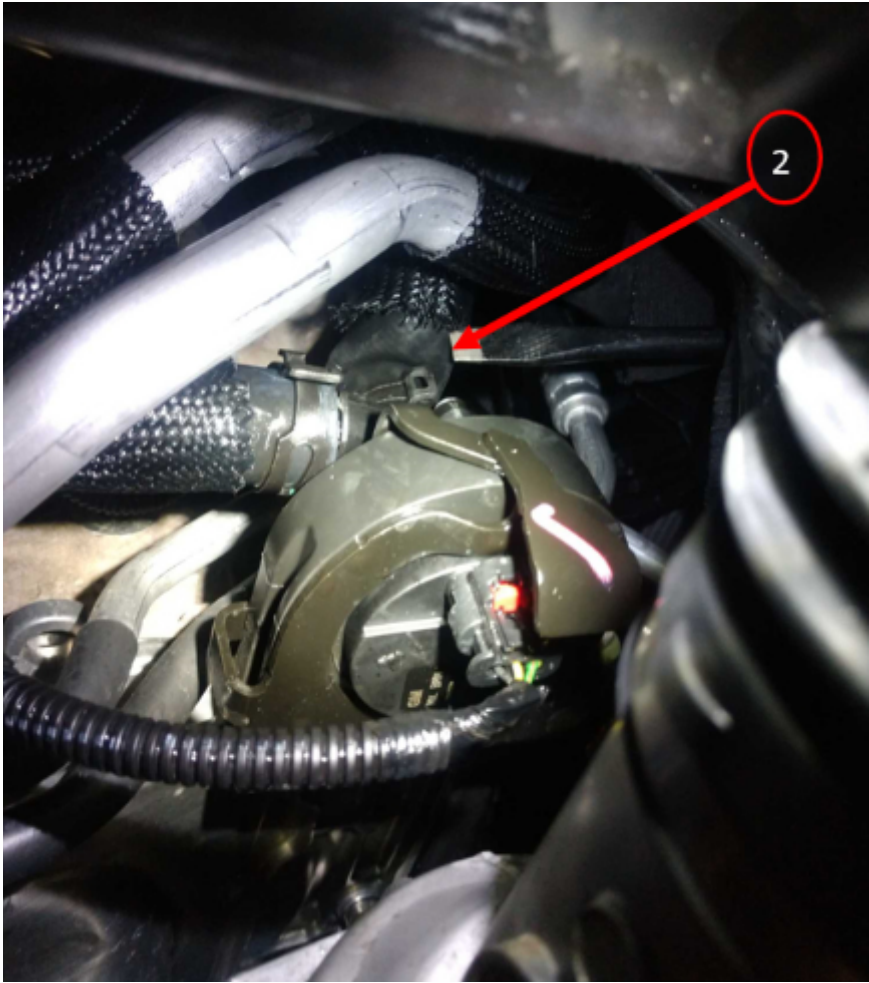
Involved Region or Country	North America
Additional Options (RPO)	3.0L Diesel Engine RPO LM2
Condition	<p>Some customers may comment on poor or no heat. When using GDS2 to compare the heater core inlet temperature sensor 3 to the heater core outlet temperature sensor 4, there will be a significant difference (example inlet temp 147 degs F and outlet temp 82 degs F, typically they are within 10-20 degs F).</p> <p>Note: When comparing the difference in the heater core temperature sensors, make sure the blower motor is on high with the HVAC temperature set to full hot.</p>
Cause	This issue could be caused by either the heater core inlet or outlet hoses becoming twisted or kinked, and as a result, this may restrict the coolant flow.

If SI diagnostics do not lead to a correction, inspect the heater core inlet (1) and/or outlet (2) hoses for being twisted or kinked, as shown below. In some cases, it can be difficult to see the twist or kink in the hose due to the conduit which covers the hoses. In the examples below, the parts catalog drawing, showing callouts 1 and 2, correlates to the actual vehicle picture callouts 1 and 2.
