### PIT5785 Night Vision Inoperative Green Pixelated / Fuzzy Screen

Product Investigation Review Required

Brand:	Model:	Model Years:	VIN:		Engine:	Transmissions:
			from	to		
Cadillac	XT5	2020 - 2021	All	All	All	All
Cadillac	XT6	2020 - 2021	All	All	All	All

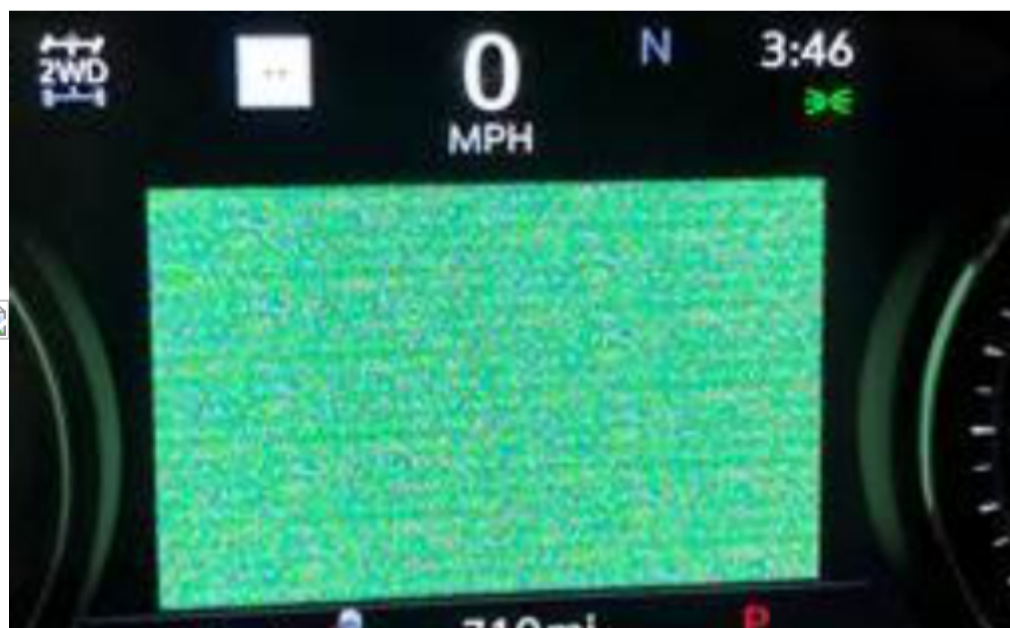
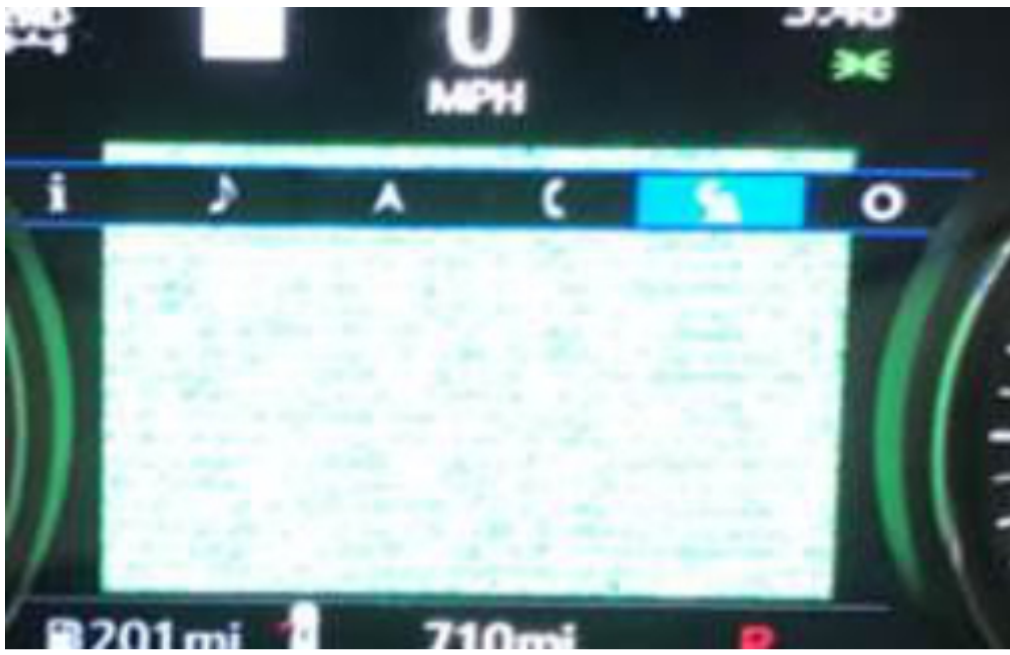
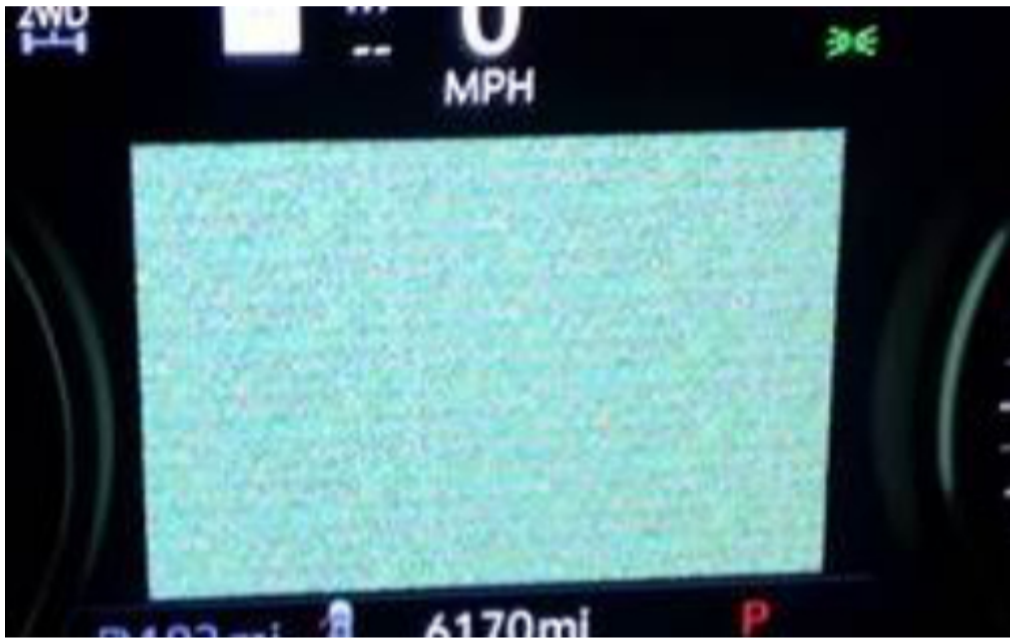
<b>Involved Region or Country</b>	<b>North America</b>
<b>Condition</b>	Night Vision is inoperative, will have a green pixelated picture in the DIC.
<b>Cause</b>	The LVDS /USB Black connector is not connected to the cluster or has a poor connection.

There are 2 LVDS /USB connectors on the back of the cluster.

One is gray and the other is black.

The gray connector is an output going to the HUD.

The black connector is the input from the Night Vision Camera Control Module.

Inspect the back of the cluster to see that the black LVDS /USB connector is seated correctly .

If the connector is missing, inspect around the cluster ip harness to find it and install it.
