Preliminary Information

PIC6293E Installation Of the GM Accessory Interior Spectrum Lighting Kit

| Brand: | Model: | Model Years: | VIN: | | Enginer | Transmissions | |
|--|---|---|---|---|---|--|--|
| Chevrolet | Camaro | 2016 - 2021 | All | All | All | All | |

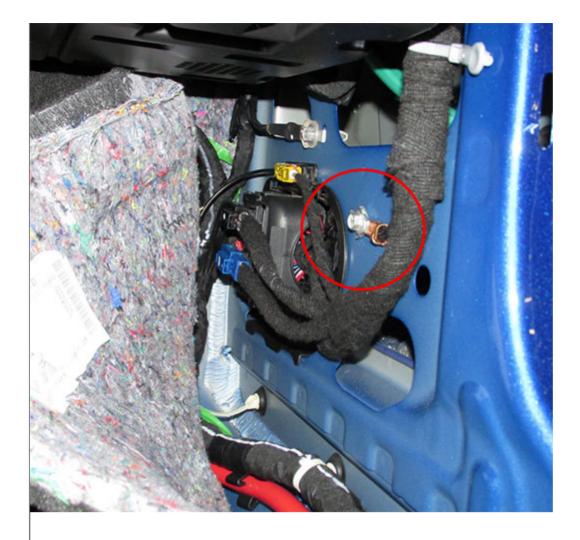
If the entire kit has been installed and the lighting is entirely inoperative, there are a few things to go back and check. The most common area for concern is G202, which is located at the right hand kick panel. Typically, this ground has paint on it when the kit's eyelet is installed. Just tightening the fastener does not provide a good ground path if there is still paint covering the sheet metal. The fastener will have to be removed, the paint needs to be cleaned or ground off, and the ground path verified.

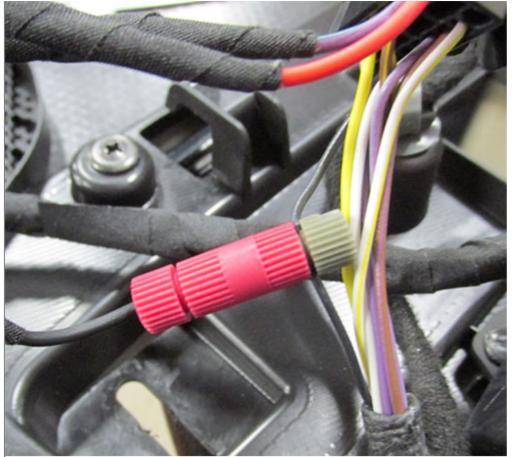
- Another common issue that is seen relates to the Posi-Tap connectors used in the kit. These connectors are used to splice the accessory harness to the vehicle's wiring harness. Dealership technicians are to go back through the installation and verify that each connector is tight. If one or more of these connecters is/are loose, this will cause any number of performance issues with the kit. The connector shown in the photo below does not have tape or a zip tie covering it for clarity. Once the connector is properly installed, the instructions have the technician tape back the splice to the main harness using cloth tape. This will prevent the connector from loosening up over time.

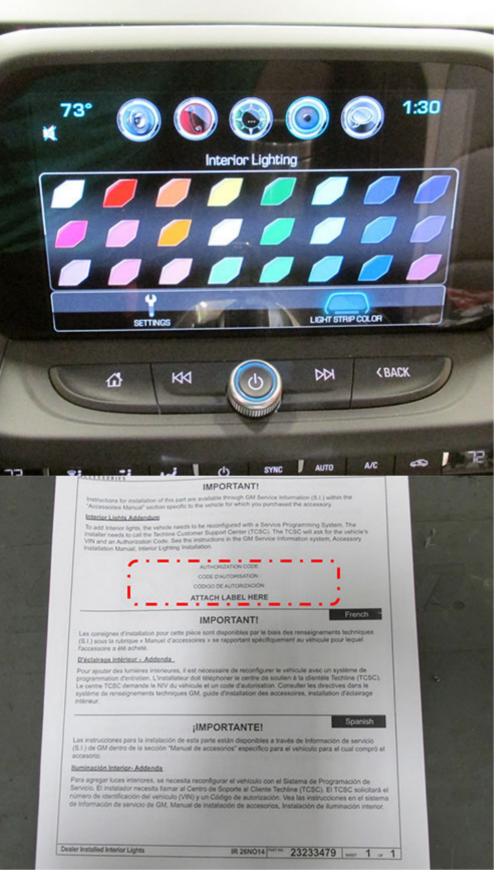
If the vehicle is equipped with an "uplevel" radio (RPOs IO5, IO6, IOS, or IOT) various modules will require reprogramming through Techline. This programming allows the customer to select the various lighting colors on the radio's touchscreen, as seen in the color palette photo below. As seen in the second photo below, there will also be a sheet of paper included in the kit that has an authorization code printed on it. Once that code is provided to Techline, they will be able to assist in correctly programming the vehicle.

For the 2016 - 2018 models with the IO5 or IO6 radio, the HMI and the BCM will require SPS programming.

For the 2019+ models with the IOS or IOT radio, the radio and BCM will require SPS programming.

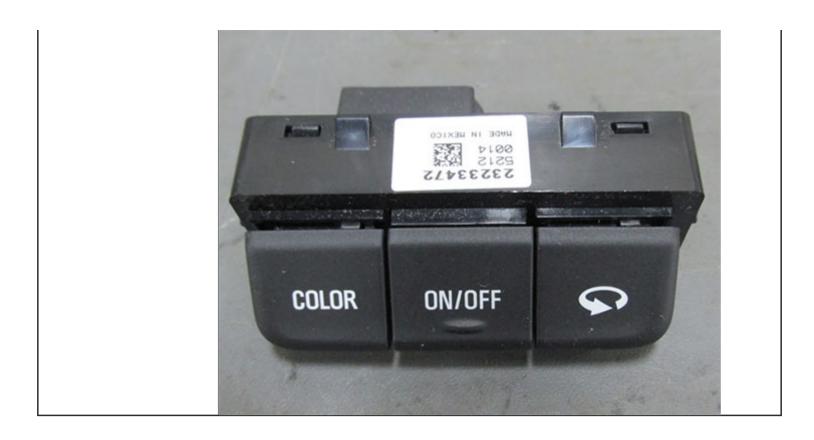
Vehicles equipped with the base radio (RPO IOB or IOR) do not require any programming. That is why the color selections are not available on the radio screen. This system uses a dashmounted switch to change the system's lighting colors. It is installed on the left hand side of the steering column. This switch can be seen in the photo below.
