Preliminary Information

PIP5748B Particulate Matter Sensor Protection Tube Performance Diagnostic May Set A False DTC P1488

Brand:	Model:	Model Years:	VIN:		Engine:	Transmissions:
			from	to		
Chevrolet	Silverado	2020	ALL	ALL	LM2	All
GMC	Sierra	2020	ALL	ALL	LM2	All

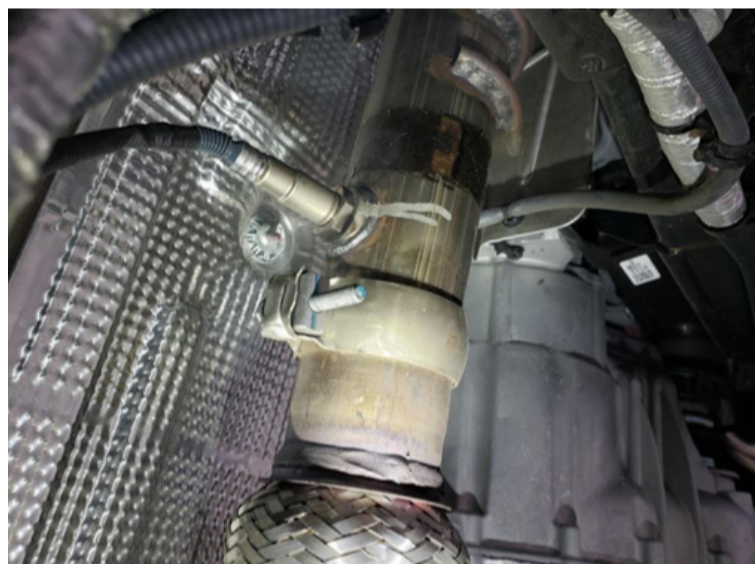
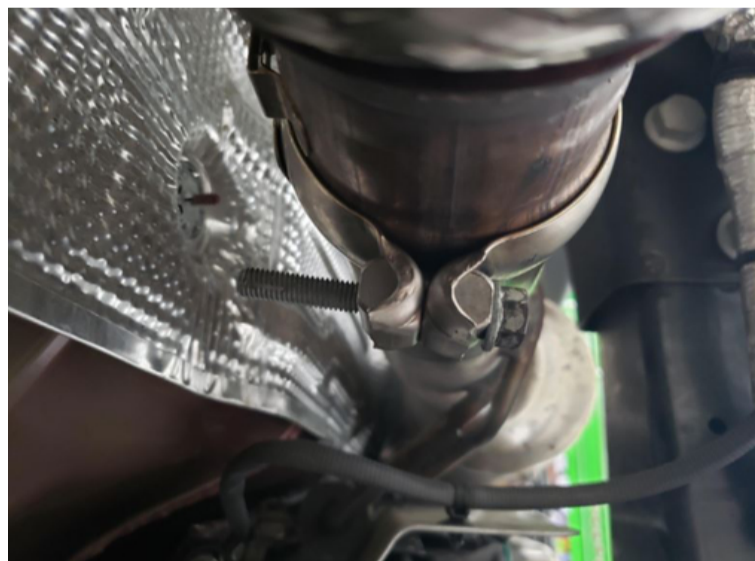
If the sensor is properly torqued and the P1488 has requested the MIL, test the exhaust for leaks using the power smoke diagnostic leak detector (GE-52250 - refer to the latest version of [PIP5684](#)). Because of the location of the exhaust cooler, the sealing bladder can't be used effectively. The pressure necessary to find the leak is minimal, so using two wraps of duct tape around the pipe will seal the cooler holes sufficiently for testing. Repair any leaks as necessary but pay particular attention to the joint illustrated in the pictures below. If the joint is leaking the clamp may have bottomed out before applying sufficient clamp load to the joint. If this condition exists, replace the clamp.

Also replace the particulate matter sensor.
