Preliminary Information

PIT5759H Service Safety Restraints System With DTC B14DC SYM 1B and/or 13

Product Investigation Review Required

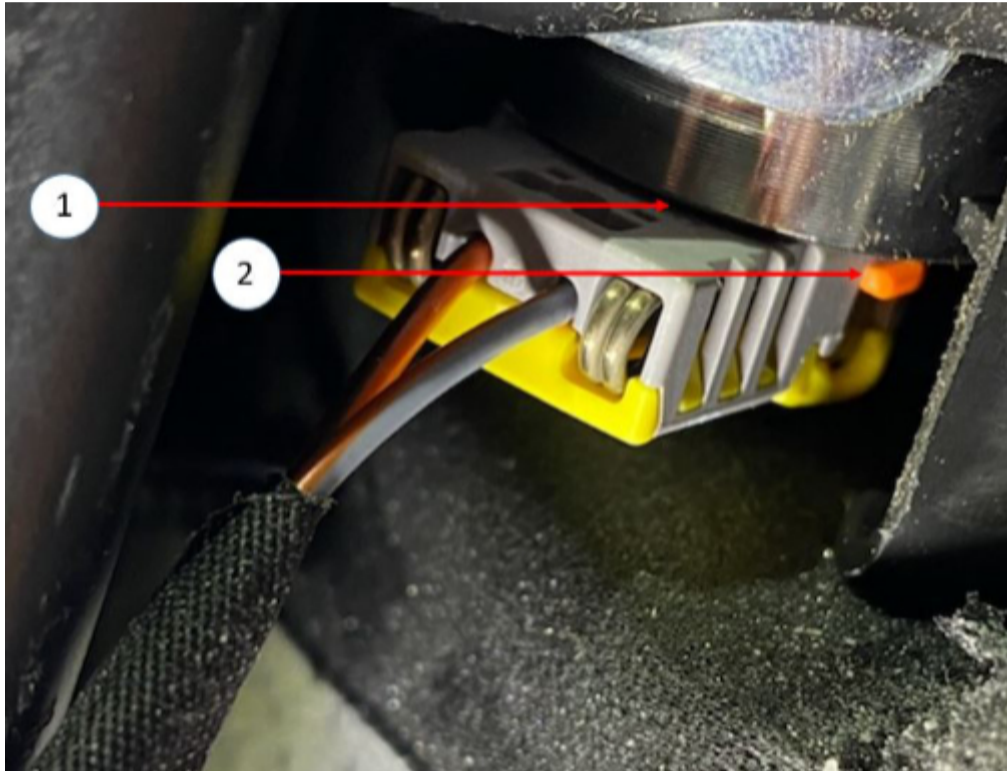
- Reconnect the F106DA Driver's front seat inboard air bag connector (shown below) and make sure it is fully seated tight up against the airbag (1). Also, make sure the orange CPA is fully seated (2), as shown below.
- Reinstall the driver's inboard air bag and torque the fasteners to 7 Nm (62 lb in).
- Reassemble the seat following SI service procedure.
