Preliminary Information

PIT5742A SES MIL / No Start / No Crank / Runs Rough / Reduced Engine Power / Loss Communication / DTCs (V8 and V6 Inspect Engine Harness)

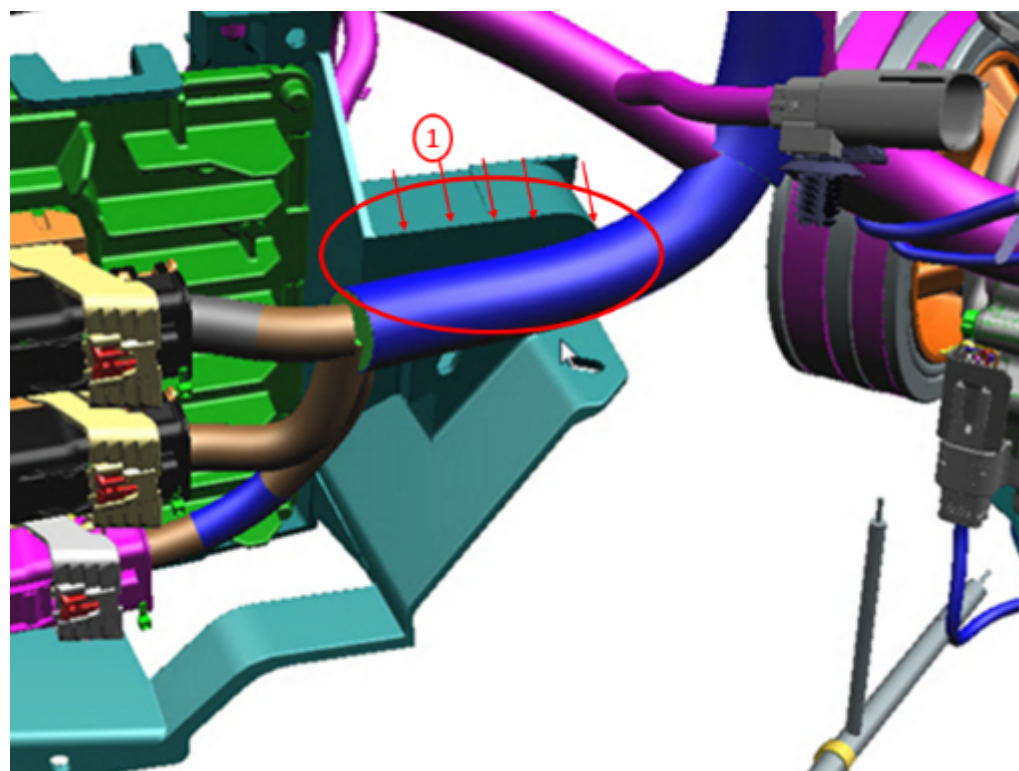
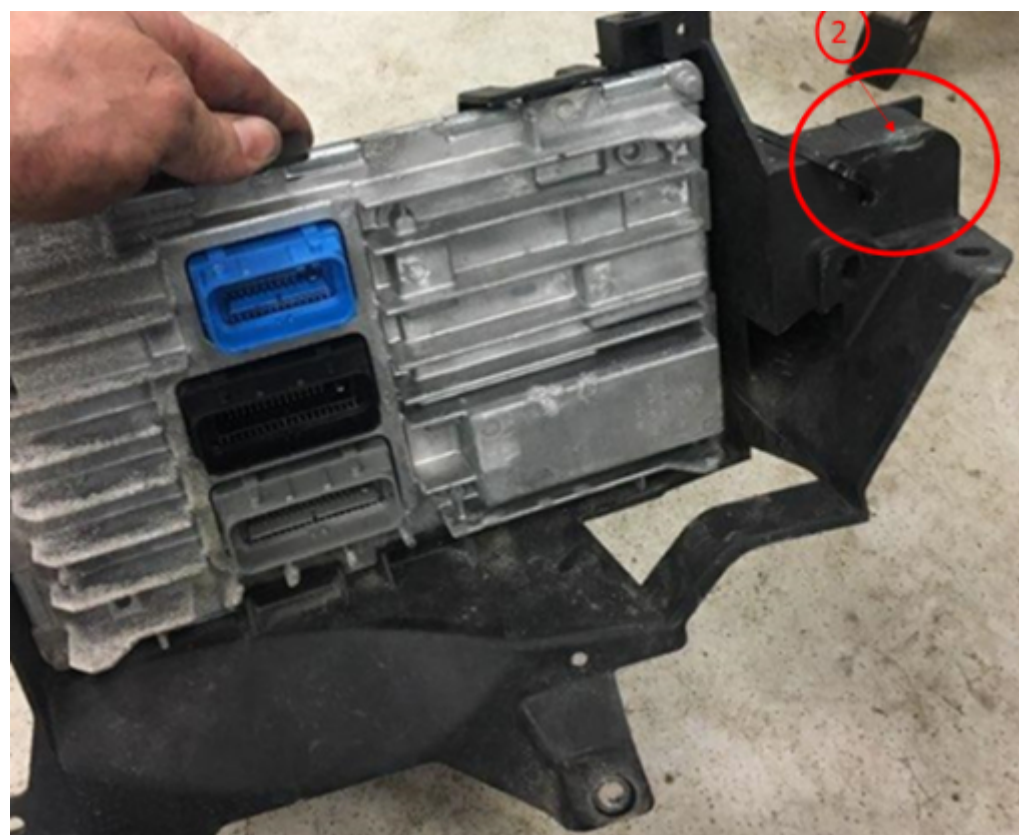
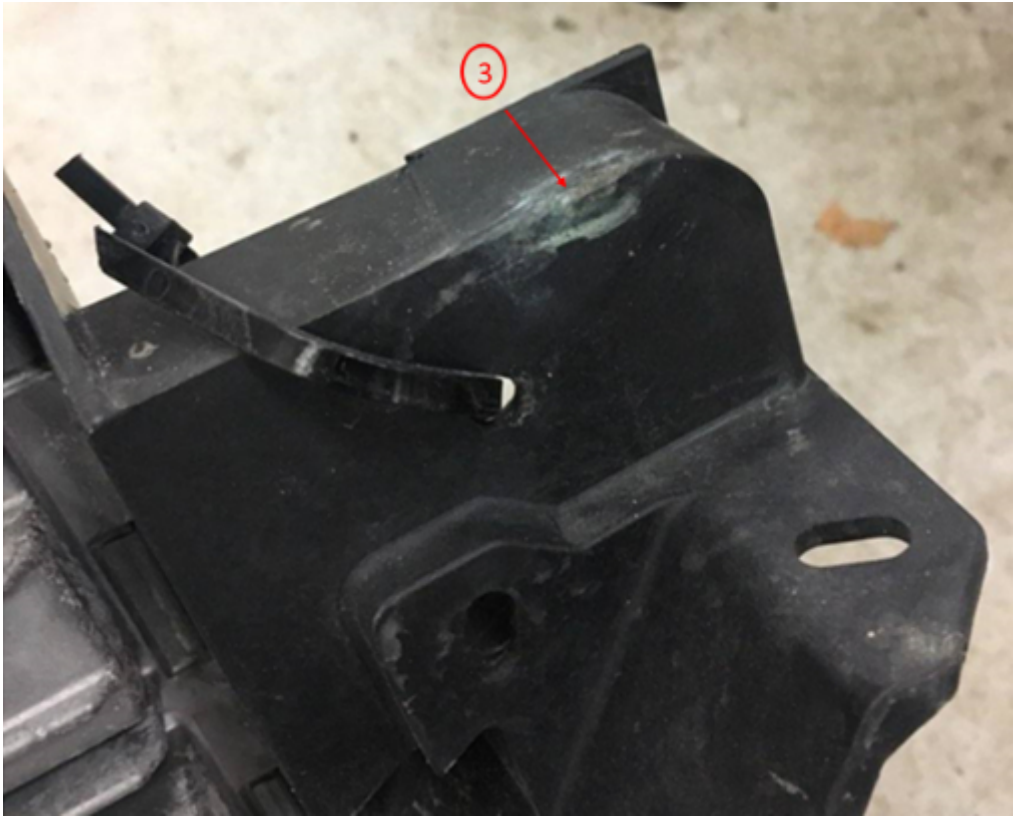
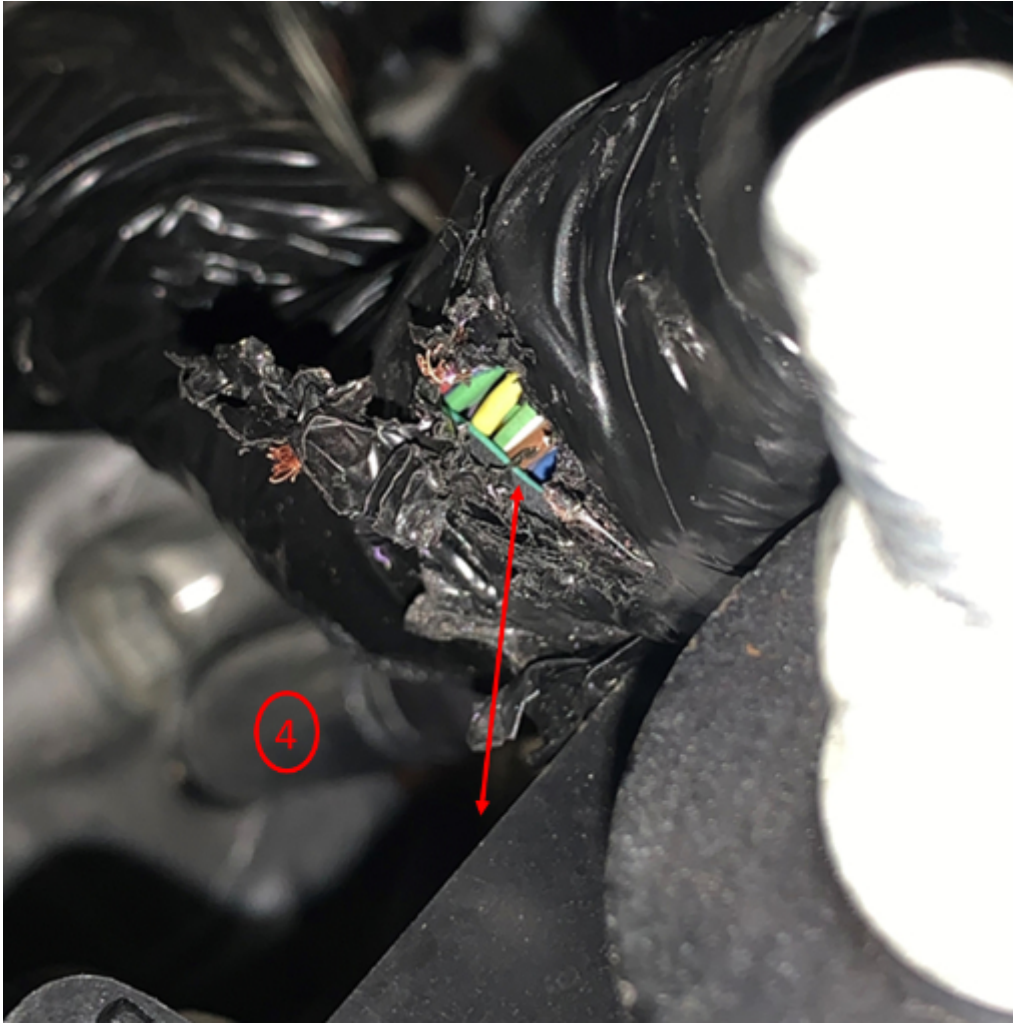
Involved Region or Country	North America
Condition	<p>Some customers may comment on any of the following concerns:</p> <ul style="list-style-type: none"><li>- SES MIL</li><li>- No Start</li><li>- No Crank</li><li>- Engine runs rough</li><li>- Reduced engine power</li><li>- Erratic gauge operation</li><li>- Transmission shifting erratically or not shifting</li><li>- Blown Fuse(s): F46UA, F78UA, F86UA, F88UA, F87UA, F90UA, F60UA, F67UA, and/or F91UA</li></ul> <p>When checking for DTC's there may be any of the following:</p> <p>P0101 P0103 P0106 P0108 P0300 P0562 P0615 P0617 P0641 P0689 P0700 P12A6 P15A0 P216E P1682 P16BD P16BC P2147 P06A3 P349P P2B96 U0073 U0078 U0100 u0101 U0102 u0121 u0128 U0129 u0131 U0140 U0146 U0184 U0422 U1345 U1346 U1347 U1348 U1349 U1501 U1502 U1503 U1510 U1511 U01B0 U18B4 U18D5 U2413</p>
Cause	<p>These concerns could be caused by the engine wiring harness chaffing on the ECM mounting bracket, as shown below. The ECM mounting bracket has a sharp edge (1) and it can cut into the wiring harness. Due to the number of circuits in the harness, there is a wide variety of different symptoms that could occur depending on which circuit(s) are damaged.</p>

Inspect the engine harness in the area shown above. If harness damage is found, repair the damaged wiring following the SI wire to wire repair procedures. Once repaired, protect the engine wiring harness using Woven Polyester (PET) Electrical/Anti-Abrasive Tape. This tape may be purchased at [kent-automotive.com](http://kent-automotive.com) Item# 1089482.
