# AfterSales Diagnostic Sheet

## MAS002310 (BOL 20-11)

### Turbocharger anomalies

**Models:** M157/M156/M161 (Gasoline engines)

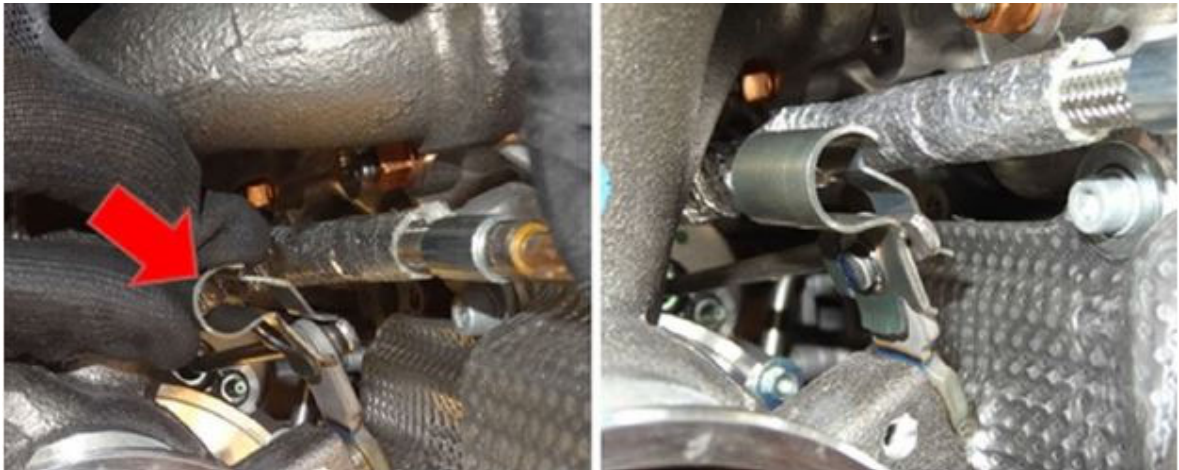
Figure 3 - Clips of the wastegate

4) Check if the clips of the wastegate are present as figure 3

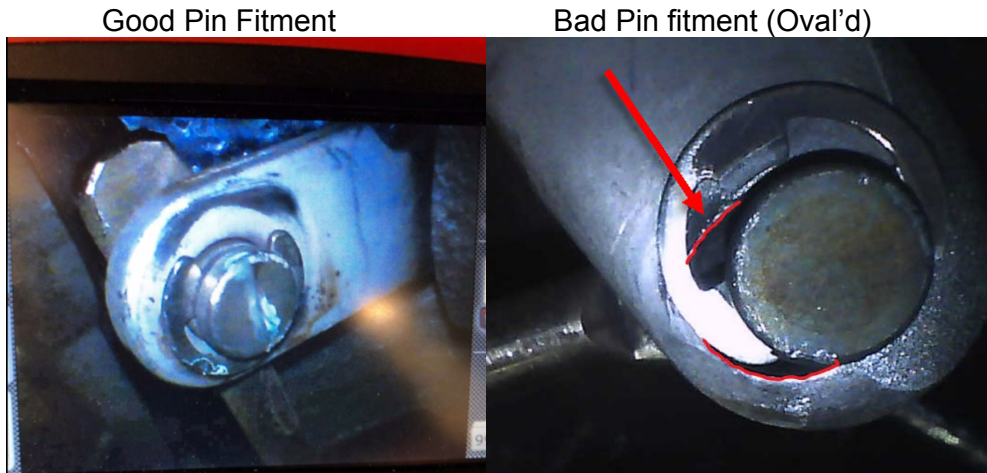
Remove Safety clip and take a picture of the Wastegate lever to actuator pin fitment. Fig. 3-1 shows example of "Good vs. Bad". In the "Bad" example you can see the hole is oavaled out (outlined in RED). If OK, then check the following:

- Check for corrosion or rust on the Wastegate lever to actuator pin  
Operate the Wastegate lever with vacuum while monitoring for binding.

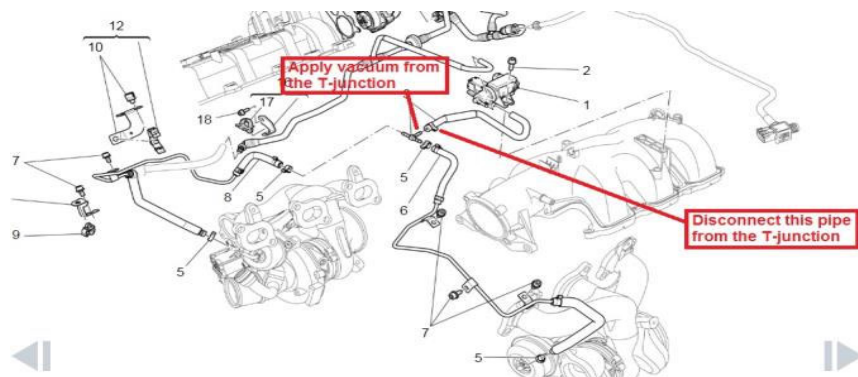
Figure 4 – Vacuum pump positioning

- 5) Activate the "sport mode" and check that the sound from the exhaust varies as expected
- 6) Disconnect the wastegate vacuum system from the point shown in figure 4 and check using a vacuum pump (for ease of access, install the pump after the output of the wastegate modulator):
  - the integrity of the vacuum system
  - If the wastegate valves, applying the vacuum with an external pump, move and close simultaneously. Also check, when removing the vacuum applied, that the wastegate valves return to the rest position simultaneously

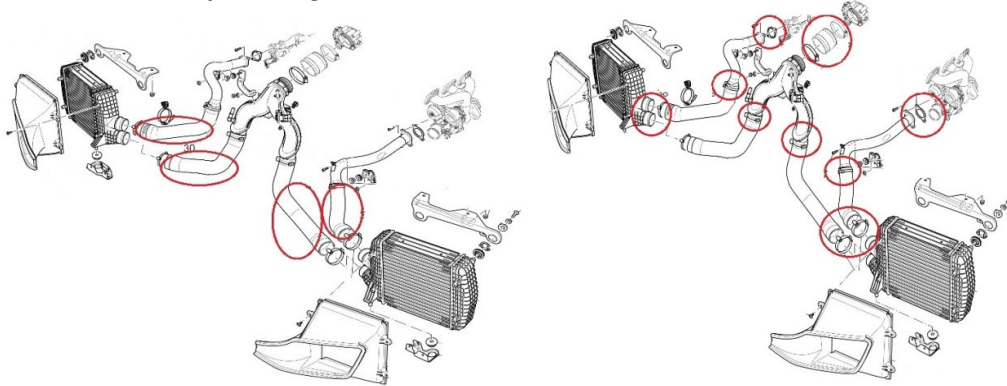
Figure 5: – Intake System

- 8) Check if there are any leaks in the intake and exhaust systems, if necessary use a smoke tester to check the highlighted areas below as shown in Fig.5. Verify that the V-Clamp in-between the turbocharger and the catalytic converter is correctly tightened and does not show any misalignment or exhaust leaks.

Possible air leaks on an intake line underneath the protective sleeve of the hose.

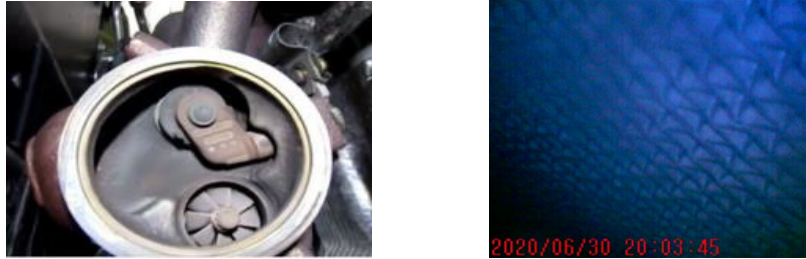
Figure 6: turbo shaft from catalyst side and inside the catalyst

- 10) Check if the turbo shaft has excessive free-play or if the vanes of the turbo are damaged (attach photos and videos). To perform this check, it is not necessary to remove the turbo but you can access from the catalyst side as shown in figure 6  
Next, with an endoscope, inspect the status of the honeycomb of the catalytic converter to make sure there is no external contamination or damage.

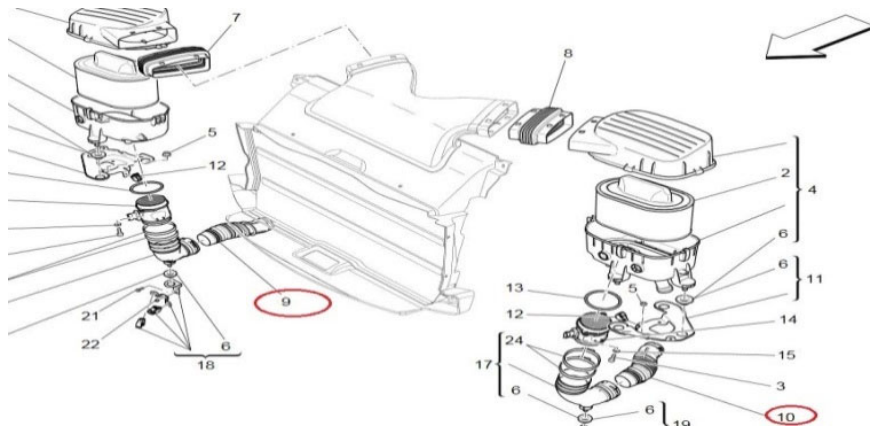
Figure 7 - lower air duct

- 11) Next, using an endoscope, check the compressor impeller (suction side). To perform this check it is not necessary to remove the turbo. It can be accessed by removing tube # 9 or 10 (lower air duct) shown in figure 7.

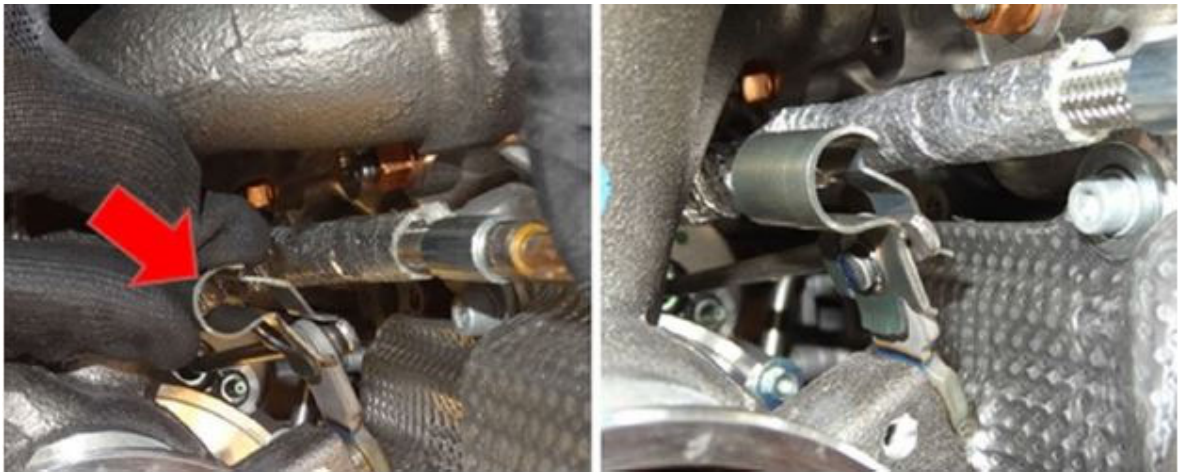
Figure 1- wastegate clip

- 1) Is the customer complaint confirmed?
- 2) Attach to the BOL the DTC and parameters report from the ECM.
- 3) Check if the clips of the wastegate are present as figure 1

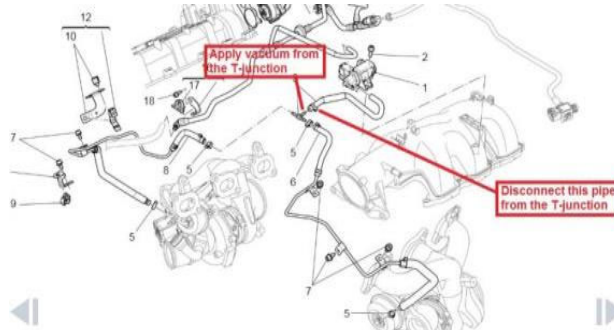
Figure 2 – Vacuum pump positioning

- 4) Activate the "sport mode" and check that the sound from the exhaust varies as expected.
  - 5) Disconnect the wastegate vacuum system from the point shown in figure 2 and check using a vacuum pump (for ease of access install the pump after the output of the wastegate modulator):
- Check the integrity of the vacuum system

- If the wastegate valves, applying the vacuum with an external pump, move and close simultaneously. Also check, when removing the vacuum applied, that the wastegate valves return to the rest position simultaneously

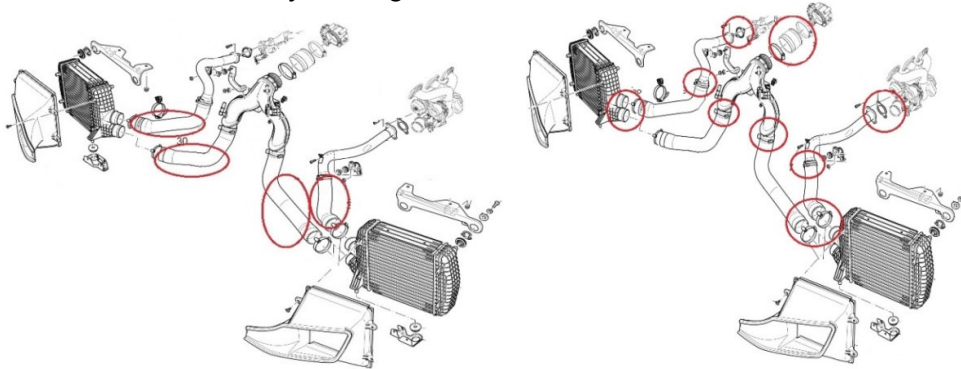
Figure 3 – Intake System

- 7) Check if there are any leaks in the intake and exhaust systems, if necessary use a smoke tester to check the highlighted areas shown below in Fig.3. Verify that the V-Clamp in-between the turbocharger and the catalytic converter is correctly tightened and does not show any misalignment or exhaust leaks.

Possible air leaks on the intake line underneath the protective sleeve of the hose.

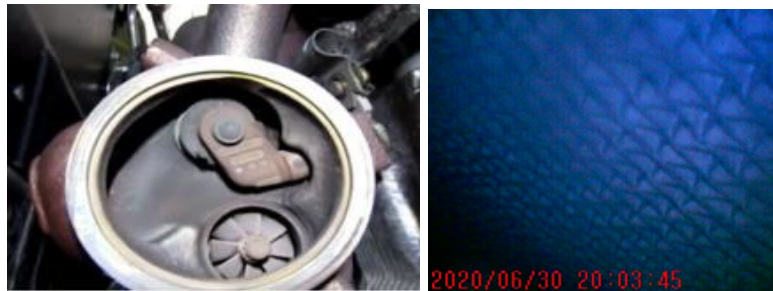
Figure 4 - turbo shaft from catalyst side and inside the catalyst

9) Check if the turbo shaft has excessive free-play or if the vanes of the turbo are damaged (attach photos and videos). To perform this check, it is not necessary to remove the turbo but you can access from the catalyst side as shown in figure 4. Next, with an endoscope, inspect the status of the honeycomb of the catalytic converter to make sure there is no external contamination or possible damage.

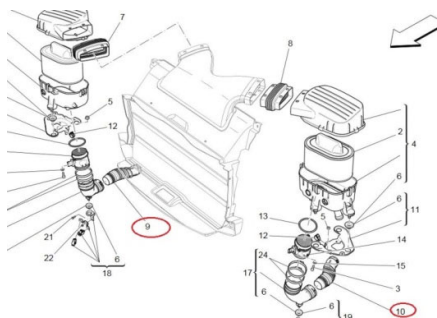
Figure 5 - lower air duct

10) Next, using an endoscope, check the compressor impeller (suction side). To perform this check it is not necessary to remove the turbo. It can be accessed by removing the tube # 9 or 10 (lower air duct) shown in figure 5.
