SIB 32 04 20

2020-10-09

GROANING NOISE DURING HEIGHT ADJUSTMENT OF THE ELECTRIC STEERING COLUMN

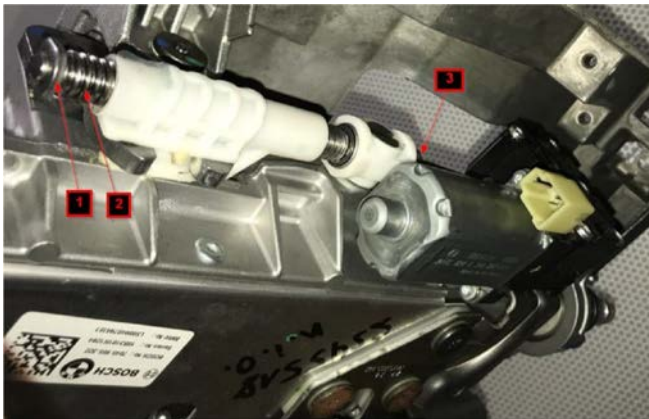
A groaning type noise is heard during the height adjustment. See attached video V32 01 20

Spindle drive of the electric steering column height adjustment

The spindle drive (2) is located on the right side of the steering column as viewed from the driver's seat

The stop panel (1) of the spindle drive will need to be turned 90 degrees clockwise.

Before adjusting the stop spindle, the lock nut in the rear of the drive (3) must be secured in place
