SIB 51 25 20

WHISTLE NOISE FROM FRONT DOORS WHILE DRIVING

E-Series	Model Description
G20	3 Series Sedan

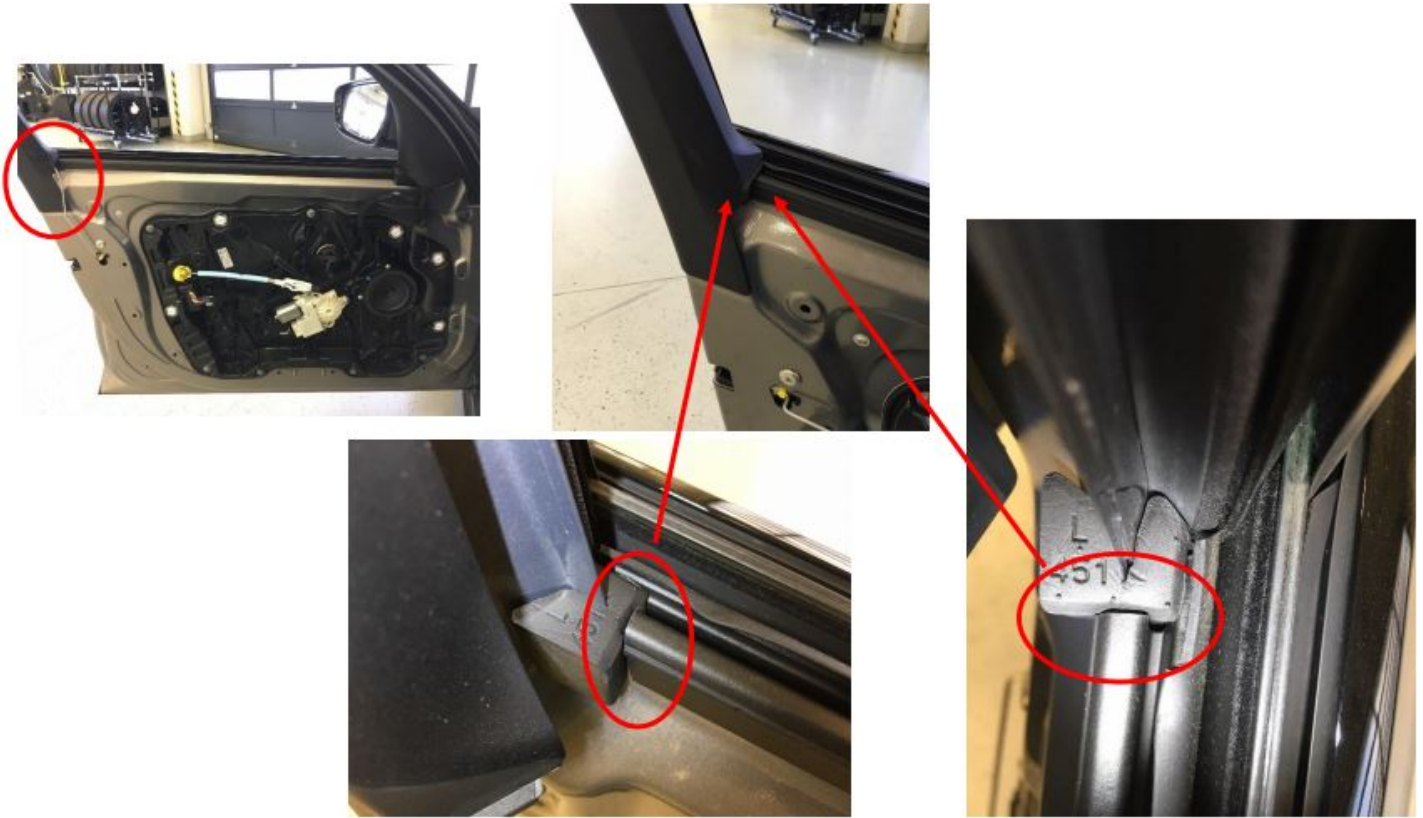
1. Remove the front door panel of the affected door following repair instructions **REP 51 41 000**
“Removing and installing left or right front door trim panel”
2. Reference the photo below to identify which foam seals will be reworked. There is one foam seal at the front of the door (towards the A-Pillar)
and one at the rear of the door (B-Pillar).

3. Ensure the foam seals are fully seated flat against the door.
