SIB 64 05 20

## CONDENSATION FROM AIR CONDITIONING LEAKS INTO PASSENGER FOOTWELL

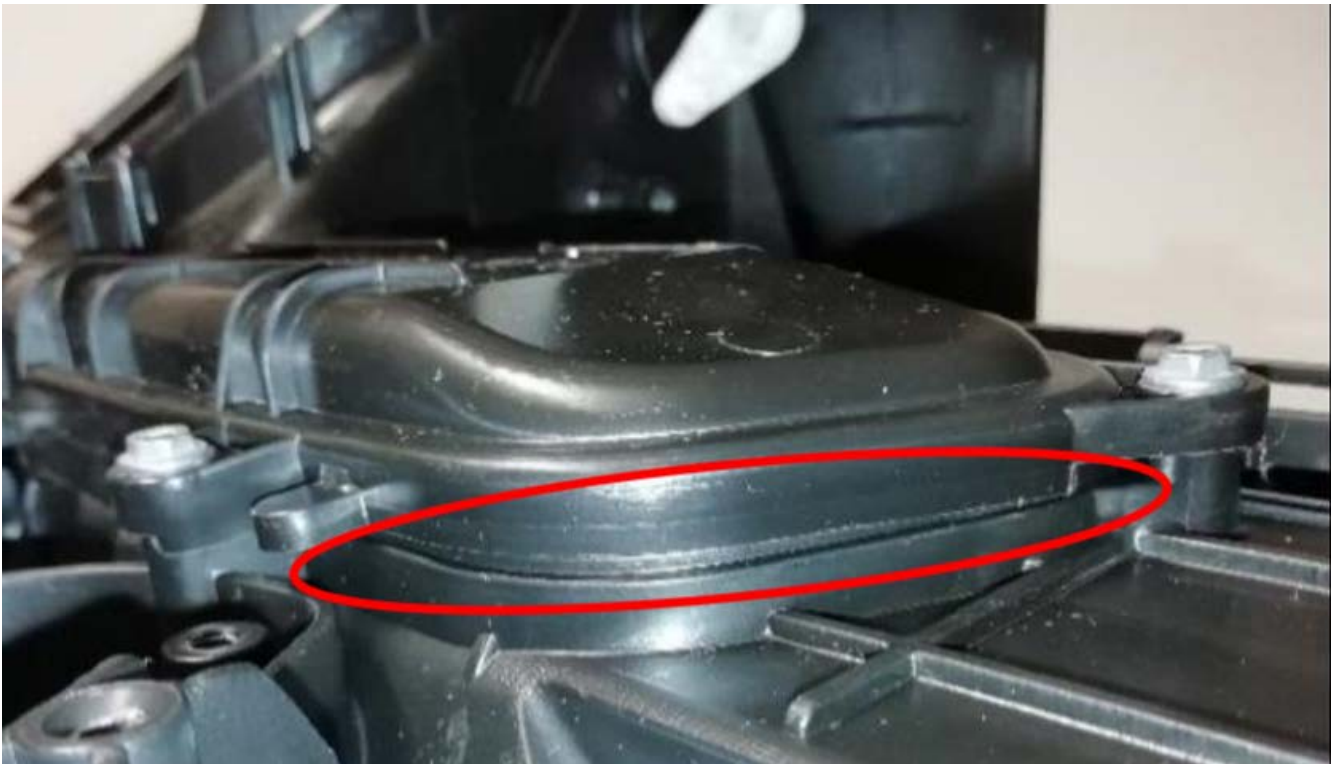
During assembly, the cover of the fresh air intake was not fully seated when the screws were tightened.

This cover can then leak condensation out through the existing gap

Remove, correctly position and reinstall the fresh air intake cover
