SIB 65 14 20

DWA ANTI-THEFT ALARM ACTIVATES FOR NO APPARENT REASON

MODEL

E-Series	Model Description	Production Date	Affected Option Code
F90	M5 Sedan LCI (Life Cycle Impulse)	June 30, 2020 - August 13, 2020	302 Alarm System (100% Option in US)

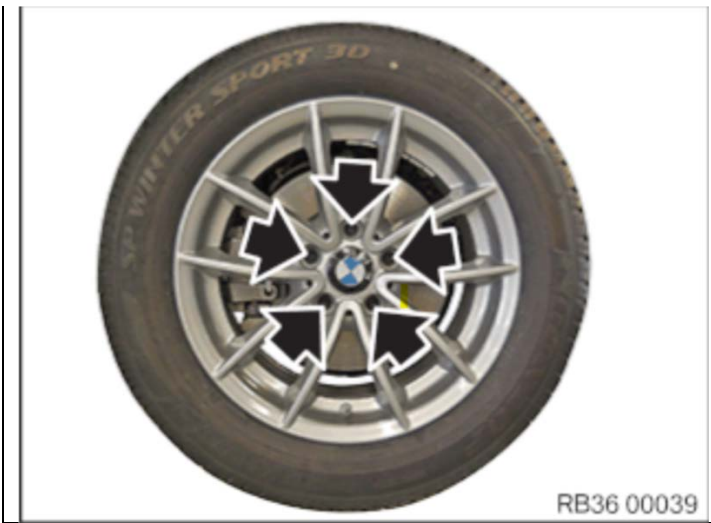
The alarm system is activated due to no apparent external or internal influence.

Sensitivity of internally installed tilt alarm sensor in the alarm system (DWA).

<p>RB36 00039</p>	
  <p>RB51 03408</p>	<ul style="list-style-type: none"> Remove the left rear wheel arch cover.
 	<ul style="list-style-type: none"> Remove the emergency horn with tilt sensor located by the wheel arch liner. <p>Note: (the emergency power siren including the cover does not have to be removed from the holder)</p> <ul style="list-style-type: none"> Clean moisture and dirt from area shown on the left picture Install vibration dampener pad. Reassemble vehicle and test system operation.
