SIM 11 04 20

SERVICE ACTION: MOUNTING THE OIL FILLER CAP CORRECTLY

E-Series	Model Description	Production Date
F60	MINI Countryman – PHEV	March 12, 2020 – June 22, 2020

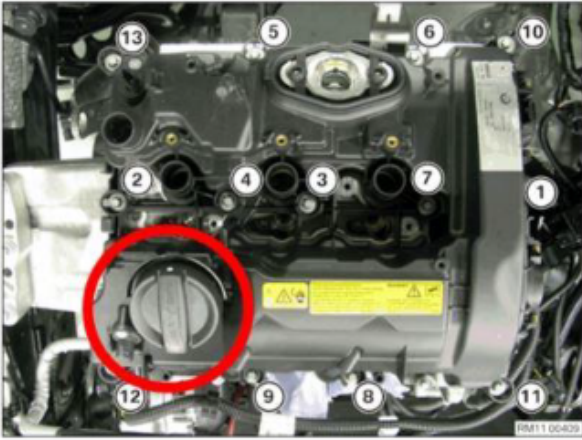
The oil filler cap may not be mounted correctly.

The cap was not installed correctly during assembly.

1. Remove the oil filler cap (circled) and install correctly. Do not replace the cap.

Remove the oil filler cap and install correctly.
