Mercedes-Benz

Campaign No. 2020090004, September 2020

SUBJECT: **Model 907 (Sprinter), Model Year 2019**  
Chassis 3.88t

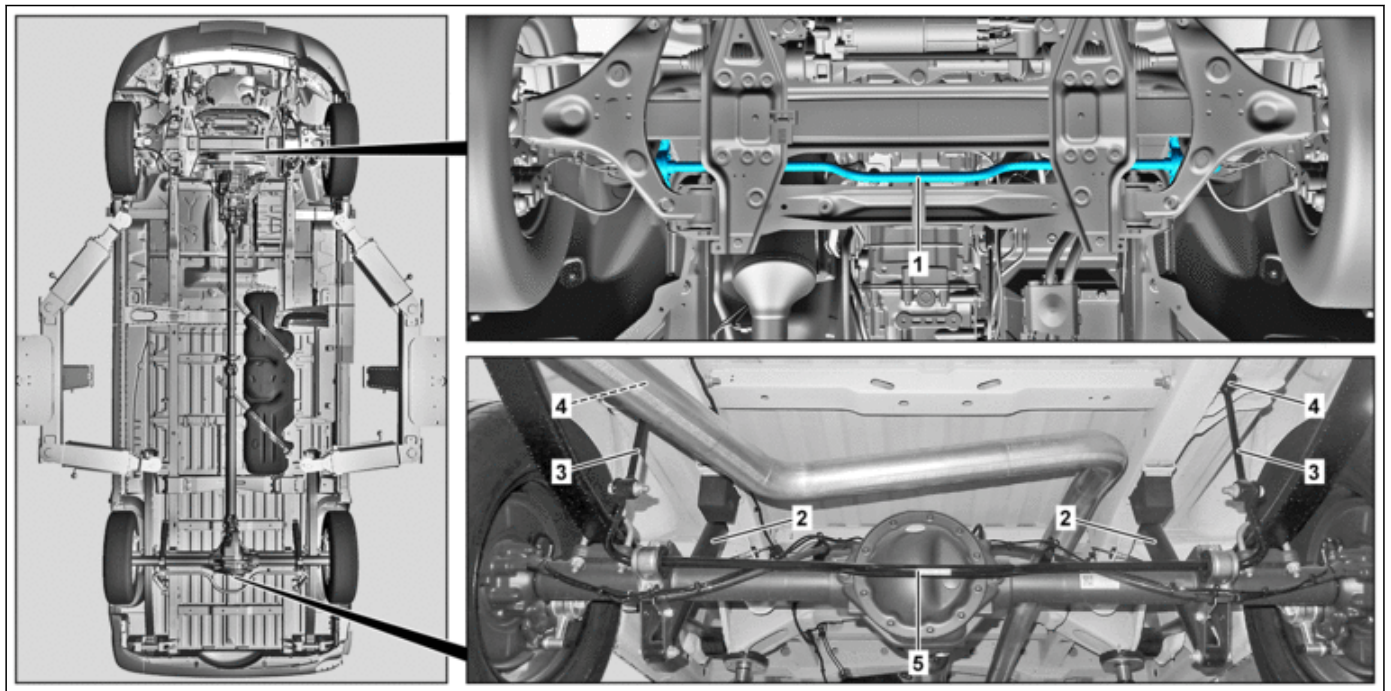
D32.35-A003-79

Mercedes-Benz AG (“MBAG”), the manufacturer of Mercedes-Benz and Freightliner vans, has determined that on certain Mercedes-Benz Sprinter vehicles from platform 907 (VS30) with a permissible total weight of 3.88t, a chassis was installed during the production start-up phase without an additional stabilization stage. This could lead to negative driving behavior effects in highly dynamic driving situations which could increase the risk of a crash. An authorized Mercedes-Benz or Freightliner Sprinter dealer will upgrade the chassis on the affected vehicles by replacing the stabilizers on the front axle and by replacing the shock absorbers and installing stabilizers on the rear axle.

Replace front torsion bar linkages.

Replace front stabilizer (1).	Model 907 except code ZG1 (engageable all-wheel drive) except code ZG3 (engageable all-wheel drive with gear reduction)	AR32.35-D-2050TS
4

Replace rear shock absorbers (2).		AR32.25-D-0110TS
5	Attach rear torsion bar linkages (3) to the longitudinal member.

Guide screws (4) through the longitudinal member. Attach and tighten nuts. Counterhold screws (4).

Install rear stabilizer (5).		AR32.35-D-2210TS
7	Enter special equipment into on-line vehicle data card.
