BLUE BIRD

S20AT

Subject: S20AT, Dual Fuse Block Assembly Inspection

S20AT - Dual Fuse Block 10041668 Assembled Incorrectly

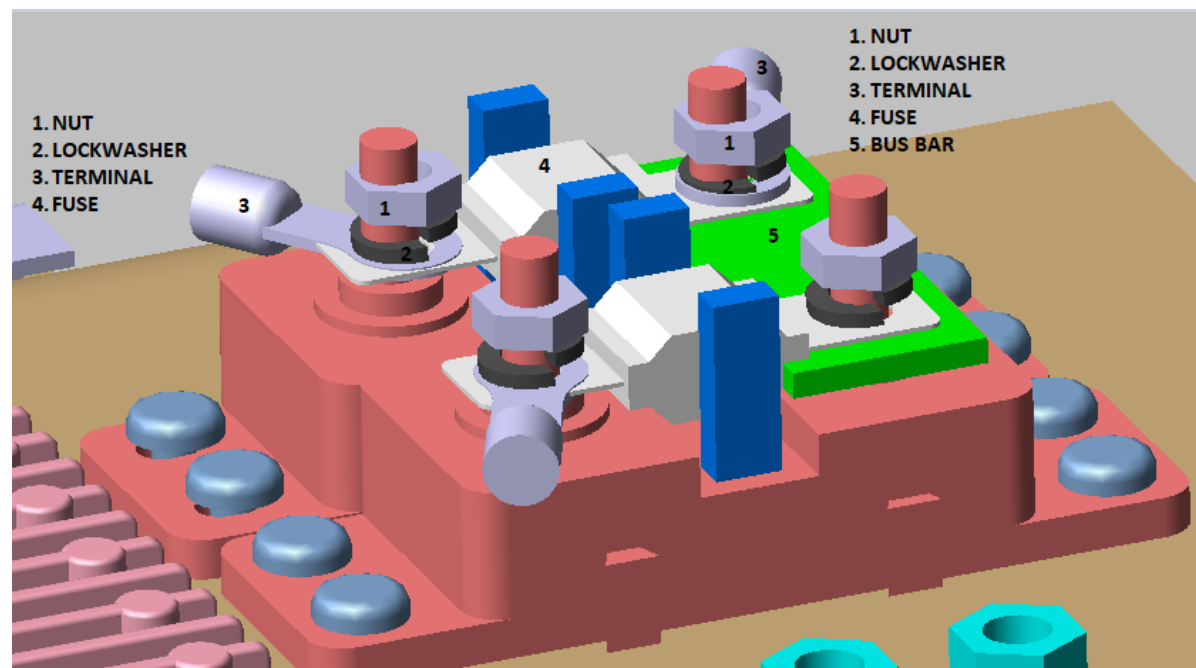
2. First inspect and verify that the Lock Washer (Item 2) is positioned under the nut (Item 1), then verify the fuses and power wires to the dual fuse block are properly oriented and secured (See Figure 1 and 2 below). Verify the nuts on fuse block are tight. Verify wires are not loose. *NOTE- Terminal (Item 3) should be on TOP of the fuse. See Figure 1 for proper alignment.

3. If lock washers are properly aligned, but nuts are loose, tighten nuts to 3-5 N-m (26-44 inch-lbs.). If lock washer is not beneath the nut, disconnect battery power (required) and reassemble per Figure 1. Be sure the wires to the fuses are connected, as shown in Figure 2.

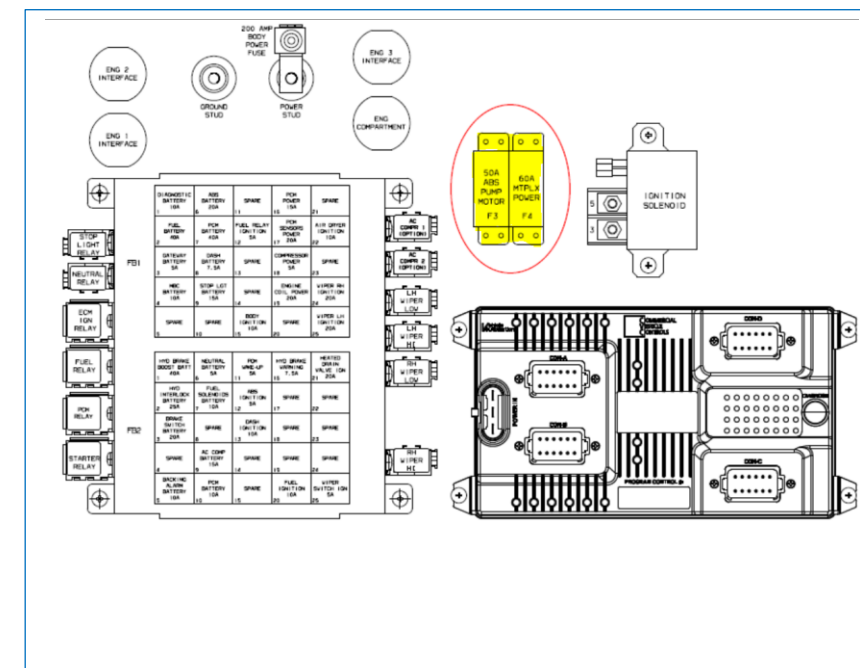
1. Remove the Power Distribution Unit (PDU) cover. It is a large black cover located below the center of the dash and is the main chassis electrical panel for the Vision. The PDU cover is easily removable without tools, secured by two thumbscrews, one on each side of the cover near the top. See decal on the inside of PDU cover for dual fuse block location (circled on Sample PDU Decal shown below).
