Technical Journal

Headlamp condensation - broken guide pin

REF NO: TJ 35662.1.0	ISSUING DEPARTMENT: Technical Service	CAR MARKET: United States and Canada	
PARTNER: 3 US 7510 Volvo Car USA		ISSUE DATE: 2020-09-23	STATUS DATE: 2020-09-29
FUNC GROUP: 3521	FUNC DESC: Headlamp, complete	Page 1 of 5

TJ Instruction VCC-519478-1

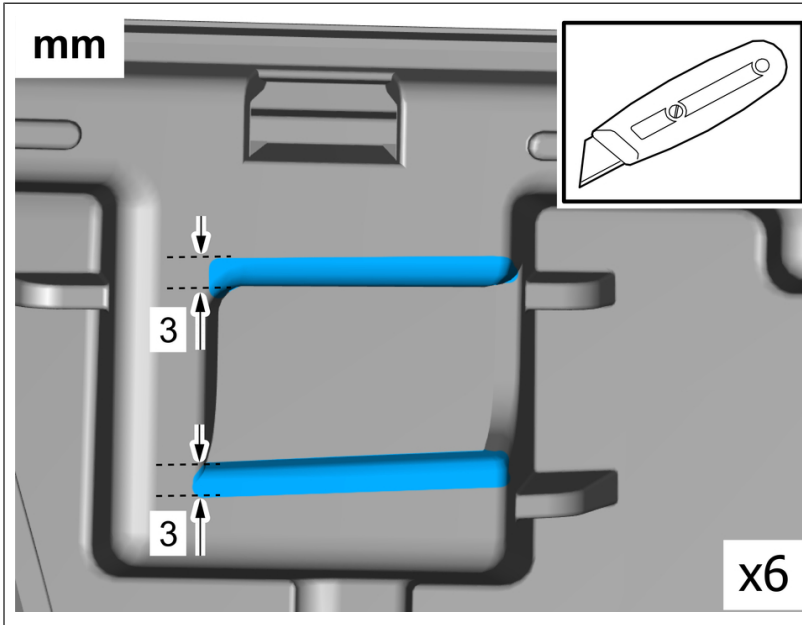
If the headlamps show signs of water intrusion and the guide pins are broken, see information and follow instruction for service solution described under “Service”.

Caution! Cut carefully to avoid unintentional damage or personal injury.

Note! Use a sharp knife.

Remove the marked parts.
